A Cruck House at Lower Radley, Berks.

By DAVID A. HINTON

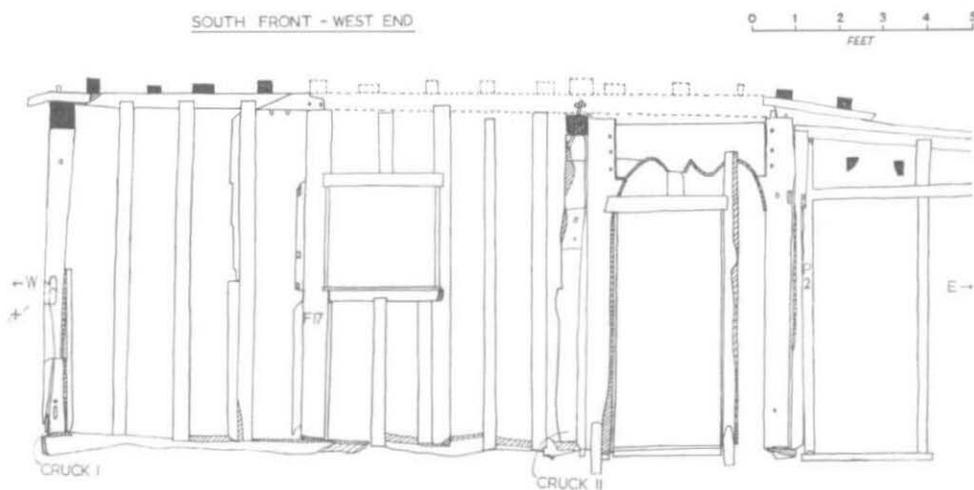
FIG. 6

It was not possible to be certain of the dates of all the timbers in the house, and many were evidently re-used. Many of the upright posts in the north and south fronts of the building (FIGS. 6 and 7) were obviously quite

recent, and had been nailed to the wall-plates by triangular joints, which showed on the outside face of the wall-plate, while a few older posts were morticed and pegged in. Mortices in the wall-plate soffits showed where there had been other posts previously. It was assumed that the newer posts were of the 19th-century period of reconstruction, for they occurred where there had been less need of complete re-building. The south front, from the 19th-century doorways to Cruck V, had been re-built mainly in brick, with intermittent timbers; most of the partition of Cruck V was similar. Presumably this front had needed more complete restoration, and it was found easier to carry out a thorough repair than to make merely a few alterations as elsewhere.

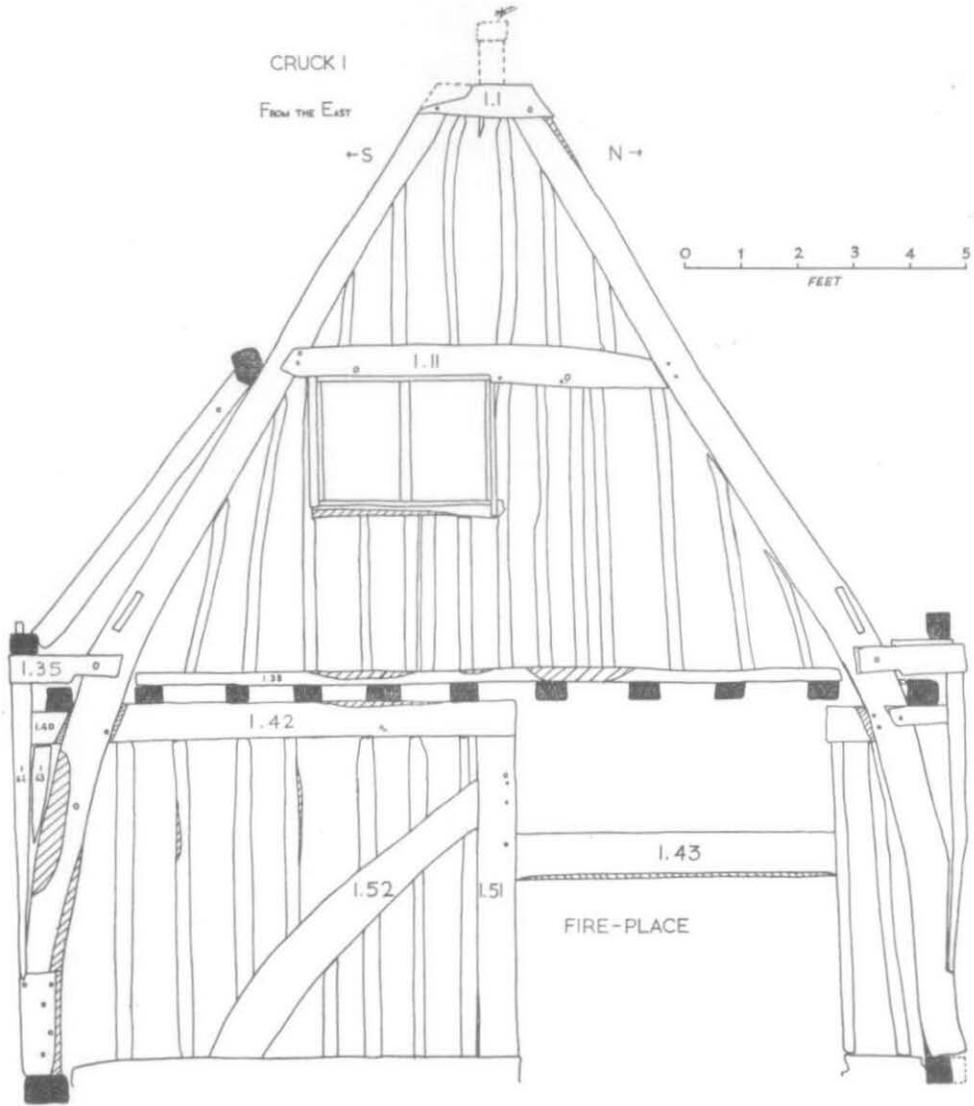
FIG. 8

The inside edges of the feet of Cruck I were 16 ft. apart, and were tenoned into the longitudinal sill-beams; the tenon at the base of the southern blade showed clearly from the exterior. This cruck had split at some period,

1 ft. 10 ins. above the sill, and a repair effected. A small upright flanking stud (I 62) was jointed into the cruck, which supported a small spur-tie (I 35), upon which the wall-plate rested, being pegged onto it. There was a blocking-

piece (I 63) between the cruck, the flanking stud, and a lower spur-tie (I 40) which abutted the stud, and upon which a joist rested. Above the higher spur-tie (I 35), which supported the wall-plate, was a wind-brace slot in the cruck; there being a corresponding one on the northern blade. The south purlin had a trench on its exterior face to fit the wind-brace, which, like all the wind-braces throughout the house, had been cut away. At its end, the purlin was pegged to the cruck, and was supported by a cleat and a principal rafter, which in its turn rested on the wall-plate. The north purlin unfortunately collapsed before it could be inspected. The cruck blades were joined at their tops by a saddle-beam (I 1), upon which stood the short king-post that supported the ridge-piece and rafters. Discretion prevented these from being measured too nicely. The north blade was similar to the south, though a small plank had had to be placed between wall-plate and spur-tie; and the foot had not split.

This truss formed the west gable of the house; the outside had been given a pebble-dash coating, and only the crucks themselves were left visible. The wall was composed of lath and plaster nailed onto upright studs, which were pushed into mortices in the soffits of the horizontal beams above, and sprung into grooves in the beams below; those which met the cruck blades were not attached to them. 5 ft. 9 ins. above the sill-beam was the tie-beam (I 42), which was morticed into the cruck blades. On this rested the joists, running East-West, there being an extra one resting on each of the lower spur-ties on the outside of both cruck blades. There was another, smaller beam (I 38) resting on the joists, unattached to the cruck blades, into which the next uprights were sprung; 5 ft. above this was the collar-beam (I 11), lapped and tenoned into the south, and tenoned into the north, blade; this had been slightly cut into when a 19th-century window was inserted, but had mortice slots where there had once been studs. It had no mortice slots to correspond with peg-holes in it, however. It supported the top row of studs. A fireplace had been added at the end of the 16th century; the chimney was built of stone and mortar, and had been extended in brick in the 19th century. The hearth projected into the room, and had a chamfered beam (I 43) across it. It had been modified in the 19th century.

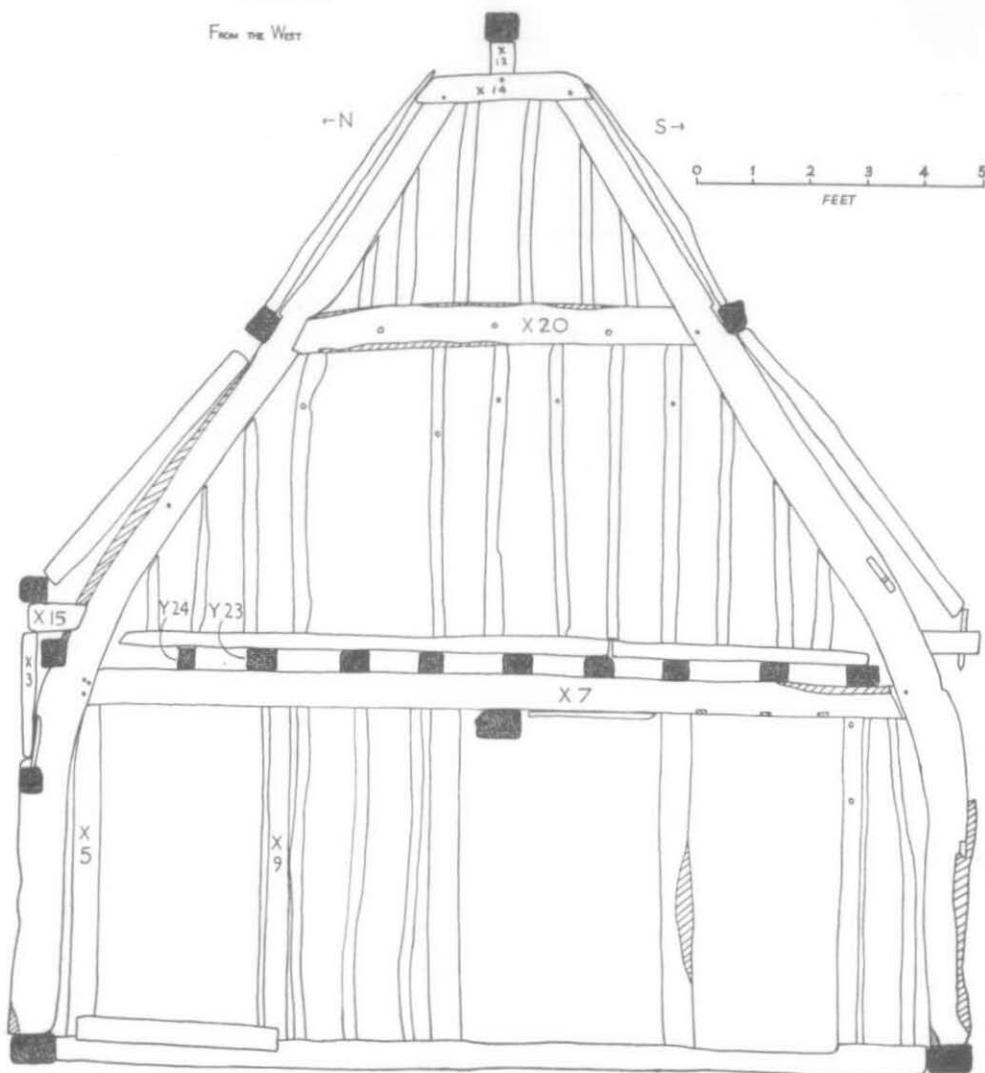
FIG. 9

The blades of Cruck II were rather more elbowed than those of Cruck I, and the foot of the southern blade may have warped, pulling the sill-beam on which it rested inwards, and causing the bend in it which was very noticeable in Bay I. The inside edges of the blades were 15 ft. 8 ins. apart. During re-building, the entrance to the 19th-century staircase had been put in, and earlier the end of the 16th-century hall-beam had been inserted immediately below the tie-beam (X 7), being cut off flush with it. Yet there was no post under it here to help bear its weight, a rash omission. Unlike Cruck I, Cruck II had not originally had flanking studs, the short one on the north side (X 3) apparently being 16th century, its tenon going in the opposite direction from those on other crucks. There had probably been a similar one on the southern blade, but it must have fallen out. The wall-plate rested upon a short spur-tie, well above the level of the tie-beam, which was tenoned into the blades at both ends. Under the northern spur-tie (X 15), was the end of the joist Y 24. The purlins on both blades of Cruck II were trenched and pegged into them, the trench being an inch deep. Principal rafters again gave the main support, as in Cruck I, though on the northern blade this had rotted away at the top, so that removal of the rafters was a particularly hazardous operation. The tops of the cruck blades were joined by a saddle-beam (X 14), rather longer than that on Cruck I, but the king-post (X 12) was not so high. What may have been a carpenter's mark,

rotted so badly. Both blades had slots on their east sides, the tenon of the brace remaining in the north blade's slot.

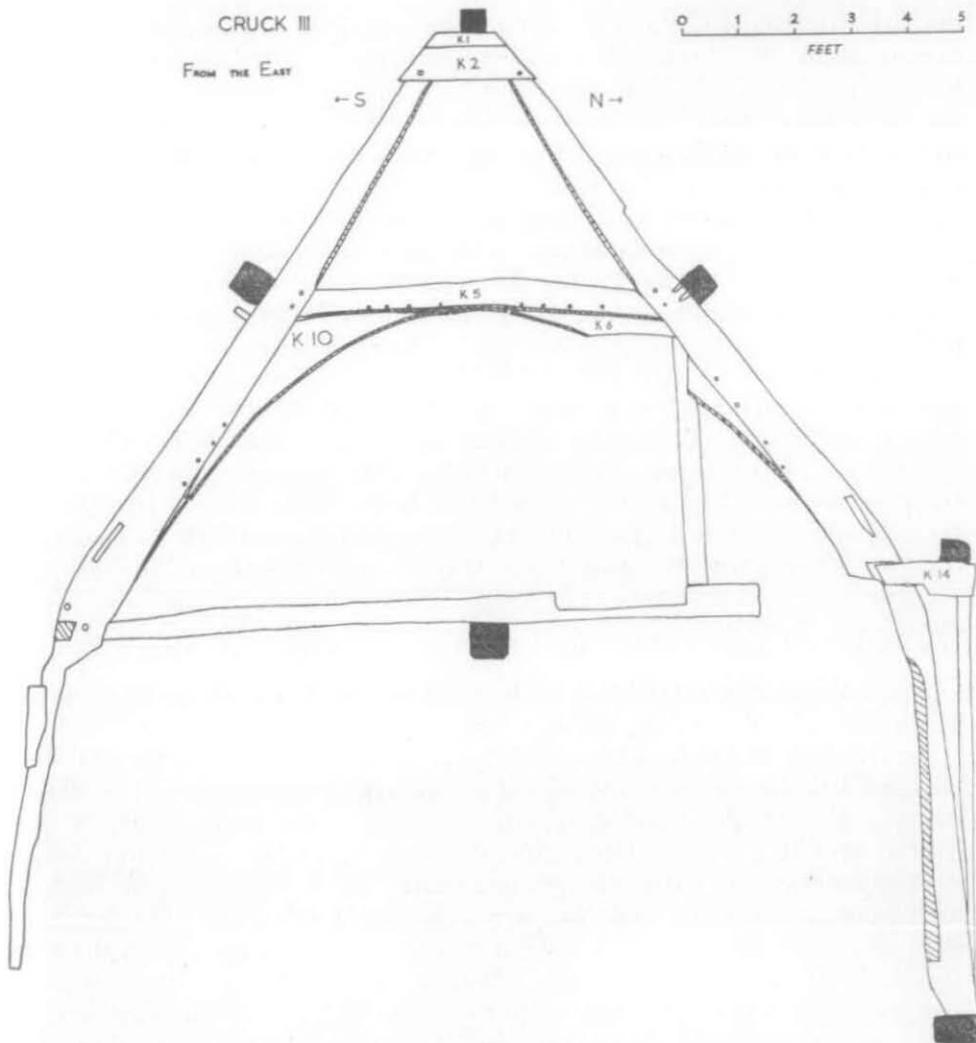
FIG. 10

The previous existence of an open Hall was proved by the arch-brace (K 6, K 10, etc.) under the collar-beam (K 5) of Cruck III, which did not originally have a tie-beam, though one had been halved into the cruck in the 16th-century reconstruction, to support the new floor. This cruck had been much cut about, being very thin on the south blade. The inside edges of its feet were 16 ft. 6 ins. apart. On the north, however, it still rested on its sill-beam, but had been altered further up to make room for the second 19th-century staircase. The arch-brace had also been cut on this side when the floor was inserted, so that a doorway could be made. The panels had been

filled with daub and wattle, but without studs, which were in all the other partitions. On the north side, the wall-plate was supported on a spur-tie (K 14), but both wall-plate and spur-tie had disappeared on the south. There were wind-brace slots on both sides of both blades, there being trenches in the purlins corresponding to them. On the north purlin, between Crucks II

and III, the sawn-off end of the wind-brace remained. This purlin had been extended immediately east of the cruck blade, a plain scarfed joint being secured by four pegs, two of which were flush with the blade itself. Neither purlin was fitted into a trench in the blade, but both had a cleat under them, upon which the south purlin no longer rested. Both purlins were pegged into the tops of the blades. If they had ever had principal rafters, these had been removed during the 19th century when the staircases were put in in the north, and a dormer window in the south. The arch-brace had five sections, including a small piece at the top joining the two main sections; these were morticed and pegged into the blades, the other three sections being cut out of the blades and the collar-beam. Slightly chamfered on both sides, this brace was an impressive feature of the house; Mr. Charles has shown that these braces also had an important structural role. The blades above the collar-beam were chamfered on both sides, as was the collar-beam itself. They were joined by a saddle-beam, which was higher than those on Crucks I and II, being in two pieces (K₁, K₂) pegged together. There was no king-post for the ridge-piece to rest on; this had been extended about 18 ins. to the east of the truss, being joined by three pegs. It was pegged into the saddle-beam.

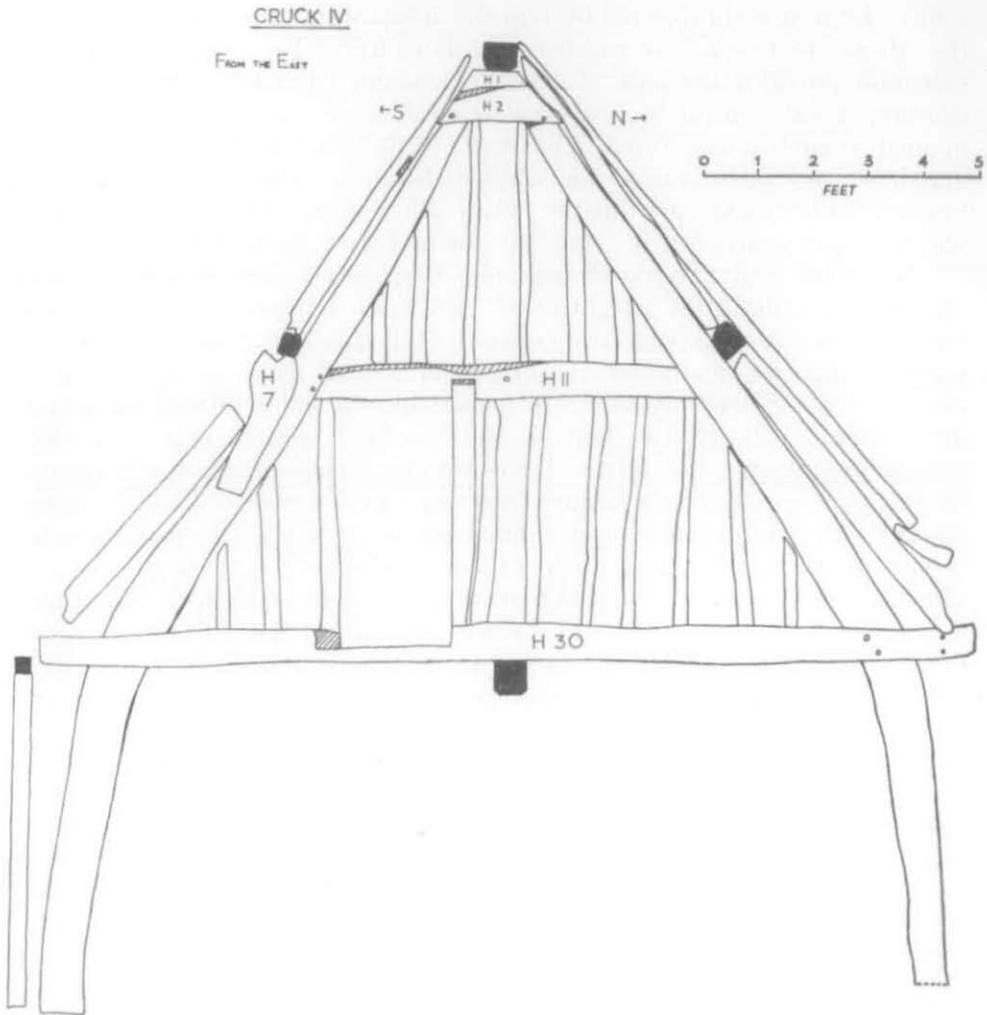
FIG. 11

The most difficult problem of Cruck IV was that neither of its blades rested upon sill-beams, either longitudinal or transverse. Its inside edges at ground level were only 15 ft. 3 ins. apart, which was considerably less than those of the other crucks. It was also lower. There were significant differences between the construction of the area round the tie-beam (H 30) of Cruck IV and the others; it was halved, not tenoned, into the cruck blades, and projected beyond to carry the wall-plate—as is normal in most cruck houses. The joists of Bay IV, like those in the Hall, ran North-South, not East-West

as in Bay I, so that the studs were able to rest directly on the tie-beam. There was less distance between this and the collar-beam (H 11)—4 ft. as opposed to 5 ft. 9ins. (5 ft. 3 ins. from the upper beam) on Crucks I and II. But the collar-beam was 4 ft. 3 ins. from the saddle-beam (H 1, H 2), against 4 ft. and 3 ft. 6ins. on I and II respectively. A doorway between tie- and collar-beams had been inserted when the Hall floor was ceiled. There were wind-

brace slots on the west, but not on the east, faces of the blades. The purlin on the south blade had evidently slipped, because an extra support (H 7) had been fixed to the blade ; but this had also apparently slipped. Both purlins had principal rafter supports. There was no king-post on the saddle-beam, which was in two pieces like that on Cruck III. The northern blade had what might have been a carpenter's mark, a scratched

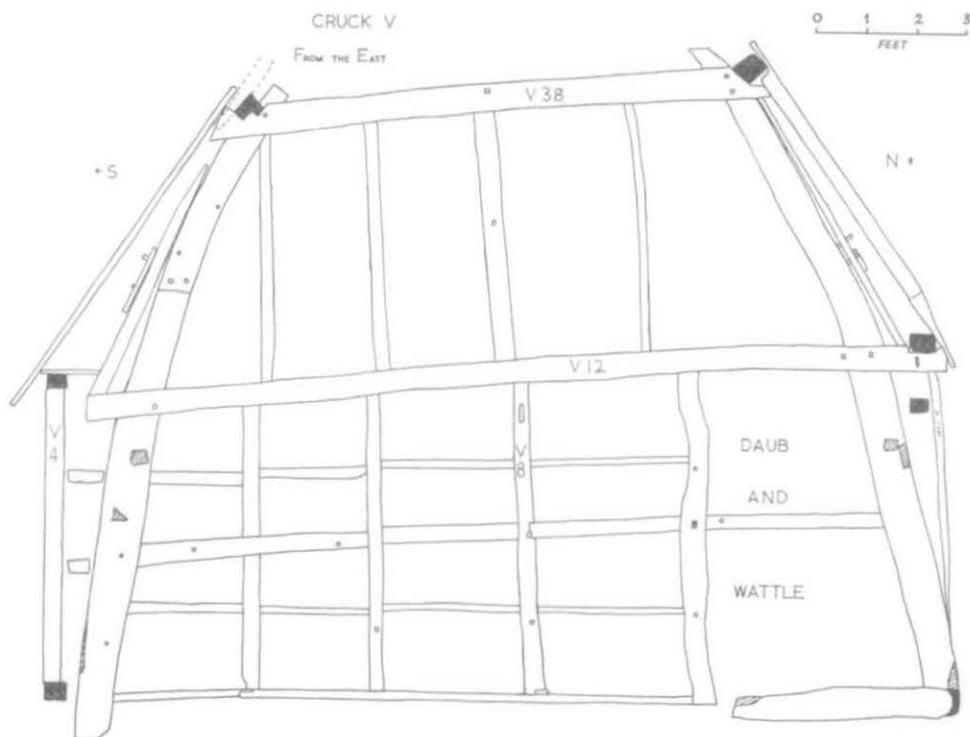
FIG. 12

The inside edges of the feet of Cruck V were 16 ft. 4½ ins. apart, and here similarity between it and the other four crucks all but ended. The most obvious difference was that it had been sawn off just above the collar-beam (V 38), which supported rafters. On the south side, the foot of the blade was

1 ft. 9 ins. lower than on the north, where it rested on a 6½ in. deep sill-beam ; there was no sill-beam on the south. The tie-beam (V 12) sloped 1 ft. 3 ins. from north to south, the collar-beam, being shorter, 1 ft. Compared with Cruck I, the tie-beam was about the same height from the sill-beam under the north blade, the collar-beam about 6 ins. lower. The blades were very much less elbowed, the collar-beam being 9 ft. 2 ins. between the blades compared with 6 ft. 9 ins. on Cruck I ; it was only 4 ft. 7 ins. shorter than the tie-beam. The rebuilding of the south front had left the cruck blade several inches behind it, and the wall-plate (such as there was) rested on an independent upright (V 4). The tie-beam was halved into the cruck, as was the collar-beam ; both projected beyond it. A principal rafter on the south had rotted, but on the north ran up to the purlin. There was a wind-brace pegged to the rafter on the south, which was also pegged to the purlin. On the north, the brace had been broken, but its pegs remained. The south blade of the cruck had been repaired between tie- and collar-beams, the two pieces being pegged together. The purlins were slotted and pegged into the cruck blades and into the collar-beam. The principal rafter on the north, which in fact was only a pole, was pegged to the projection of the collar-beam, and fitted under and round the purlin. The wall-plate was pegged and slotted into the tie-beam projection, and there was a long, thin flanking stud (V 27) fitted into the cruck blade, and under the tie-beam. Several of the timbers in the framing of the partition were old, but were probably re-used. The partitions were filled with brick, except for the two under the tie-beam next to the north blade which were daub and wattle. Various slots and grooves in the cruck were caused by a lean-to shed which had been a continuation of the half-hip roof angle. Re-used timbers in the shed were measured, but it was impossible to prove that they had ever been used in the house itself.

It also seems possible that there was in the 19th century a dramatic collapse of the south-east corner of the house. The extreme slope of the tie- and collar-beams on Cruck V, and the greater depth of the foot of the south blade compared to that of the north, suggest that there may well have been considerable subsidence. This perhaps caused a similar movement in Cruck IV, which would explain why the foot of its south blade did not rest on a timber sill-beam, but disappeared into the ground for about 6 ins. from the floor—a total drop of about a foot. This would also explain why the central beam in the Hall rose so noticeably after its horizontal start. The movement altered the whole line of the south front beyond Cruck III, so that it was re-built completely. Unfortunately, the north blade of Cruck IV, which also lacked a sill-beam, could not be measured for depth, but as Cruck V, and the front between Crucks IV and V, still rested on a sill-beam, the north presumably held firm. Slight movement in Cruck III on the south is suggested by the small gap between the lower part of the arch-brace and the blade. Further evidence of this is that the wall within Cruck V had been re-built in 19th-century brick, except for the northern 4 ft., which was daub and wattle—and stood on a proper sill-beam. Subsidence would therefore explain the failure of Cruck IV to stand in a line with Cruck I, the upright F 17, the front door-posts, and Cruck III, its alignment with Crucks I and II being coincidence, caused by the warping of Cruck II.

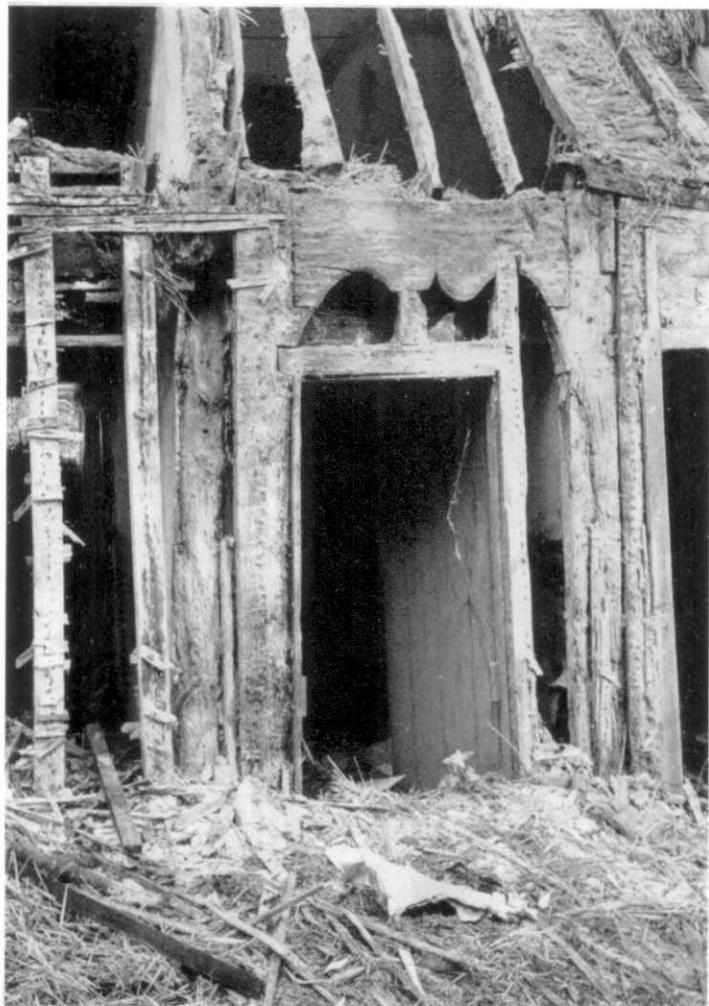
During the process of demolition, one of the most important features of the house was revealed, for a very fine doorway with double ogee-arched and chamfered head-board came to light (PL. II A, FIG. 6). This had been completely covered with lath and plaster in the 19th century, when a smaller door-frame had been built into it. This is the first time that a doorway of any significance has been reported in a cruck-built house;⁶ stylistically, however, it could belong to the late 14th century structure, or to the late 16th century re-building. The touch of distinction which it gave to the house can be compared to the slightly luxurious feature of the chamfered brace under the collar-beam in Cruck II, but this is a feature found in many cruck houses. The fire-place beams and the central beam in the Hall, of the late 16th-century period, were also chamfered—a comparable small decorative addition. The door-posts have tenons, to fit into the wall-plate, as do the other first period uprights, such as F 17 in the same front, but this would have been the normal joint in the late 16th century also. No associated pottery was found in the holes in which the posts had stood—for the sill-beam had rotted away—nor were the posts in line with the sill-beam of Bay I. A sill could have run almost without deviation from the foot of Cruck I to F 17, and then to the two door-posts and Cruck III; but its actual line altered between F 17 and Cruck II. Had this cruck shifted by warping, it could have pulled the sill-beam with it. Had it always been its present shape, there would have been nothing to prevent

LOWER RADLEY. A. MEDIEVAL DOOR-FRAME IN
SOUTH FRONT

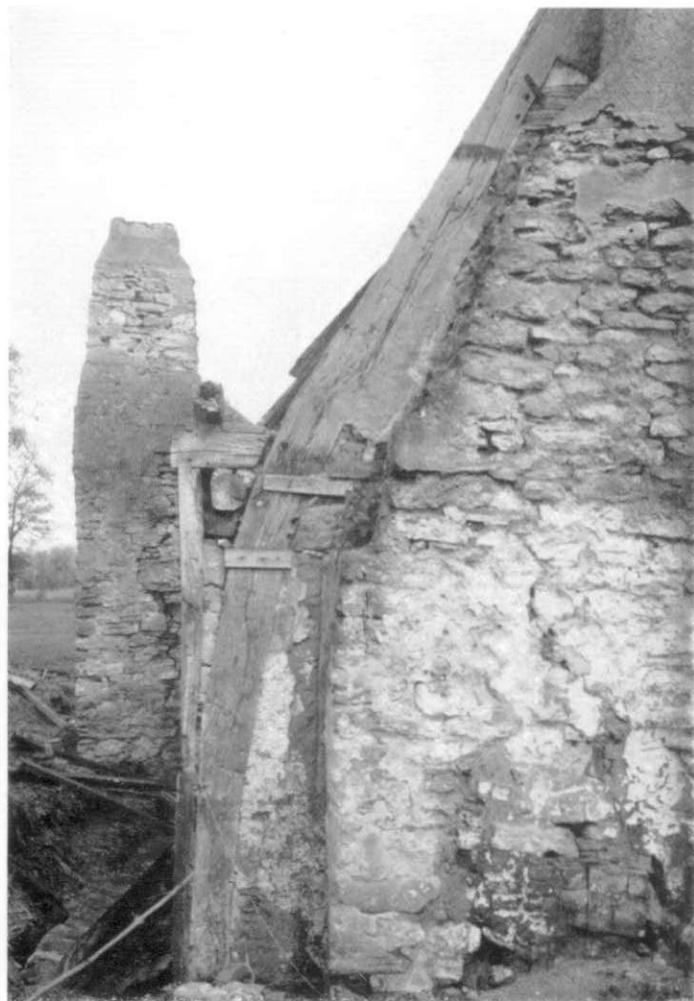
B. CRUCK I, NORTH BLADE FROM EXTERIOR

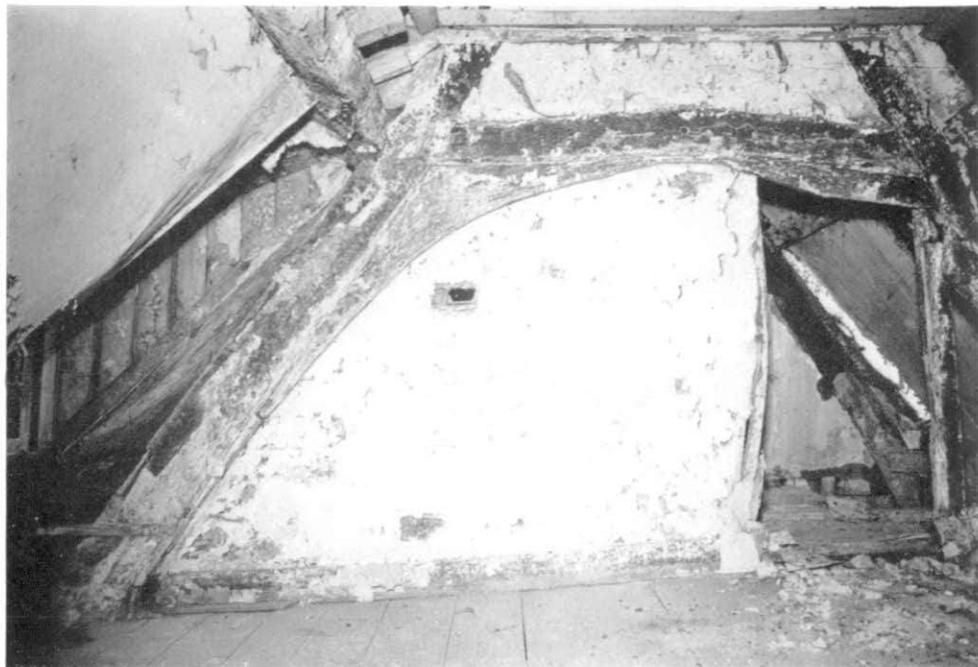
LOWER RADLEY. A. CRUCK III, ARCH BRACE OVER HALL, FROM THE EAST

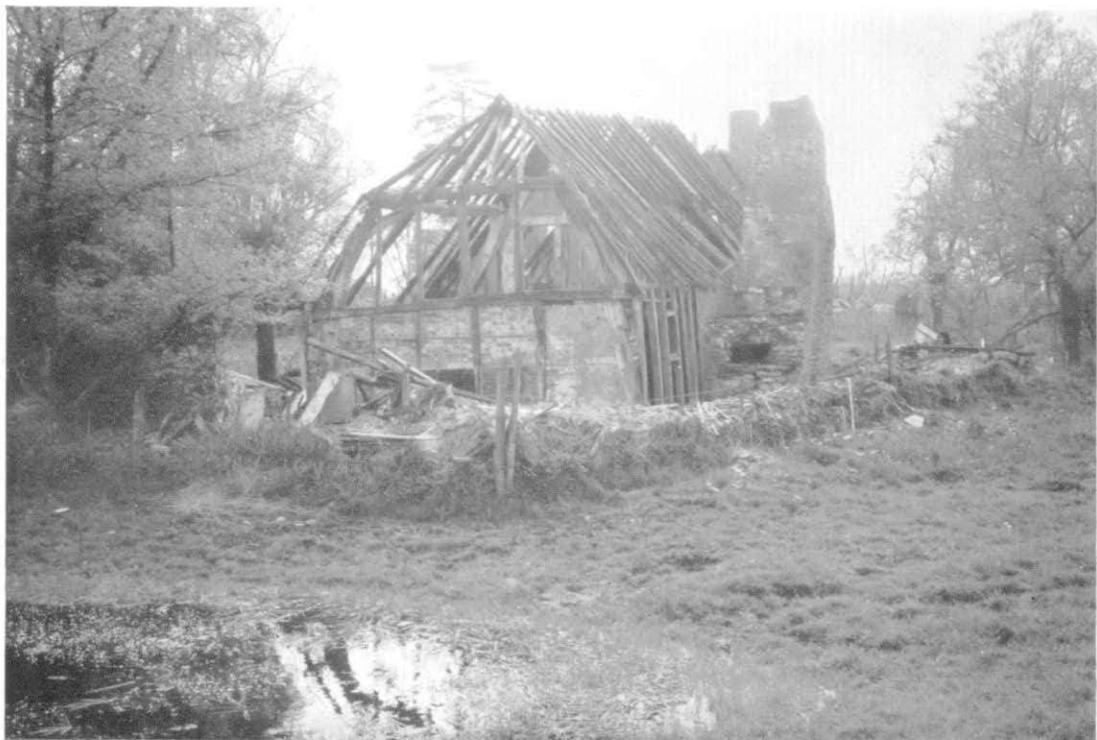
LOWER RADLEY. CRUCK V, FROM THE EAST. CHIMNEY LENGTH PROBABLY AS IN
16TH CENTURY
