Swalcliffe: a New College Barn in the Fifteenth Century

By J.T. MUNBY and J.M. STEANE

SUMMARY

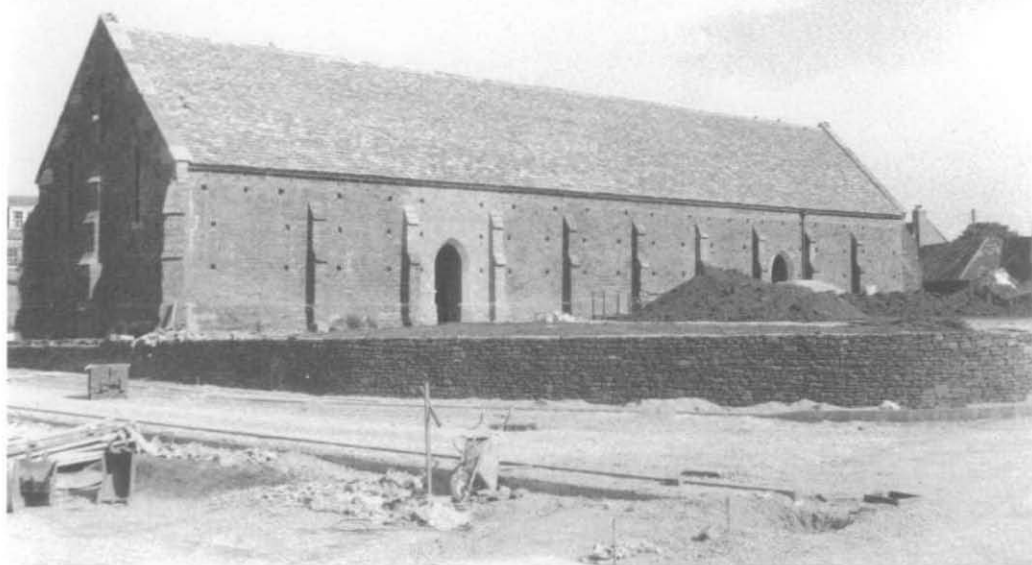
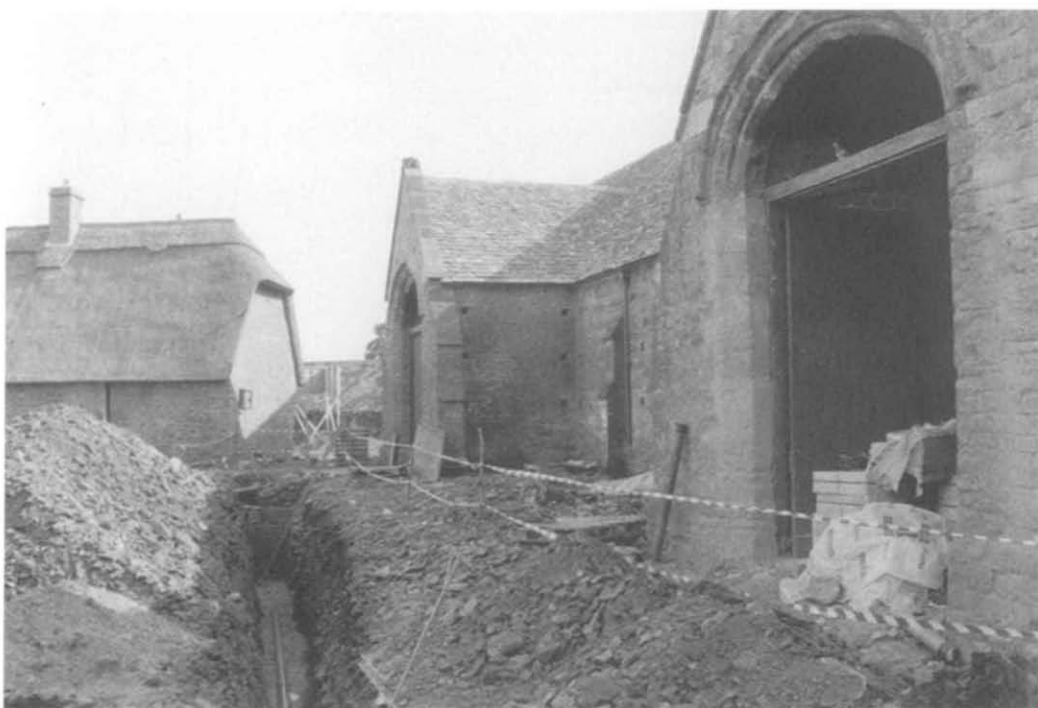
Fig. 4. Exterior of great barn during restoration. *Top*: from north-west; *bottom*: from north-east.

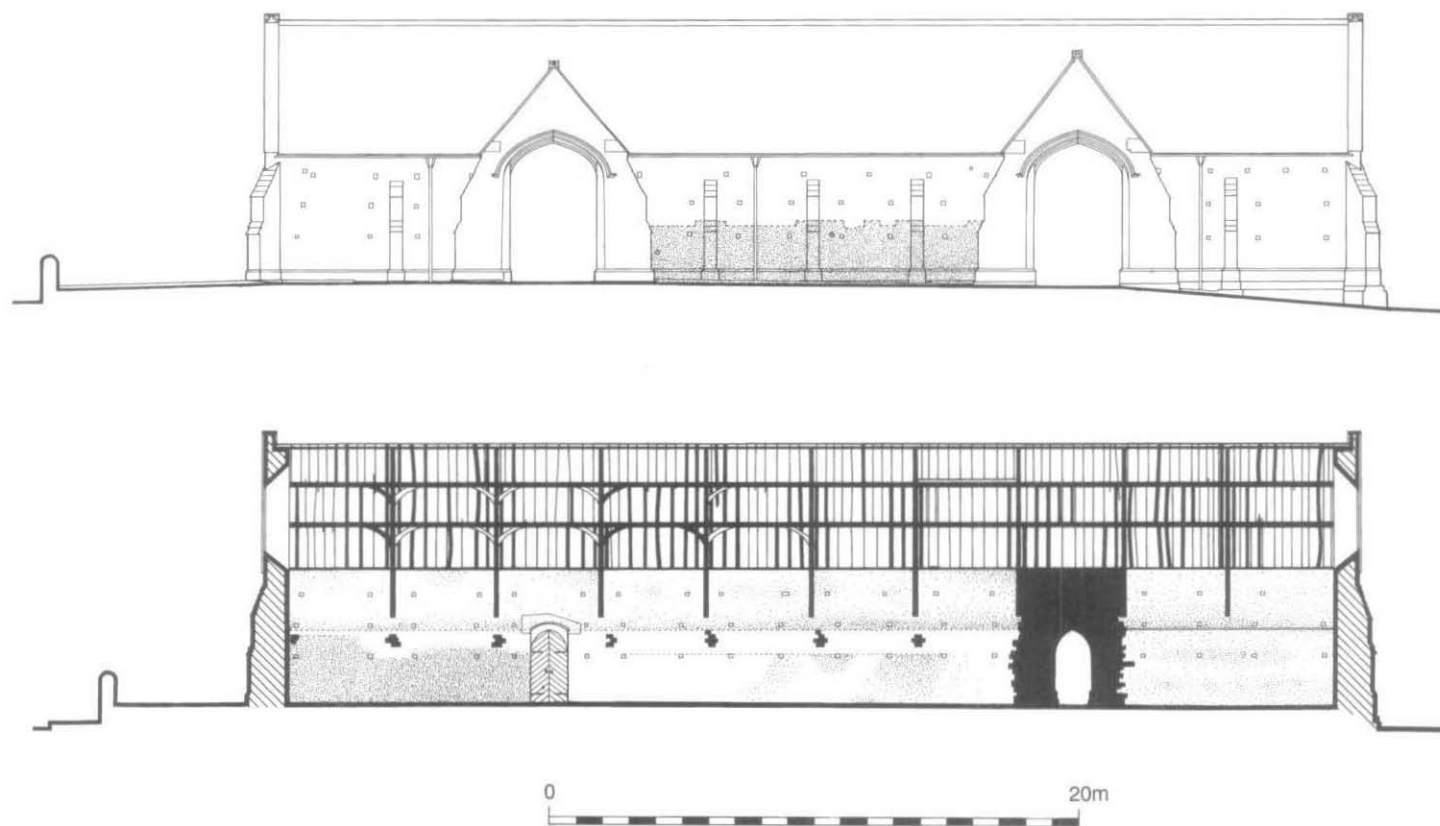
Fig. 10. Great barn: east elevation of east and west walls, showing new stone (in black), whitewash (stippled), and survival of original timbers (in bold).

In the restoration work (see Figs. 10–11) new purlins have been introduced rather than removing or repairing the original ones; the new ones are easily recognized by their steel shoes bolted to the cruck blades.

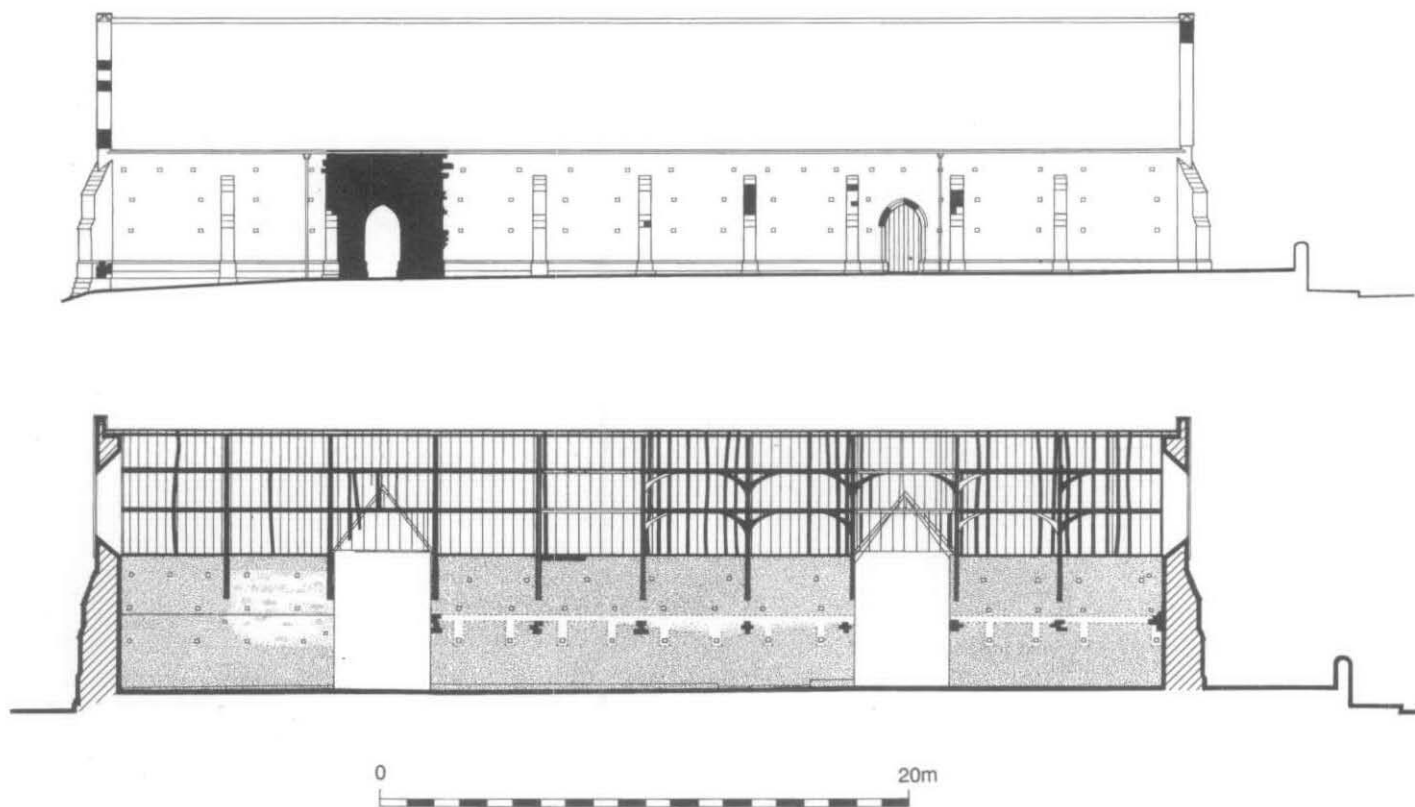
Fig. 11. Great barn; west elevation of east and west walls, showing new stone (in black), whitewash (stippled), and survival of original timbers (in bold).

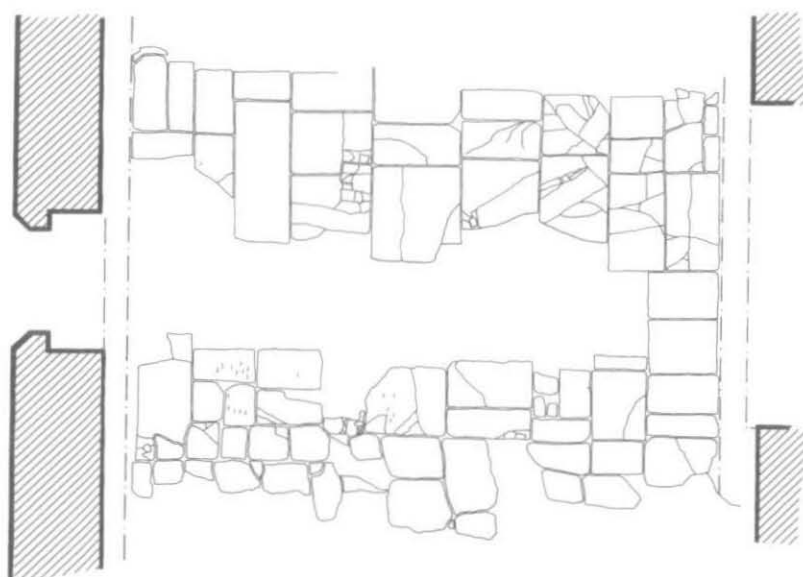
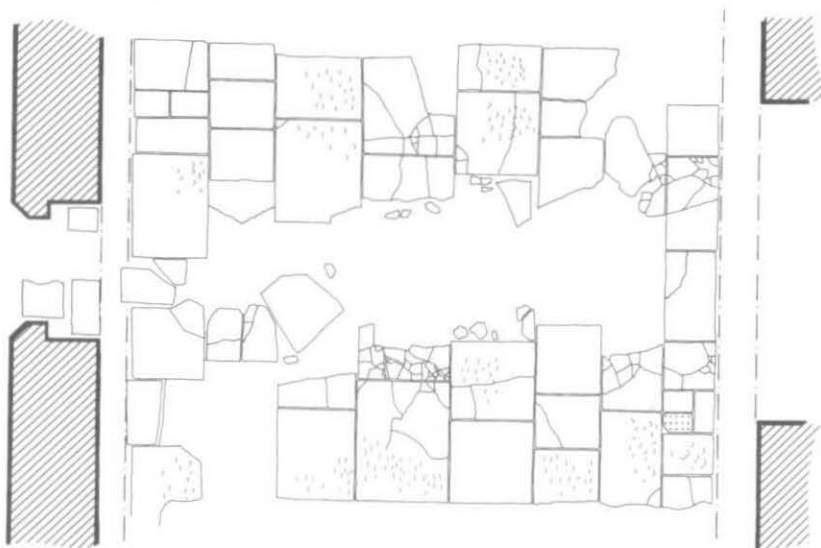
These are in a damaged state. It would appear that the stone slabbing is a secondary floor covering, because nothing in the accounts refers to equipping the barn with stone-slabbed floors and it is likely that these were of earth in the earlier phases of the barn's use, possibly covered during threshing with a temporary floor of timber planking (*pace* Chambers in Section IV above). The stone slabs varied in thickness from 50 to 125 mm. (2 to 5 ins.). Those of the south threshing floor had been laid in one campaign since the edges of the slabs lined up regularly right across the floor. It had been damaged by fracturing, more heavily in two areas near the entrance to the waggon porch, less heavily on the western side near the smaller doorway. The further patches of intense wear causing fragmentation had taken place in the centre slabs. It would seem a reasonable

Fig. 14. Great barn: threshing floors, showing wear marks.

inference that these four areas corresponded with the stress which the wheels of a heavily loaded cart might cause when being rocked during unloading. Extensive damage had been done right across the floor with slabs broken and removed. Local information alleged that the floor slabbing had been penetrated in this way to provide space for a corn auger to operate. Another suggestion is that the slabs might have been taken up to create a void for a vehicle inspection pit. The north threshing floor showed similar fragmentation patterns but slabs were irregular in size and in general showed more signs of disturbance and remodelling. The thickness of the slabs here varied from 50 to 90 mm. (2 to 3½ ins.). A large patch of concrete near the reconstructed door was bounded on its south side by a ledge which supported the idea here of an inspection pit with a wooden cover. The rest of the floor in the barn had been covered in concrete probably during the time of Mr Douglas Jack of Swalcliffe Lea. He had adapted the barn for storing root crops and potatoes.

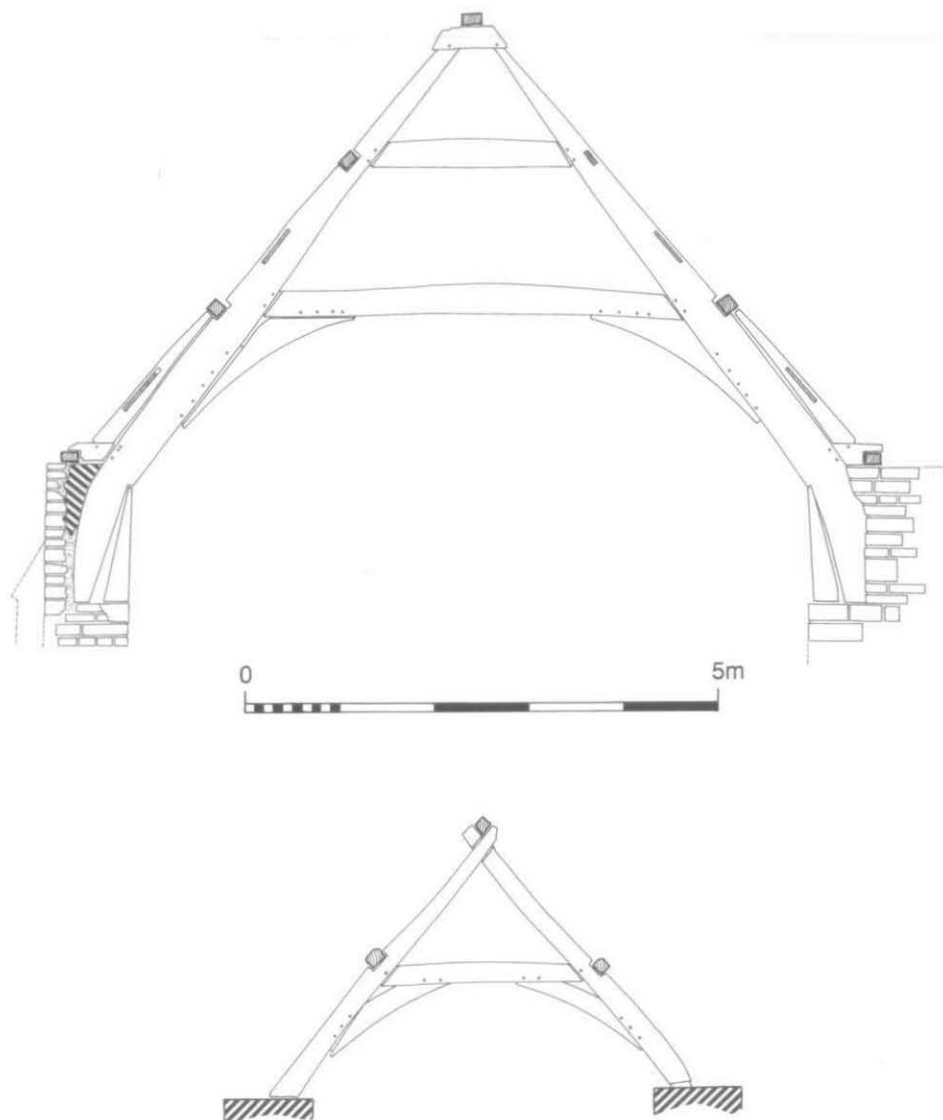
Fig. 15. Great barn: roof trusses. A (top): Truss 3. B (bottom): Truss in north-east porch.

Repair of all the cruck trusses was achieved *in situ* including the third truss from the north which had splayed most. This was the only cruck truss which required significant repair, to the cruck foot, on the west side. The cruck truss required easing back together and supplementing its strength by the insertion of a thin steel tie. Similar thin steel ties were installed elsewhere including above the main tie beam level of the fifth and sixth cruck trusses from the north. Such ties, when dull painted, are scarcely noticeable, involve minimum intervention and are the successors of a traditional method of repair.

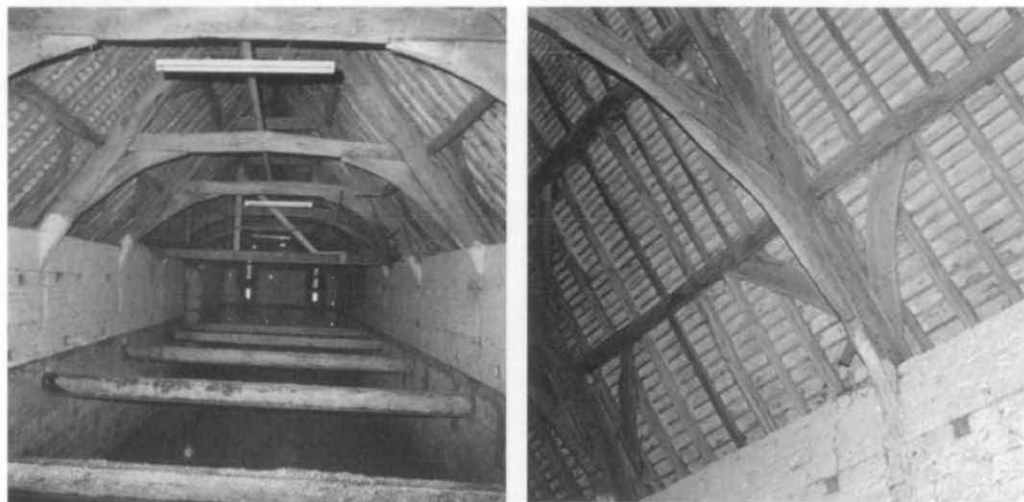
Fig. 16. Great barn: roof prior to restoration. *Left:* Interior view with inserted floor. *Right:* Cruck beam and windbraces.

The most significant change to the character of the roof had been the loss of the windbraces for which good evidence survived and which were apparently in place when Sir Henry Dryden wrote an account of Swalcliffe in 1887, which is discussed below in Part III. Following consultations, the decision was taken to replace the windbraces and was justified for these main reasons: there was adequate reliable evidence for the presence and former character of the windbracing; their reinstatement would improve the structural integrity of the roof frame by reinstating their function in helping to provide additional longitudinal stability to the roof (identified as a problem by English Heritage's engineer, Peter Badcock); the reinstatement would involve no loss of historic fabric; the reinstatement of the windbraces would enable the visitor to understand and appreciate the built design.
