Chapel of the Blessed Trinity, Stonor

DAVID CLARK and JOHN STEANE

SUMMARY

Recent renovation work provided the opportunity to carry out in-depth building recording at the Chapel of the Blessed Trinity at Stonor in the south Oxfordshire Chilterns. This article presents the findings of the structural analysis and of documentary research in the archive at Stonor House. A new tree-ring date confirms the building's fourteenth-century origins as a family chapel belonging to the locally prominent Stonor family. It is shown that the tower, probably started in the early fifteenth century, was the first major addition, perhaps associated with adjacent accommodation for the six chaplains employed by the Stonor family. The chapel continued in use after the Reformation, used clandestinely for Catholic worship by the recusant Stonors. The authors' detailed study of the roof structure shows that towards the end of the sixteenth century there was a major rebuilding of the chapel roof. The old roof was largely removed, and the four eastern bays were provided with a new crown-post roof which supported a lath-and-plaster ceiling. Finally, in the 1790s, when Catholic places of worship were given leg

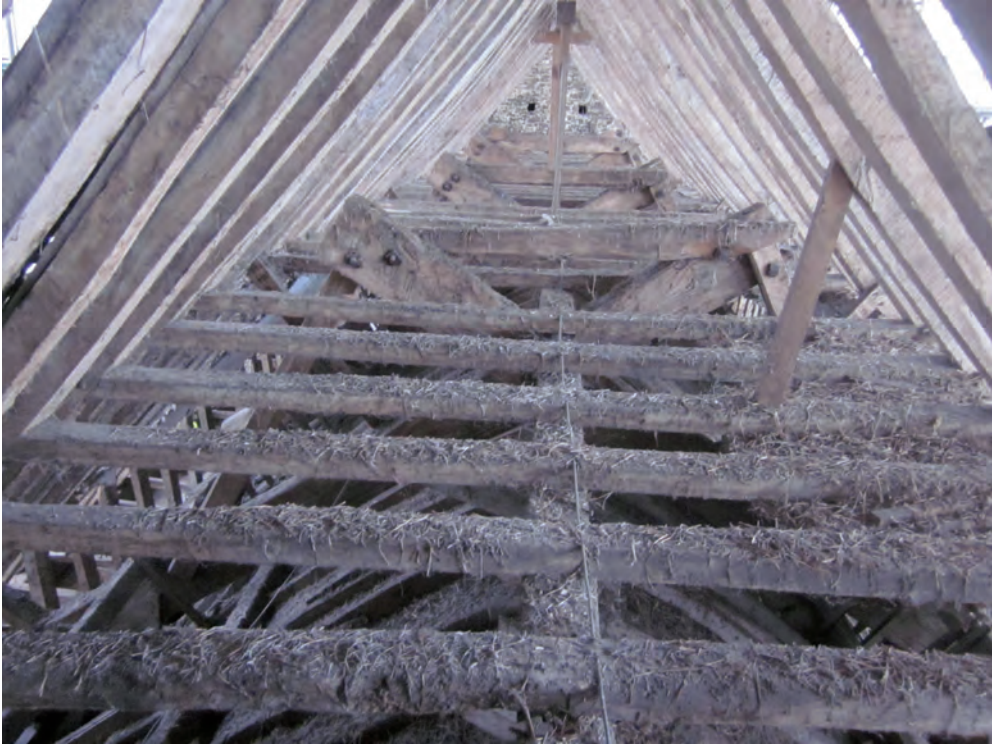
Fig. 11. Crown-post roof from west. Photo by David Clark.

The crown plate survives (see the centre of Fig. 11), with empty mortices in the soffit and two peg-holes for the braces to the crown-posts. Parts of the braces survive within some of the mortices, indicating that they had been used. The plate itself consists of three lengths joined by face-lapped scarf joints with full-length tongue-and-groove, square vertical abutments and two edge pegs. These were noted between rafters 13 and 14 and at 26 where it was pegged through the collar. This joint has been found at Canterbury Cathedral (c.1455), the Long Gallery at Abingdon Abbey (1455), and the top plates of the great barn at Harmondsworth (1426).⁷⁴

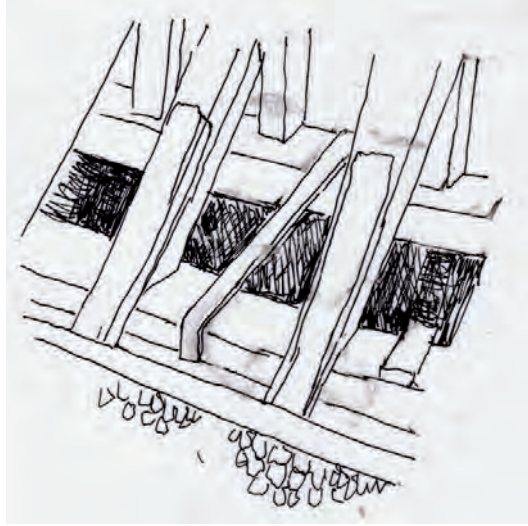
Fig. 13. Iron tie between rafters N16 and N17. Drawing by John Steane.

There is a splayed scarf joint in the outer north wallplate some three feet to the east of its point of entry into the tower brickwork, through a crudely broken opening. It is truncated seven inches into the tower brickwork. Between the wall-plates are short ties (17–19 inches long) with chiselled assembly marks, tenoned into the plates. Movement in the roof has caused these to break apart, with gaps of between 1½ in to 4 inches. Timber ties have been nailed across the wall-plates to prevent this movement from spreading; iron ties are also used to supplement these in places (Fig. 13).

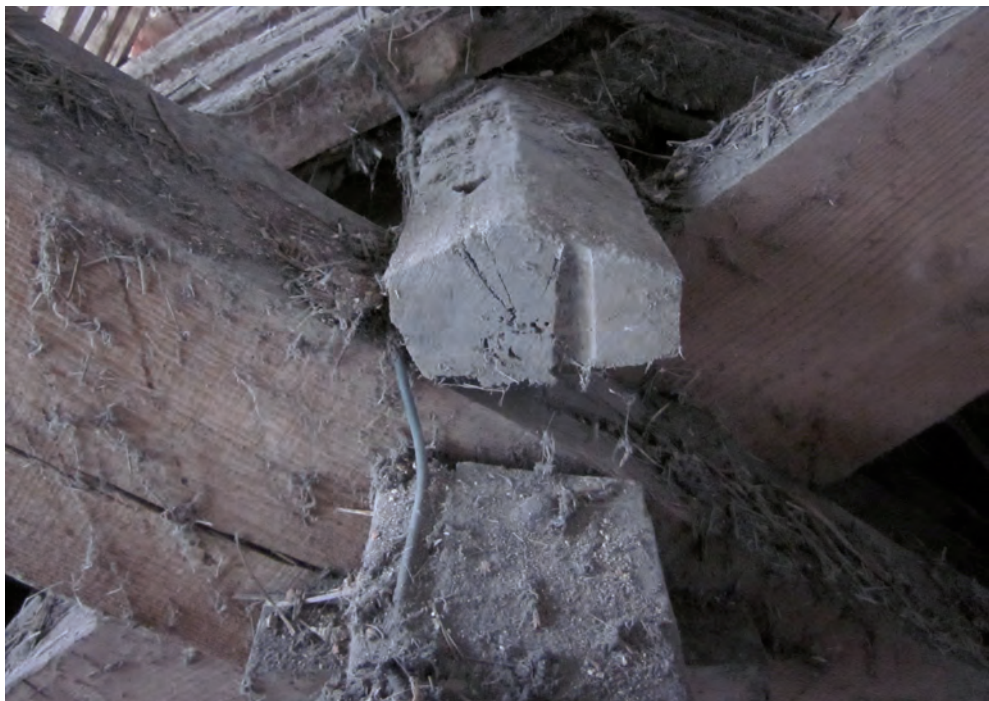
As noted above, although there was a truncated tie-beam at truss V, it was not set on the wall-plates of the crown-post roof, but in a notch in a slightly lower wall-plate to the west. The dendrochronology (see below) showed that this was a replacement of 1517. The principal rafter was placed centrally on the tie-beam – not to the eastern face – and there was no visible assembly mark. The rafters at truss V had been part of the scissor-braced roof at the west end of the chapel. Both had grooves down their east faces and an empty mortice (and peg) for the missing scissor-brace. The position of the northern rafter has also been altered, since its foot rests on an inserted softwood plank somewhat to the south of the tower, rather than on the wall-plate (or its continuation). As with the other principal rafter trusses, truss V (Fig. 14) has been largely replaced by a softwood insertion to support the 1790s vault.

Fig. 14. Truss V – crown plate in foreground. Photo by David Clark.

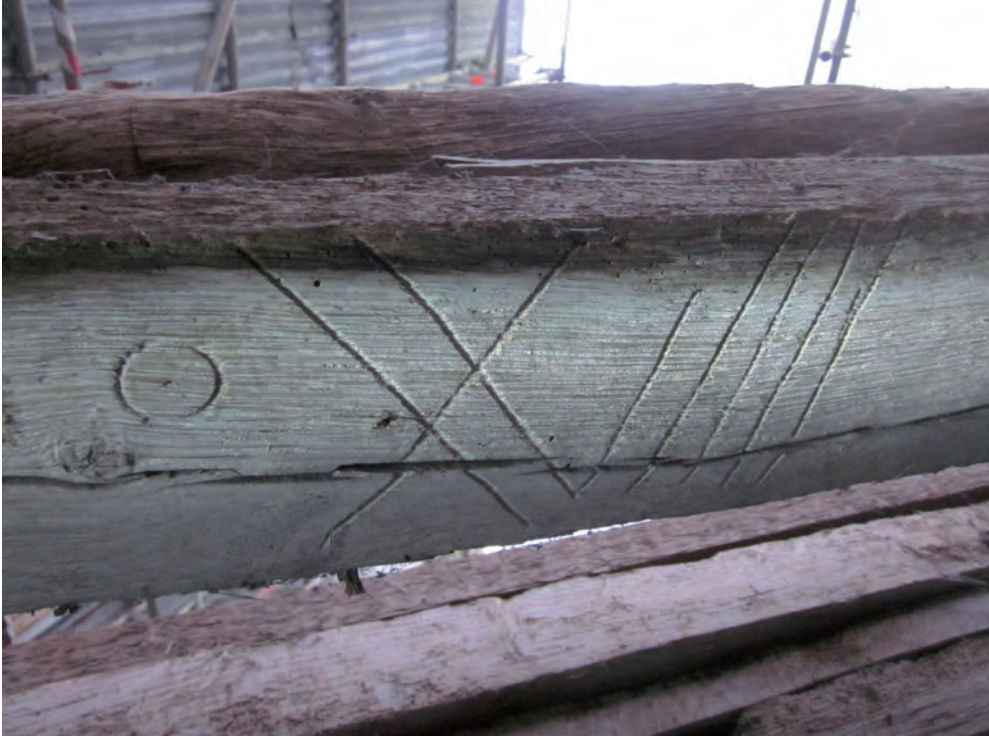
Fig. 16. Assembly mark on rafter S39. Photo by David Clark.

others were stronger, as can be seen in the example in Figure 16. In both cases a race knife was used.

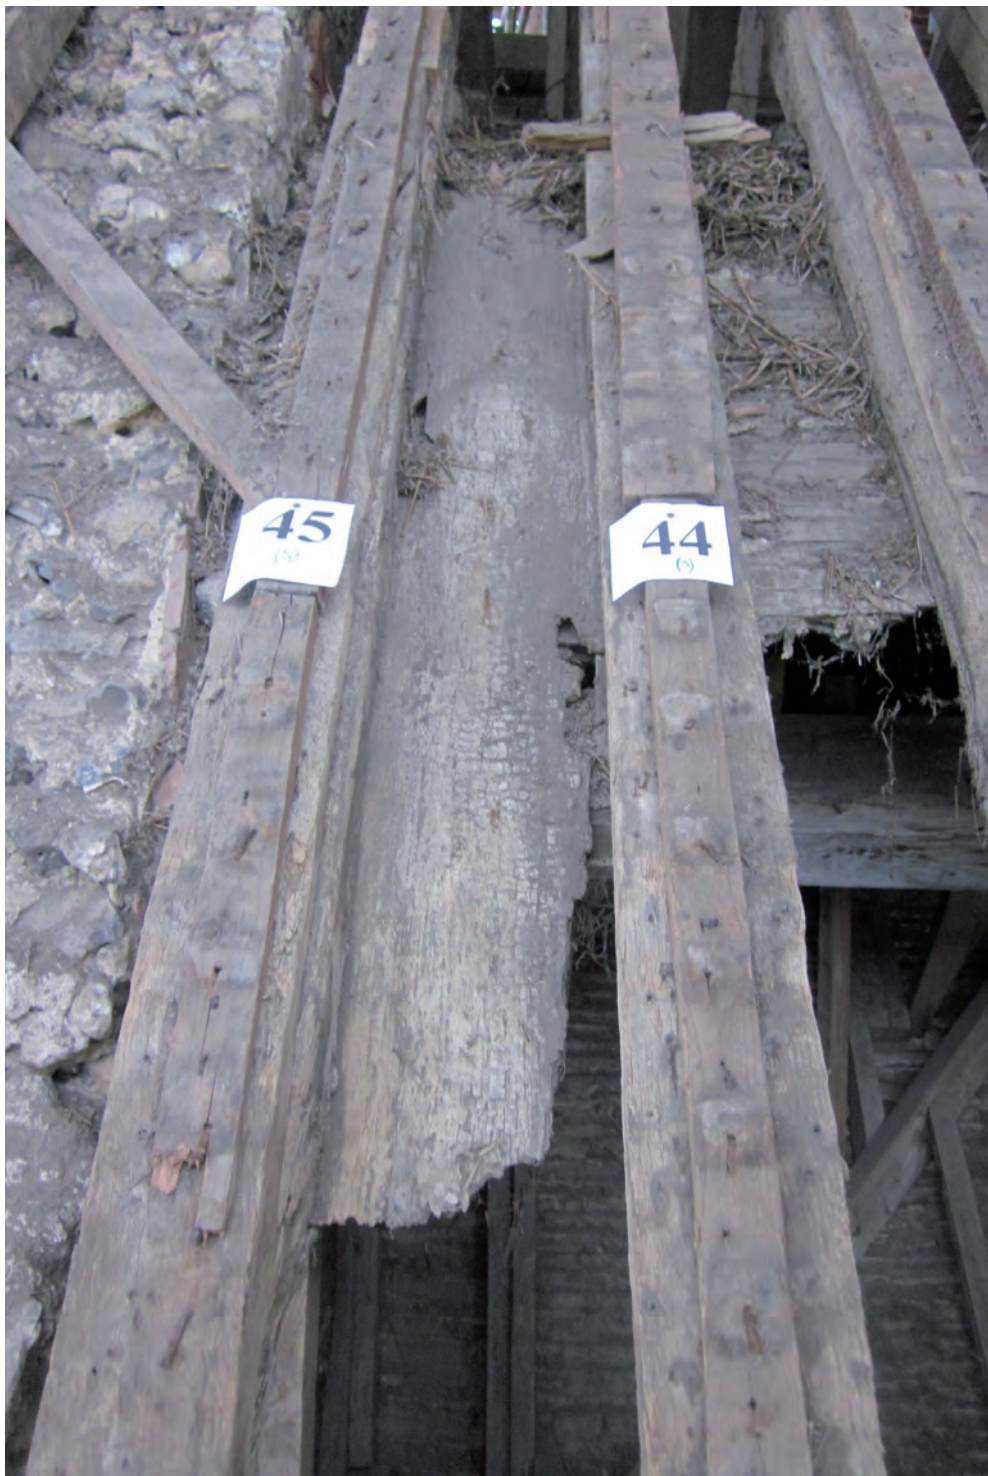
Fig. 17. Ceiling plank at west end of south slope. Photo by David Clark.

The ceiling plank (Fig. 17) was assessed by Dr D.W.H. Miles of the Oxford Dendrochronology Laboratory as being Baltic oak, but was undateable. It appeared to have some sort of yellow ochre coating, but there was no evidence of a decorative scheme such as survives in the Lady

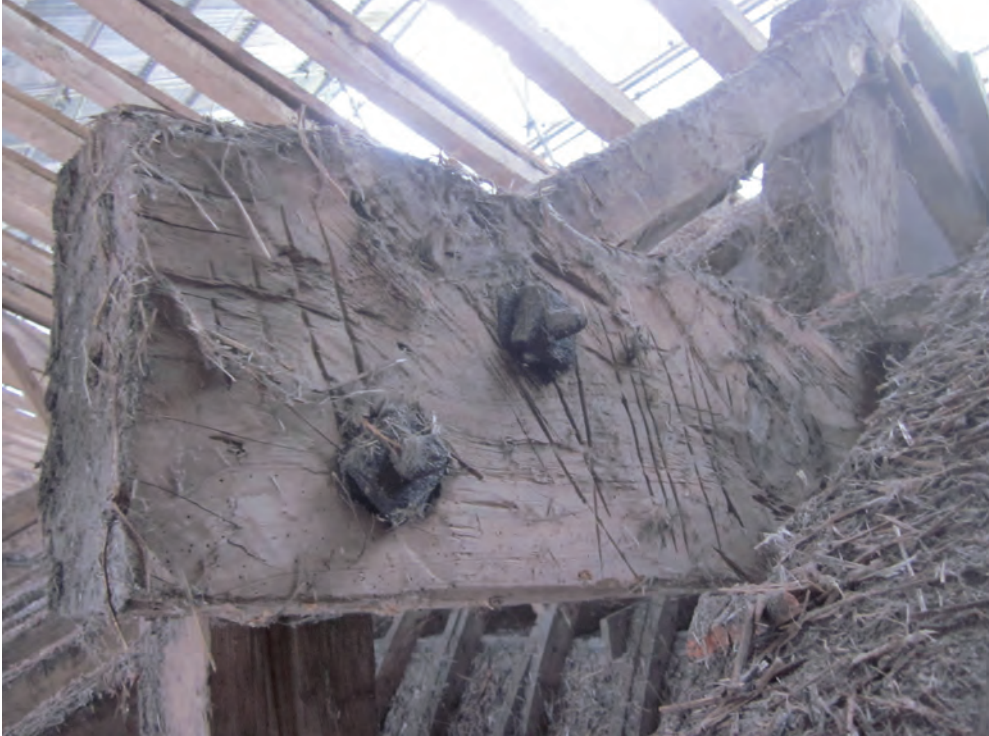
Fig. 18. Baltic timber marks at truss IV (rafter N27). Photo by David Clark.

A number of the baulks have distinctive Baltic timber marks (Fig. 18), one with the star-

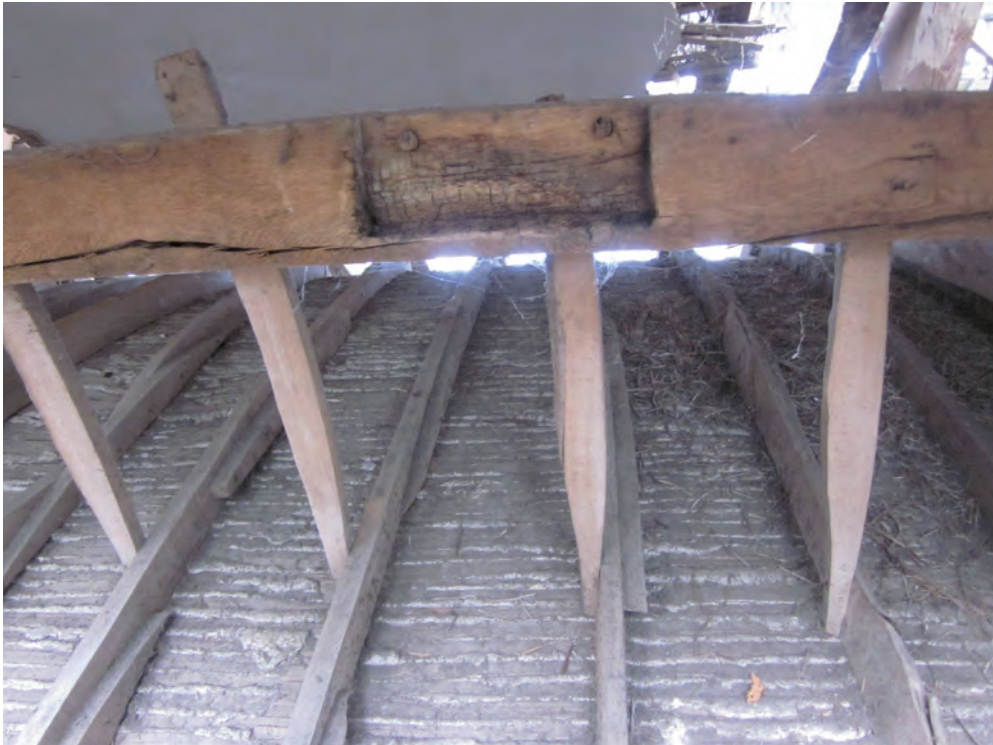
Fig. 19. Purlin in Bay 2 south with struts supporting the ribs of the plaster vault below. Photo by David Clark.

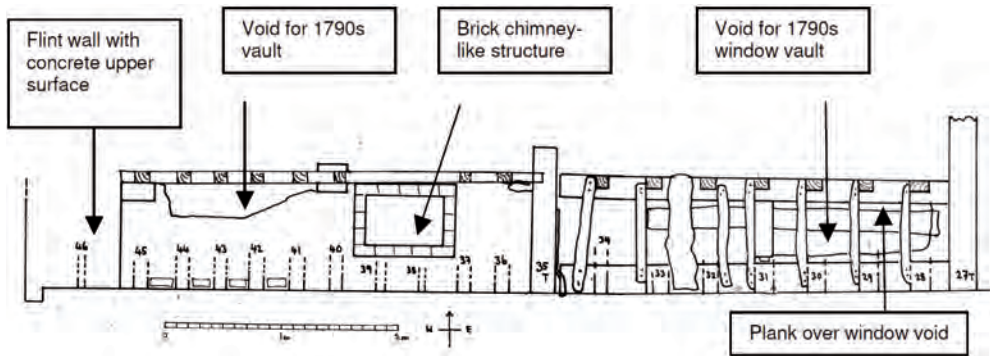
Fig. 20. Plan of west end of south wall measured at the wall-plates. David Clark.

Wall-plates: between rafters S45 and Truss V (S35) there was a waney timber wall-plate some 5½ inches to 6 inches deep supporting the rafters and some loose bricks. The truncated tie-beam at truss V sat in a notch on this wall-plate. The wall-plate supporting rafters S3 to S34 (and shown in Fig. 20) was at a higher level and terminated just before S35, to which it was attached by means of a twisted iron strap as shown. The tie-beam at Truss IV (S27) sat on top of this wall-plate.

The western part of the roof had an inner wall-plate as shown in Figure 20, also truncated at Truss V. The gap between inner and outer wall-plates was slightly greater at the west end than towards the east. This movement had caused the stub tie shown beneath rafter S31 to spring from its mortice in the outer wall-plate. The ashlar piece to rafter S36 had a groove down one side suggesting it was part of one of the scissor-braces described above.
