Crucks in the West Berkshire and Oxford Region

By JOHN FLETCHER

CRUCKS IN THE WEST BERKSHIRE AND OXFORD REGION

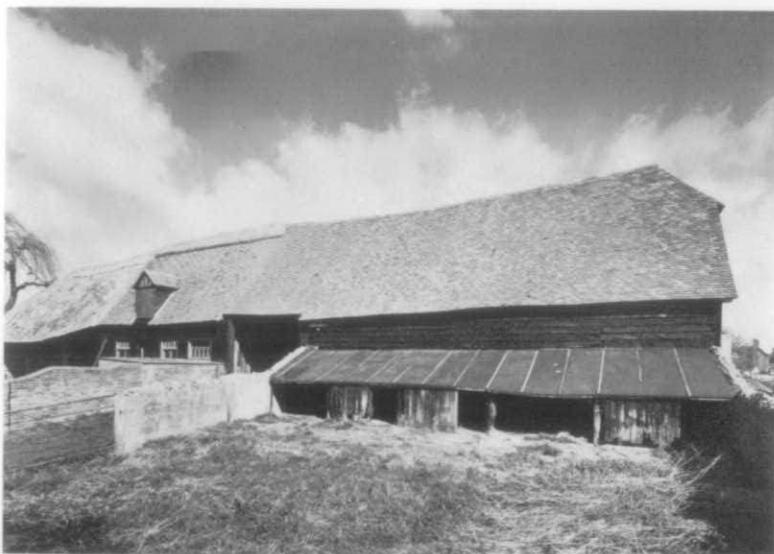
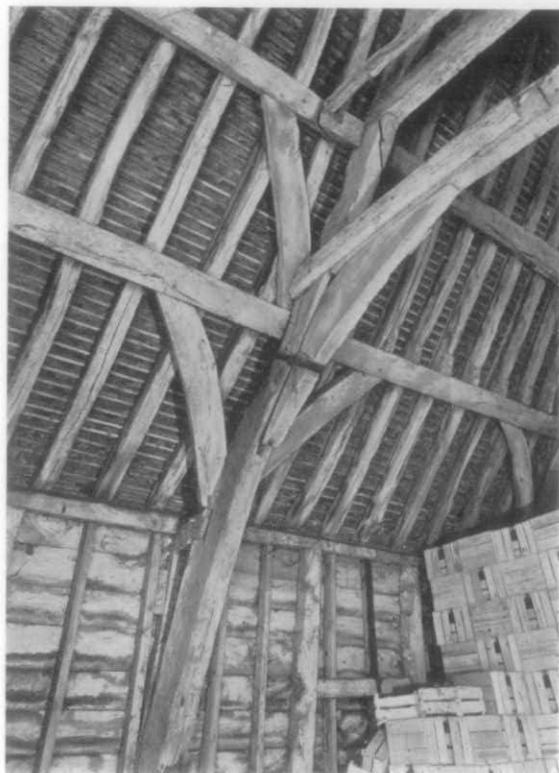
MIDDLE FARM, HARWELL.
A, B. Cruck Barn. A, Exterior; B, North part of Truss III.
C. Cruck Out-house, Open Truss.

Harwell, Middle Farm (Brounz's Manor): A fine cruck barn lies at the corner of the homestead (FIG. 22 and PLATE VIII). It has already been suggested¹⁷ that Richard Brounz, Sheriff of Berks. and Oxon 1381-2, built the hall, north wing range and cruck outhouse at this manor about the year 1365: the cruck barn appears to be contemporary.
