Excavations on the Second Site of the Dominican Priory, Oxford

By GEORGE LAMBRICK and HUMPHREY WOODS

SUMMARY

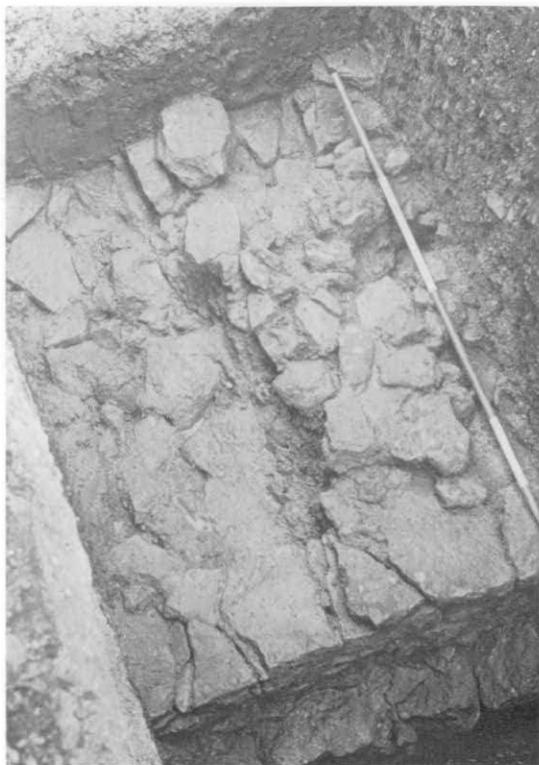
A. The footings of the South Choir Wall (F14).

The original footings are impressive (PL. VI, A). There must have been considerable technical difficulty in building the footings below the water table, and the size of the foundations represents the enormous effort which was expended in digging the construction trenches and bringing in the stone. The problem of the water could have been overcome by leaving a layer of clay on the bottom of the trenches for as long as possible, by never having open at one time a longer section of trench than was necessary, and by packing the lower parts of the footings with clay. This probably entailed digging the trenches and building the footings simultaneously, but this does not seem to have affected the accuracy in the laying out of the buildings or the consistency in the size of the footings, which was the same on both sides of the cloister. It was clearly the low-lying nature of the site which made the friars go to such lengths: the equally important Oxford Greyfriars had very much shallower, narrower foundations for the buildings sited on the firm ground of the second gravel terrace.⁶² The size and quality of the walls presumably also reflects the benefits the friars enjoyed from gifts and the sale of their former property. The lack of evidence for rebuilding (as opposed to extensions) is a tribute to the quality of the original work: even though the superstructure may have been refaced or rebuilt, the footings were never replaced.

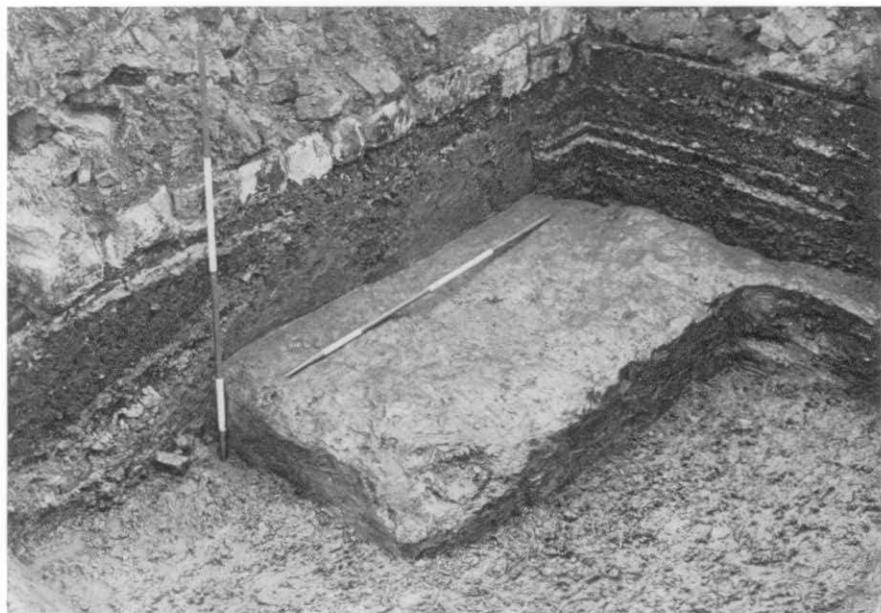
B. The area at the north end of the East Cloister range from the north-east.

At the west end of Trench II was a feature (F221) cut 1.00 m. into the dumped clay and alluvium (Section HJ, FIG. 4 and PL. VI, B). Only its eastern side was found, where its profile was a vertical side rounding out at the bottom. It became shallower towards the north, petering out between the butt end of Robber Trench 208 and the stair footing (F238). It was not found in Trench IV, but could have been destroyed by later disturbances. It contained fifteen layers of mixed mortar, clay, stone and tile (Layers 221/1-221/15). The only dating evidence was a sherd of 'Tudor Green' of the late 14th to 16th centuries, from Layer 221/8, indicating that it was a late insertion.

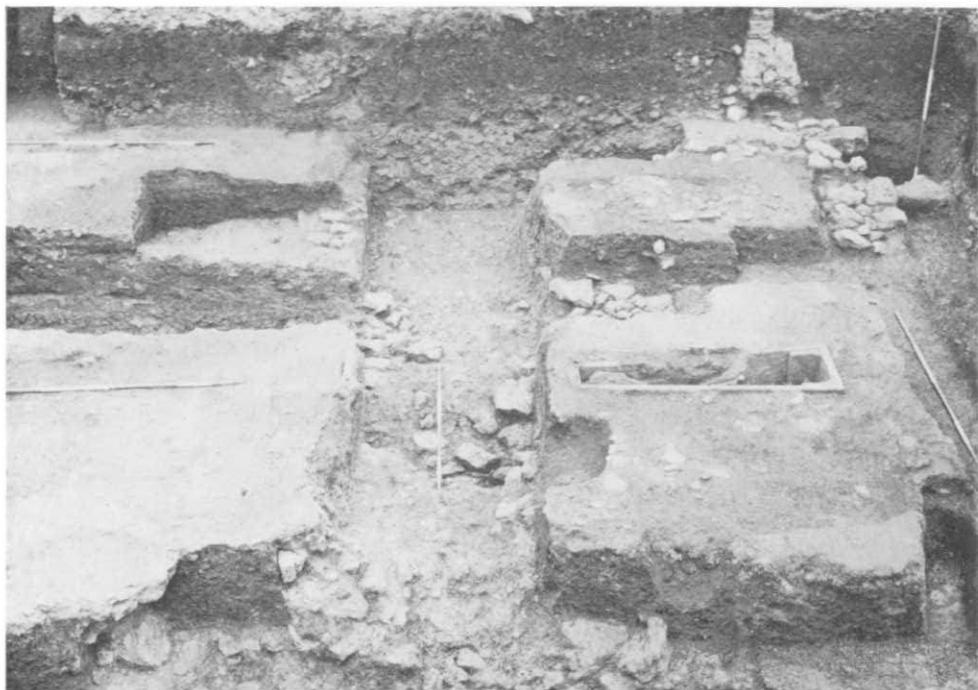
A. The extended West End of the Church from the north.

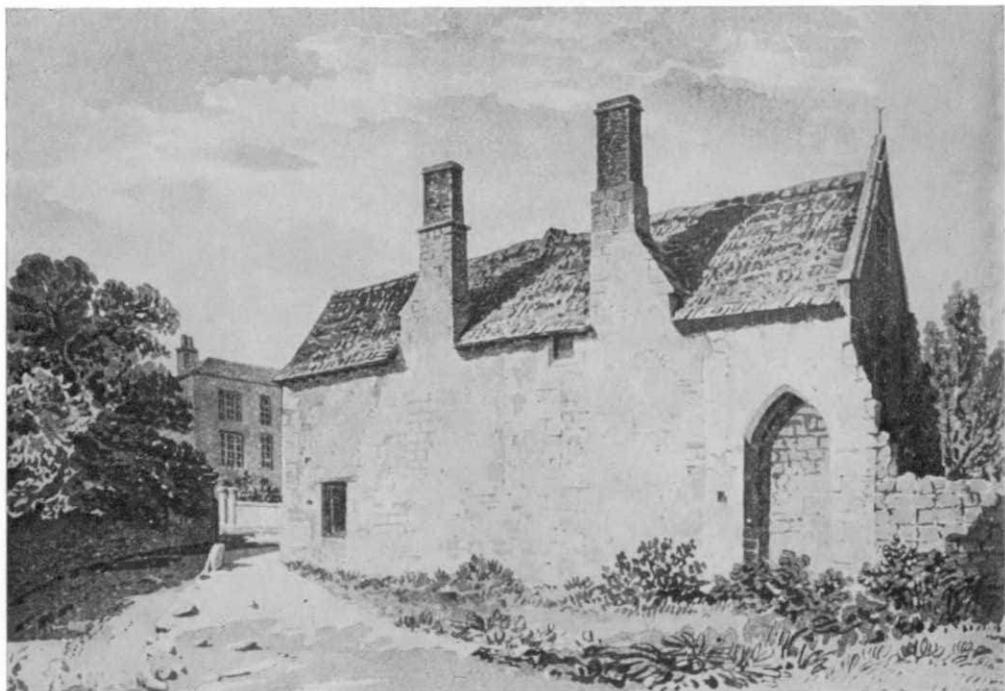
B. Buckler's drawing of the Priory Gateway from the south-west.
