# The Restoration of Berrick Salome Church

LIAM TILLER

*The parish church of Berrick Salome in south Oxfordshire was restored in 1890. This is an account of why the restoration was undertaken, who initiated it, what was altered and what conserved, the discoveries made during restoration works, and how the money to pay for it was raised. The outcome of the restoration scheme was the conservation of much medieval and Jacobean building fabric, albeit with the application of exterior decorative features which have offended some architectural critics. The extent of the works seems to have been limited by both the funds available and the increasing appreciation in the later years of the nineteenth century of the need to conserve historic buildings.*

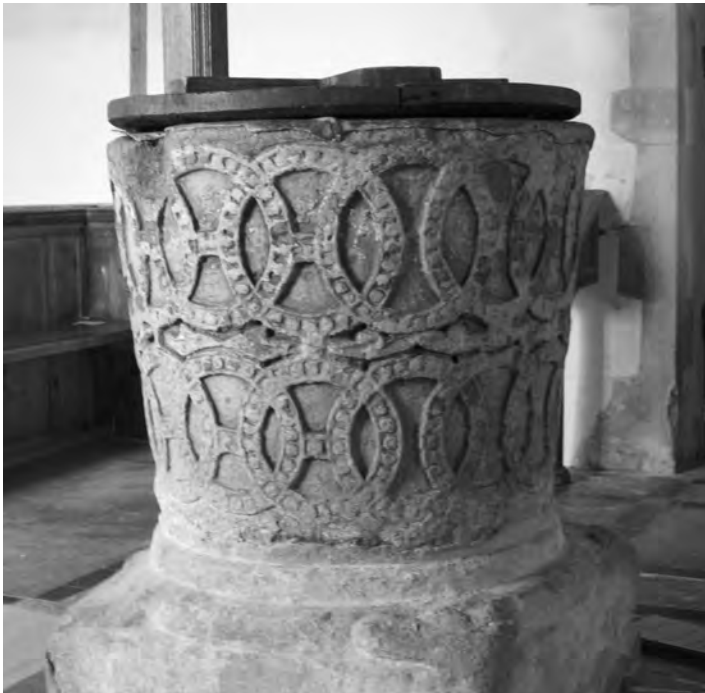
Fig. 1. The Norman font.  
Photograph by the author.

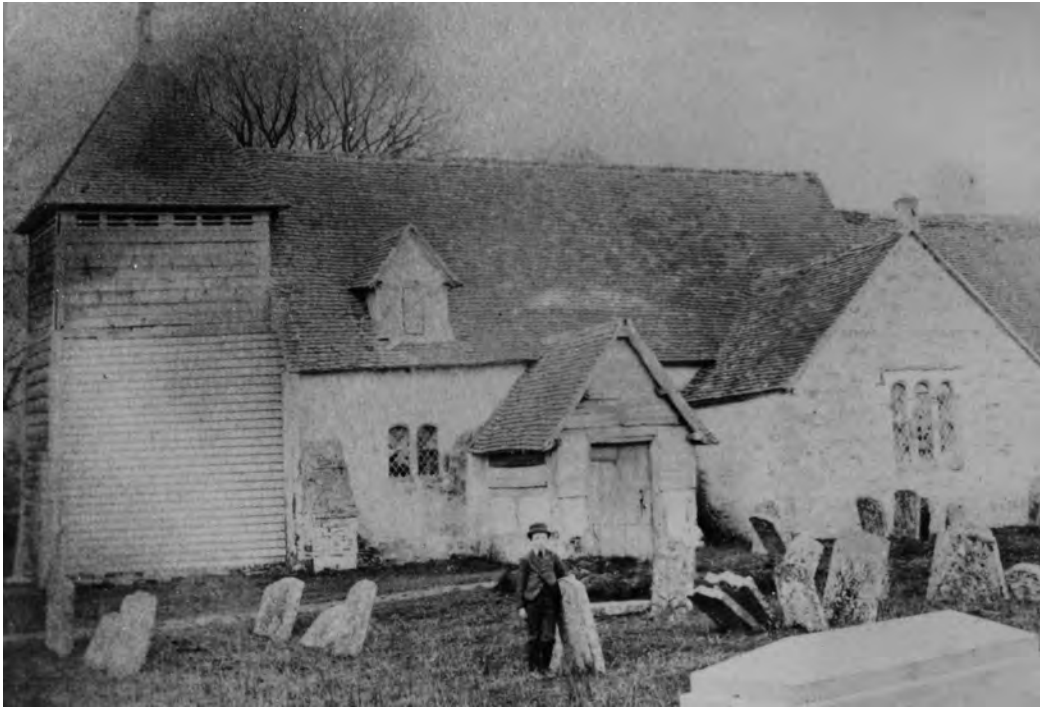
Fig. 3. Berrick Salome church from the south before restoration, c.1861–5. Photograph of original by the author, courtesy of Dr Marian Shaw, churchwarden.

Great care and artistic taste have been shown by the architect, Mr A. Mardon Mowbray F.R.I.B.A., of Oxford, in the planning and supervision of the work, and his instructions have been carried out in a workmanlike manner by the contractors, Messrs R. and G. Smith, of Lane End, High Wycombe. The whole restoration may be pronounced as most successful. All ancient features have been carefully and reverently preserved. The new work, especially the carved oak barge boards to the gables, and the dormer windows, together with the artistic treatment of the wooden tower and porch, call for particular notice [see Figs. 3 and 7].

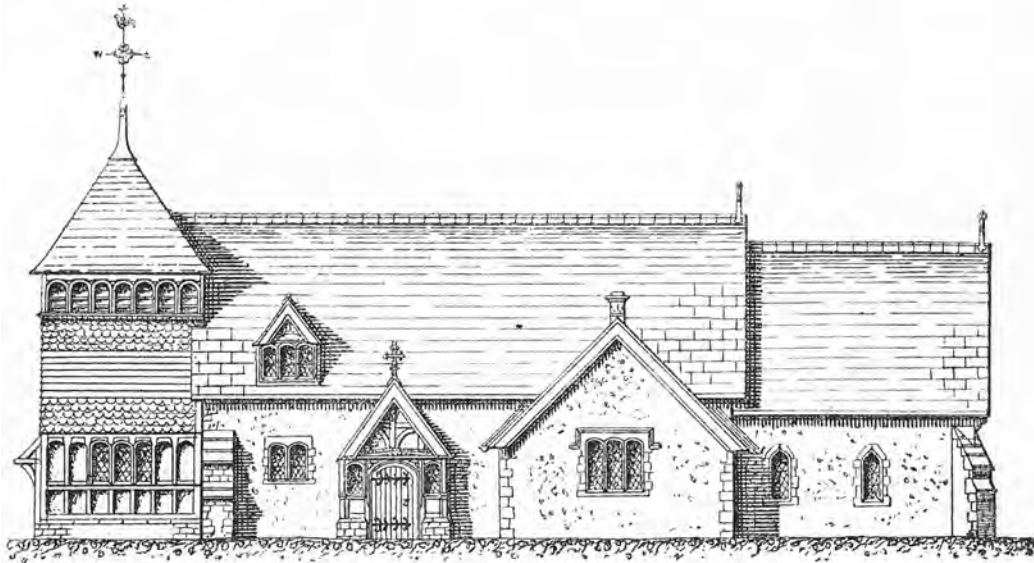
Fig. 4. Architect's drawing of the proposed south elevation of the church, taken from the appeal leaflet published in February 1890. Used by permission of the Bodleian Library, University of Oxford (MS Top. Oxon. c. 105, fol. 52).

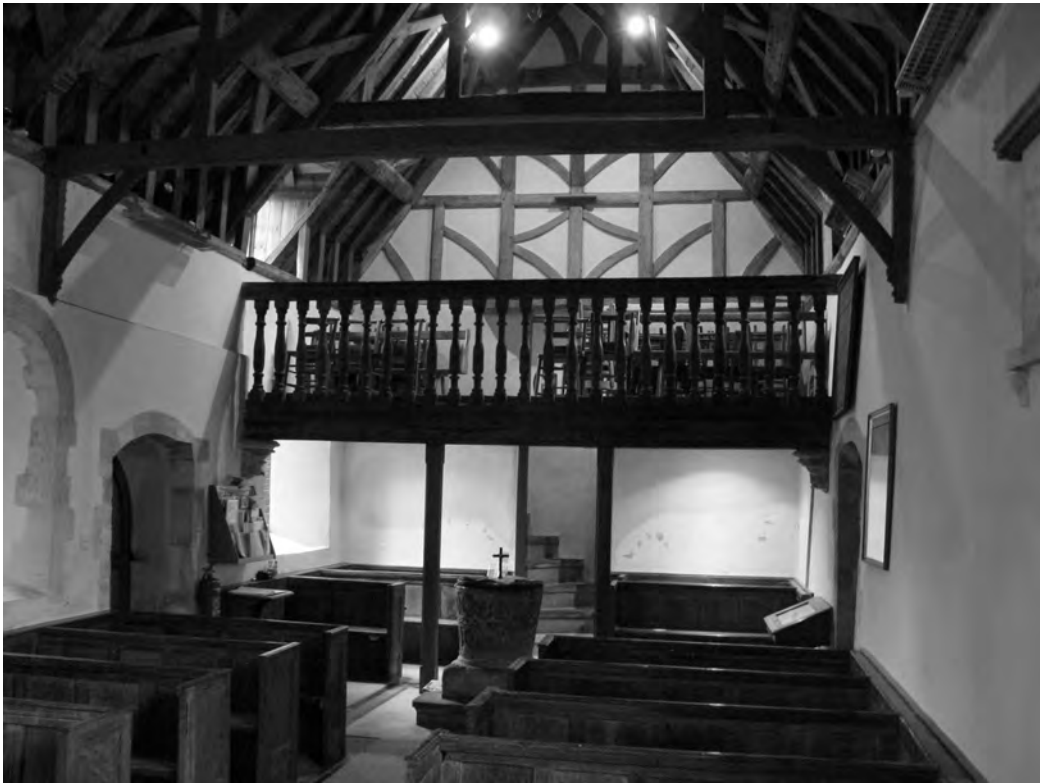
Fig. 6. Interior looking west, showing seventeenth-century roof and gallery, repositioned font and remodelled pews. Photograph by the author.

The removal of the arched plaster ceilings over the nave revealed an oak Jacobean roof erected in 1615 (Fig. 6). This date is carved on the chancel beam and on a plaque fixed to the beam which also gives the names of the then churchwardens, John Hambelden and Henry Wisse. This roof and the oak transept roof were repaired. A new panelled, match-board ceiling was fitted over the chancel. The west gallery had been erected in 1676; a carving on its principal support beam records the date. The whole gallery was moved back some feet and placed on new carved stone corbels with inscriptions 'Born of water', 'and of the spirit'.<sup>30</sup>

Any assessment of the merits of the restoration must be a matter of personal taste, something over which architectural critics have no monopoly. Richard Lethbridge in the *New Shell Guide* described 'the small church down a track ... restored in a curiously cottagey style and ... rather engaging'.<sup>46</sup> Those who know the church well and most visitors would be more inclined to Lethbridge's view than Sherwood's. The interior of the church does not have the idiosyncratic features of the exterior but retains the quiet and peaceful character of an ancient church (Fig. 6; Plate 6).

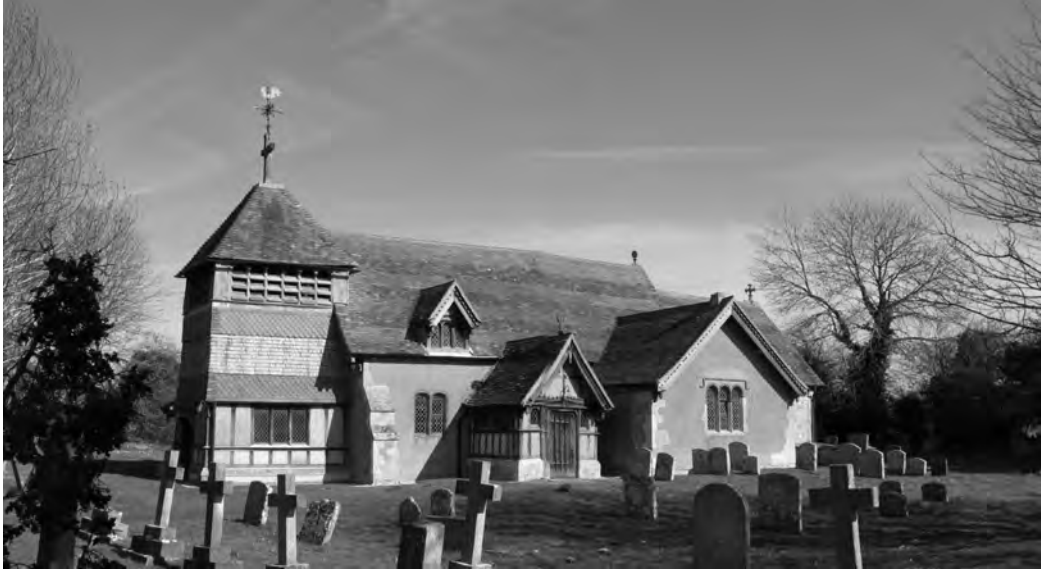
Fig. 7. Berrick Salome church in 2010. Photograph by the author.

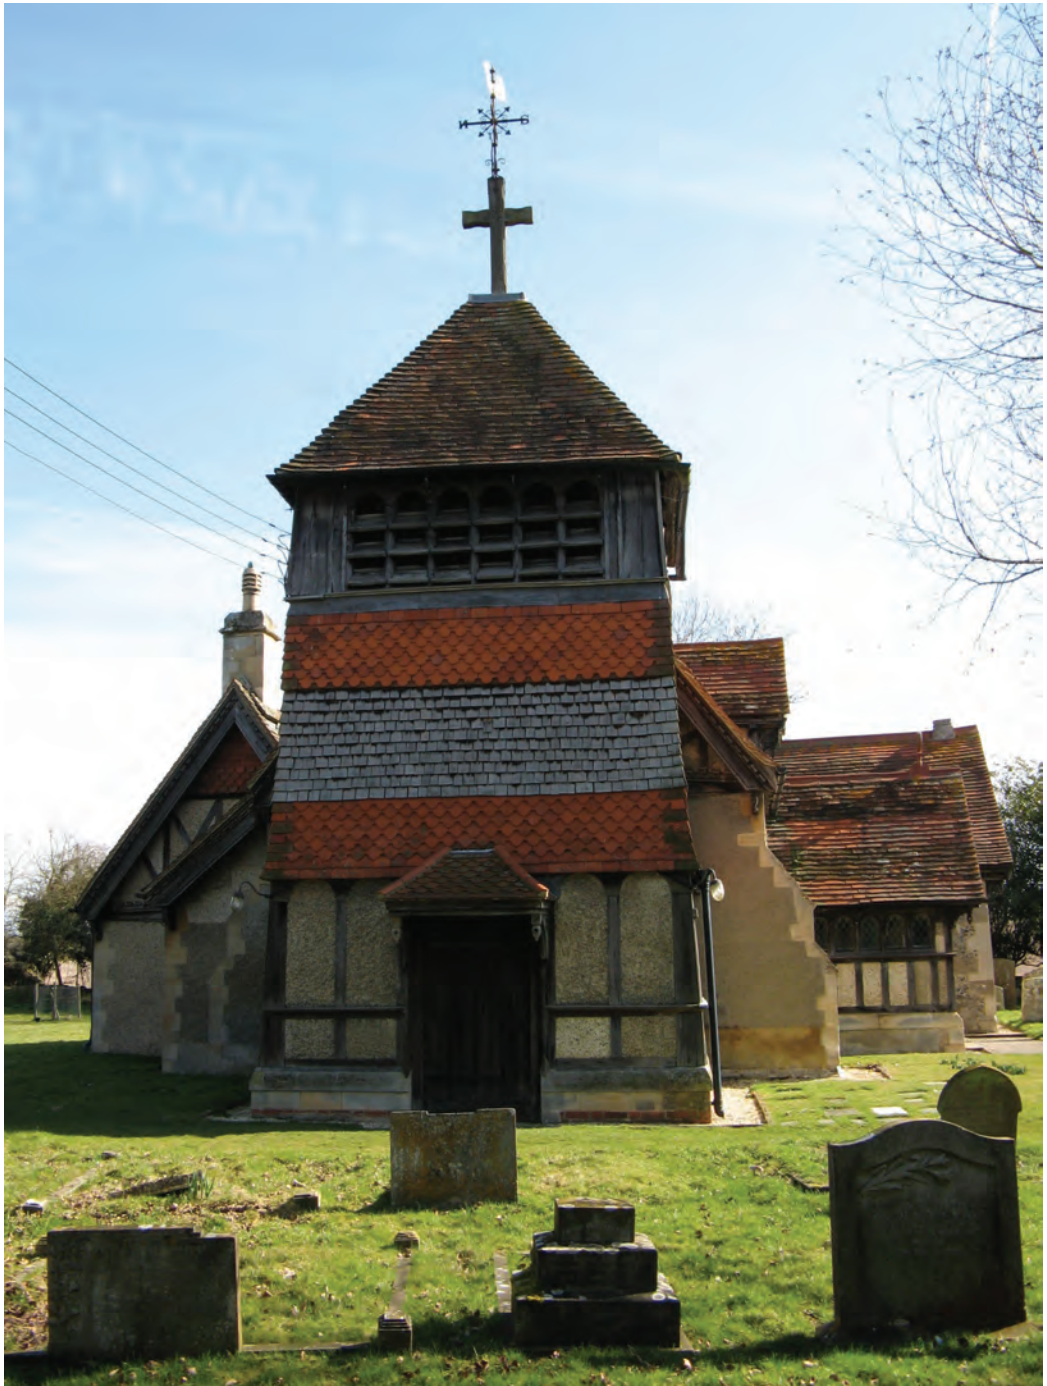
Plate 5. Berrick Salome church tower, looking east. Photograph by author. [Tiller, p. 89]

intersecting tracery similar to that shown in Buckler's drawing (Fig. 2). A damp-proof course was installed and a drain built around the base of the walls. The roofs were re-tiled and overhanging gables with bargeboards formed. The old weatherboarding was removed from the tower and porch and replaced with blind wooden arcading above a stone plinth, 'Jacobean' windows and doors were fitted, and the tower clad with bands of tile and shingles (Plate 5). The sun-dial on the gable of the transept was reduced in height.

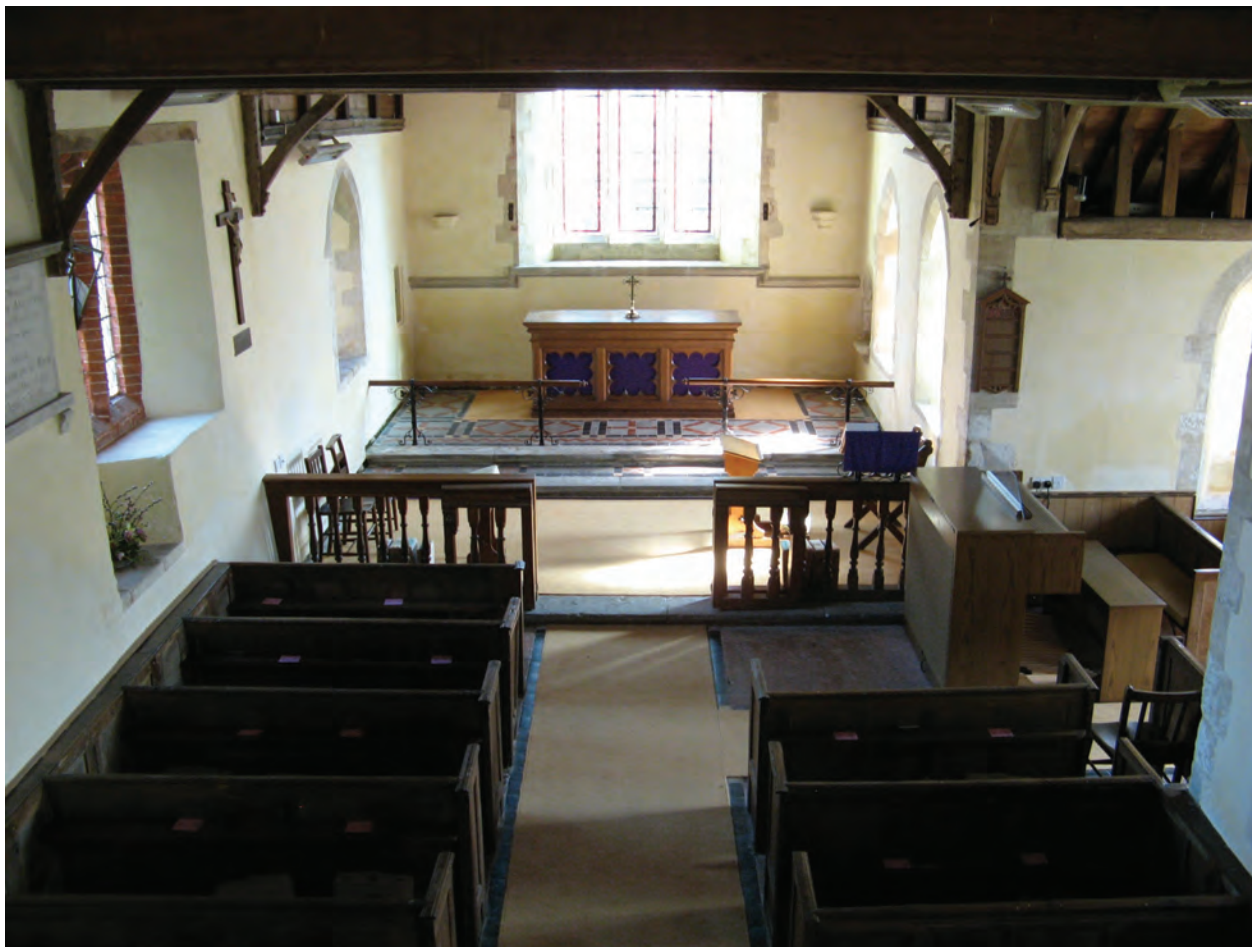
Plate 6. The interior of Berrick church, looking down from the gallery. Photograph by author. [Tiller, p. 94]
