Cruck Cottage in Church Lane, Harwell

By J. M. FLETCHER, M.A., Ph.D.

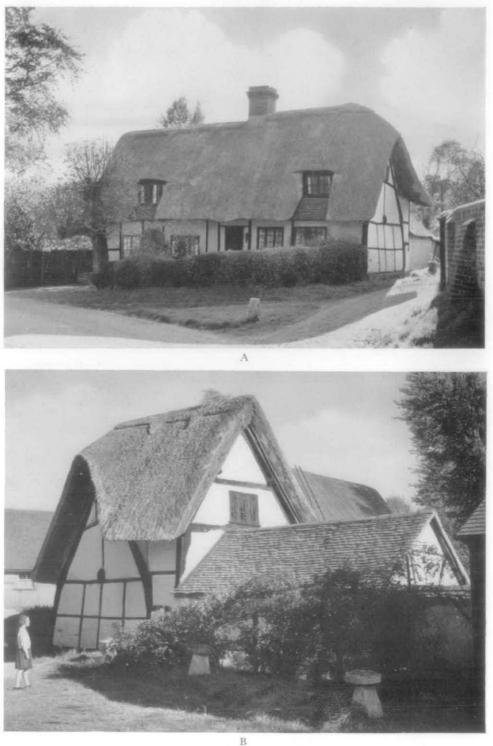
A. Dell Cottage. From Church Lane looking south-west. B. Dell Cottage. Western cruck from south-west, with Le Carillon, Church Lane, in background on left. Phh.: H. R. Grooks

CHURCH Lane winds south-eastwards from the High Street, across the small Chilbrook to the Church and Prince's Manor. Dell Cottage (PL. XII A), the subject of this article, is a small medieval dwelling which lies at a slight angle to the lane on its south-west side. Till 1951 it was part of a croft of 1 rood 22 poles which was described in the Enclosure Award of 1805 as a copyhold 'house and garden'. At that time it belonged to Martha Thomas, a person who owned three other small properties and 13 acres of land in the parish: more recently it was owned by the Rev. W. Gooderidge till c. 1920, then by Henry Tyrrell, a former baker who also purchased the adjacent Lockton Farm : since 1946, the occupant has been the owner.

THE WESTERN CRUCK (FIG. I B and PL. XII B)

The blades at this end are representative of cruck construction at its apogee. They are firmly elbowed³ and wide, 17-18 ins. where elbowed, and 12 ins. at their apex ; the knots in them and a marked irregularity in the grain above the tie-beam show that they were formed by the division of a single elbowed board.³ They are $5-5\frac{1}{2}$ in. thick and there has been deterioration of the feet which are tapered to a width of about 7 in. On the north side there are traces of the original sill beam : the stone block, V, on which it rested protrudes prominently.

Evidence is provided by truncated wall-plates that the wide extension on the south at one time reached further south than the present face (seen in PL. XII B). An additional bay, 15-20 ft. wide, would have given the house a typical L-shape. The destruction of this bay had left a truss, originally internal, to form an unusually wide gable, in which all the beams except the half-height plate E are likely to be original. The single-storeyed unit F contains as studs, etc., several aged oak beams which may have been taken from the previous structure.

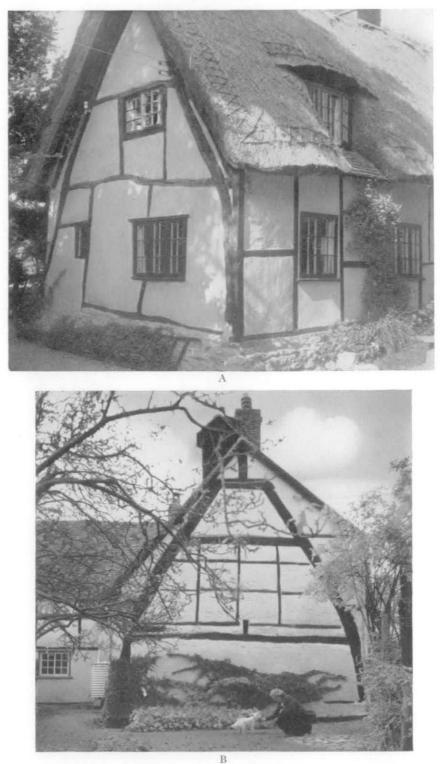
A. Dell Cottage. Eastern cruck from north-east. B. Le Carillon. North-east face. Phh.: A. J. M. Fletcher; B. H. R. Crooks OXONIENSIA, VOLS. XXVI/XXVII (1952) FLETCHER, CRUCK COTTAGE IN CHURCH LANE, HARWELL

THE EASTERN CRUCK (FIG. I C and PL. XIII A)

This is very different from the western one. The blades are narrow and feebly elbowed : instead of acting as the main support to the roof, their function is largely reduced to that of carrying the ridge pole : thus the wall plates rest entirely on the flanking studs. The timber framework at this end also is visible inside the house : here, the blade, IV, at the south-east corner is of interest as it has both an extended tie-beam halved into it and also a spur-tie 2 in. above. At the north-east corner, the blade, III, has no similar spur-tie nor does it show the remnant of any windbrace such as exists on the inside of blade IV. Thus a blade, which had at one time been part of a partition truss elsewhere, was used as IV and another beam of narrow scantling was used as III.
