# Excavations in Merton College, Oxford, 1970

By T. G. HASSALL

A section of Oxford city wall dug in Merton College Grove (SP51670600) did not locate the late Saxon defences but showed that a stone wall was built here in the early 13th century on an alluvial deposit.

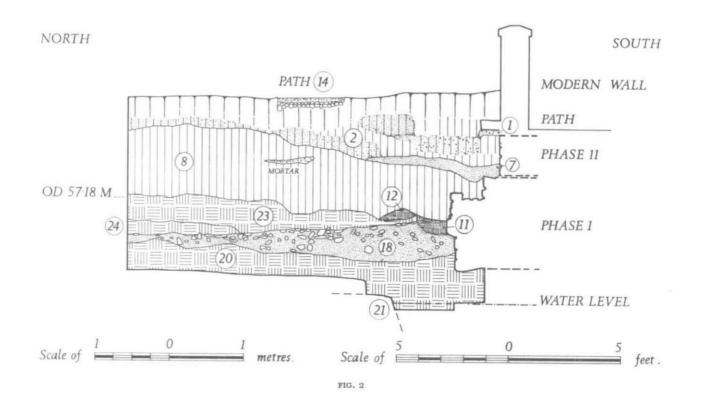
# OXFORD MERTON COLLEGE GROVE CITY WALL SECTION 1970

Layers. The following layers were excavated; not all appear in the published eastern section of the trench:

- ① Mortar, very clean, lying under modern wall. No finds.
- ② Top soil, dark grey with patches of gravelly soil, heavily disturbed by roots. This layer also includes layers ③—⑥, ⑤ and ⑥, although only layer ② appeared in the east section. Post-medieval and medieval sherds.

- 3-6 See 2. No finds.
- Sandy soil with pebbles and shells, resting against the footings of the Phase II wall and presumably associated with that wall's construction. No finds.

- S Loam of varying texture, at times very clayey. This layer also includes layers ① and ⑤. The lower step of the Phase I wall was sealed by layer ③. One post-medieval sherd, otherwise all medieval pottery, small lead object.

- Stone and mortar construction of Phase I wall. Also includes layer
   No finds.
- 10 See 8. 12th-13th century sherds.
- Clay and soil fill of foundation trench of upper half of Phase I wall. 12th-13th century sherds.

- ② Clay, blue-grey in colour and very hard, possibly the up-cast from layer ①. 12th-13th century sherds; bones.
- (13) See (18). No finds.
- Tarmac of modern path removed after the extension of the trench northwards.

- (b) See (8). No finds.
- 16 See 23. 12th-13th century sherds; bronze object (Fig. 4).
- To See 23. 12th-13th century sherds.
- (B) Clay with sand and stones. This is the same layer as (3) and (9). 12th-13th century sherds.

- 19 See 18. No finds.
- ② Clay, very sticky: probably an alluvial deposit. This layer continued under the Phase I wall which was slightly dug into it. Immediately behind and below the Phase I wall this layer dipped below the level of layer ② and further excavation was prevented by the water level. 12th-13th century sherds; bones; iron horse-shoe.

- ② Blue clay, possibly natural.
- 2 See 9. No finds.
- 23 Loam with clay forming continuous layer with 16, 17 and 24. No finds.
- 2 See layer 2. No finds.

- 25 See layer 2. No finds.
- 26 See layer 2. No finds.
- Stone and mortar construction of Phase II wall. No finds.

The Walls. The modern wall of the Grove was found to overlie an earlier stone wall: this modern wall did not have a foundation trench but rested on a layer of clean mortar (layer (1)). The earlier wall, Phase II, was also without a foundation trench, but layer 7 may have been deposited during the construction of this wall. The Phase II wall rested on the footing of another, Phase I. Both the Phase I and II walls were constructed of corralian random rubble stones, crudely coursed, with a lime mortar. The top of the surviving Phase I wall had been partially robbed. The footing itself was stepped: the upper half was set in a foundation trench, layer (I), and it projected over the lower half. The Phase I footing rested in alluvial material, layer 20.

Interpretation. The Phase I wall must date from the early 13th century. It was set in what appeared to be an alluvial deposit, layer ②, and not as might have been supposed, on the natural gravel. Layer ② can be accounted for by the presence of the Gutter and this point is discussed below. The construction of the Phase I wall requires explanation and two possible theories can be advanced. First the alluvial deposit, layer ②, was sealed by layer ③, the lower half of the Phase I wall was then built with its external face tight against the side of its foundation trench, but the upper half of the footing was then made within a wider foundation trench, layer ①. The upper part of the wall was found to overhang slightly. This projection might be explained by a local correction in the wall line during construction. Second, it is possible that this wall was built in two phases, the lower part being constructed on a slightly amended line at a later date, although on inspection, the Phase I wall showed no break between its upper and lower halves.

Before the deposition of layer 18 there can have been no solid ground surface here. This layer may indicate an attempt to create a solid working surface, or possibly a pathway. Either way, layers 3 and 4 must have been laid down on top of layer (8) before the building of the upper part of the Phase I wall, since its foundation trench, layer (II), has cut through both layers (23) and (18) and the upcast, layer 12, also rests on layer 23. Layer 8 then represents the build-up of the ground level of the Grove during the later medieval period, terminated by the construction of Phase II wall. Only one post-medieval sherd came from the top of this layer. Layer (7) must be the building debris from the Phase II wall, but unfortunately it produced no sherds so that exact dating remains uncertain. From its appearance, this wall could be medieval, since the material of which it is built is identical to that of the Phase I wall. But it is more likely that the Phase II wall represents a post-medieval wall on the line of the city wall. This interpretation is supported by the post-medieval sherd from layer (8). A reasonable explanation is that the Phase II wall is simply a garden wall, possibly that constructed in 1754-56.33°

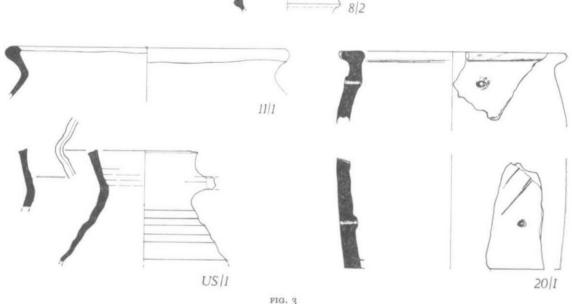
Merton College, Oxford. Cooking pots. St. Neot's ware: 8/2; sandy ware: 11/1. Perforated vessel in sandy ware 20/1. Green glazed jug in fine sandy ware, us/1.

8/2 Rim sherd of cooking pot in soft soapy shelly ware of St. Neot's type. The form is difficult to parallel with published sherds from Oxford. It is not clear whether it came from a narrow necked cooking pot or a jug. In form it resembles a sherd from under the castle mound.<sup>34a</sup> However, the Merton example is of a different fabric and lacks decoration on top of the rim.

11/1 Rim sherd of cooking pot in grey sandy fabric, light brown external surface, everted, thickened at the top.

20/1 Rim sherd, base angle sherd and body sherd (not illustrated) of an unglazed, straight-sided pot in sandy grey ware with light brown exterior. The rim is a simple flange, the body is very thick, ranging from 1·2 mm. to 1·5 mm. with marked internal rilling: the base seems very thin in comparison with the thickness of the sides. Each sherd has been perforated from the outside with small holes, approximately o·8 mm. in diameter. This vessel was probably used as a colander. It

Us/I Top of a jug in very fine buff ware, simple pouring lip and rim, plain strap handle, marked rilling inside beneath the rim and outside the shoulder, mottled green glaze. ?14th century.

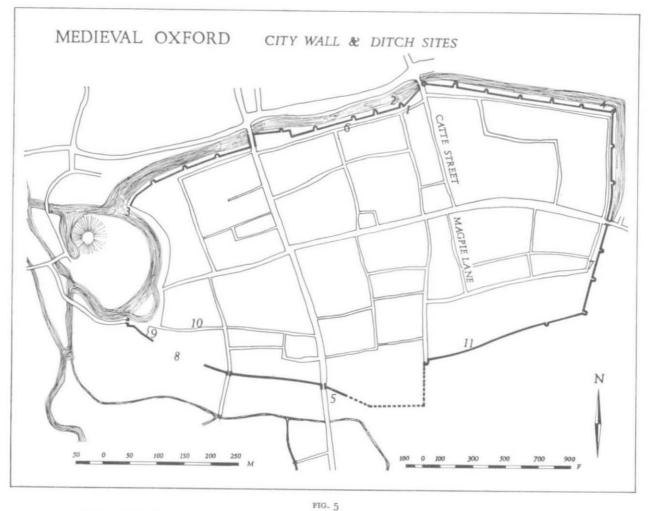
Medieval Oxford, the walled area, showing the more important previous excavations on the city wall and ditch, see Appendix I for the Key to the numbered sites.

- 1. Clarendon Quadrangle, 1899.
- 2. Clarendon Quadrangle, 1939.
- 3. Canal Wharf Site, now Nuffield College, 1949.
- 4. New College, 1949.
- 5. Christ Church, 1954-5.
- 6. Exeter College, 1963.
- 7. Merton College, 1963.
- 8. Greyfriars Church, 1969.
- 9. Prince's Street, St. Ebbe's, 1969.
- 10. Church Street, 1970.
- 11. Merton College, 1970.

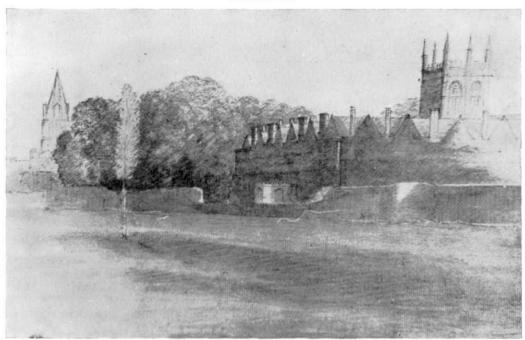
A. Pencil and water colour sketch of Merton College, Oxford, in June 1772 showing the Grove, the wall and Bastion 20. Corpus Christi College, sketch books of J. B. Malchair No. 111  $\phi$  F 1. 10, 33.

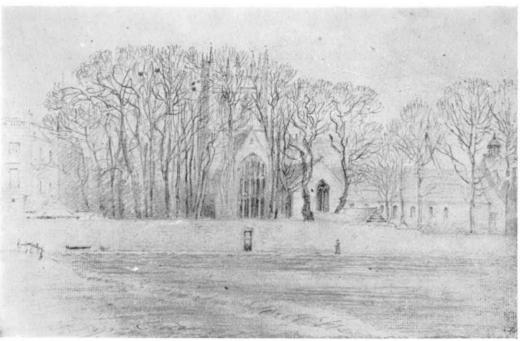
B. Pencil sketch of the wall at Merton College Grove, Oxford, in May 1771; Corpus Christi College, sketch books of J. B. Malchair, No. 1  $\phi$  F 1. 8, 17.

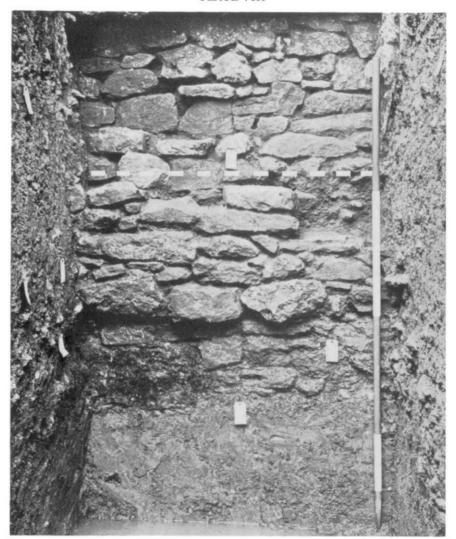
### PLATE VIII

The footings of the city wall in Merton College Grove, Oxford. Composite photograph from the north; the 13th-century city wall, the phase I wall, is below the broken line, resting on alluvium. Scale = 2 m.
