## 'The Great Barn' Lewknor: The Architectural Evidence

By M. C. J. MORREY and J. T. SMITH

BARN at CHURCH FARM, LEWKNOR, OXON.

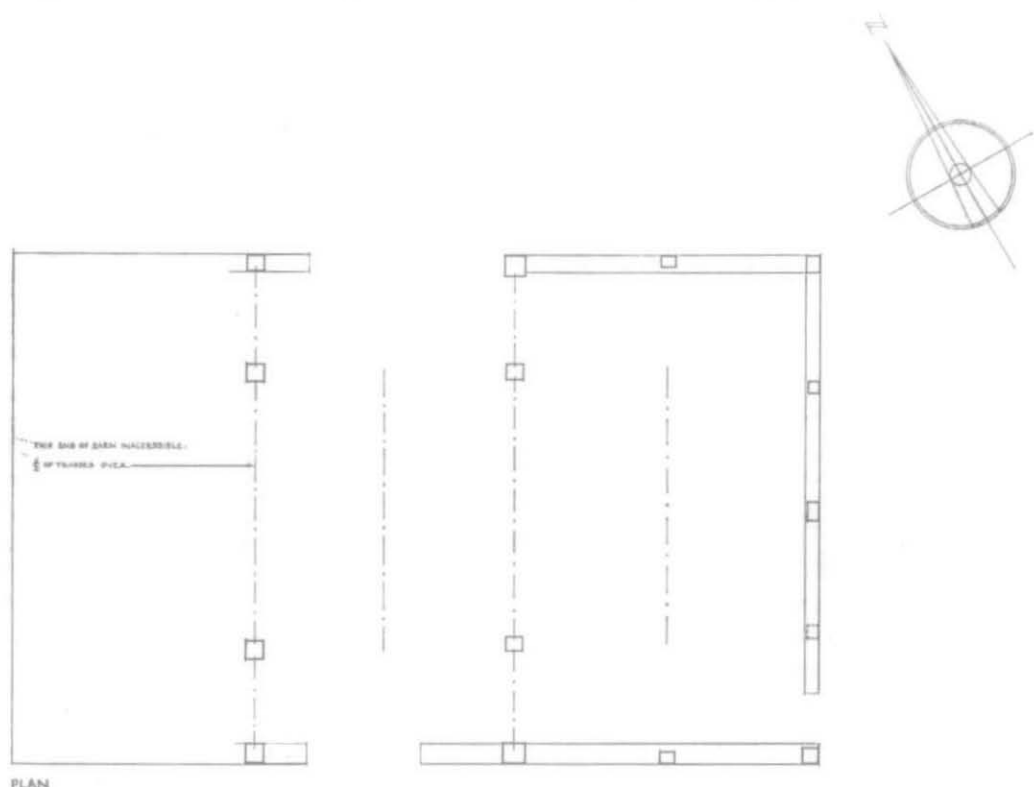
FIG. 1.

The hall-house—for that is undoubtedly what it was originally—comprises three bays which vary in length between 15 and 18½ ft. Its plan (FIG. 1; PL. XXIII, A) is of the end-hall type, that is to say that such minor or service rooms as there were stood at one end. The hall itself, about 34 ft. long, and open from ground to roof, comprised two bays divided by an open truss with a clear span of about 29 ft. (FIG. 2). A spere-truss (PL. XXIII, B; FIG. 4, left) divided the hall from the cross-passage and whatever rooms lay west of it,<sup>2</sup> but since this part of the building is now occupied by large bins its recording and interpretation are inevitably inadequate.

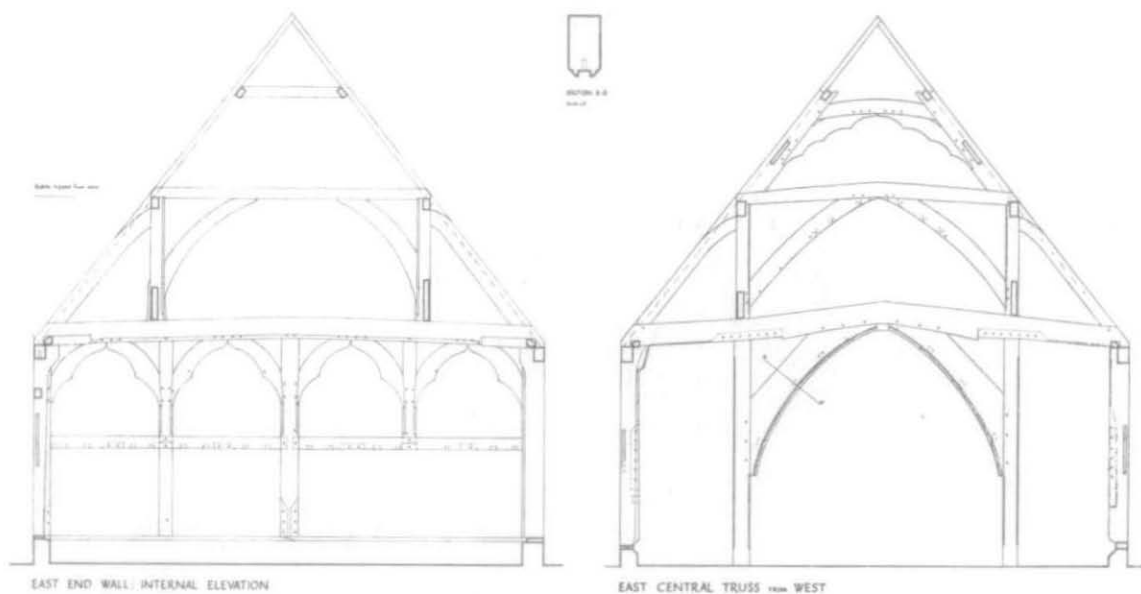
FIG. 3.

From a structural standpoint the hall was remarkable principally for the span of the open truss, which is quite unusually wide for a timber-framed building (FIG. 3, right). This truss, like the others, was of tie-beam type, with two very large arch-braces from wall-posts to tie-beam. Although it was reconstructed as an aisled truss when the hall became a barn, its form can be reconstructed thanks to the reuse of the original arch-braces. The braces have two chamfers and their soffits are trenched and mortised to take other timbers which have been removed (PL. XXIV, A). Since such decorative timberwork as survives in the building is extensively cusped it can be presumed that the open truss was treated similarly with a series of cusps, perhaps seven, matching those which survive in the topmost part of the truss (PL. XXIV, B). They were evidently secured in place by the extensive use of buried (or slipped) tenons, i.e. tenons mortised into two timbers and pegged through to hold them together, and probably the peg-holes which now help to secure the braces reset in their present position were originally cut for the tenons at the upper end of the cusped members. Above the tie-beam the roof was of raised-aisled type<sup>3</sup> that is to say, it is in effect

an aisled hall raised high above the ground. The aisled frame thus formed has square posts, chamfered on the inner edges, which support plates and a slightly cambered tie-beam and which are themselves propped by braces, tenoned into the ends of the tie-beam below. In the arch-braces which join the raised aisle-posts to the tie-beam are a series of peg-holes and tenons which must have been intended for applied cusping like that below. The topmost part of the truss comprises short principal rafters into the top of which purlins are slotted; the principals are linked by a collar-beam which is supported by cusped arch-braces and there are cusped wind-braces from principals to purlins. The topmost tie thus forms a clasped-purlin roof.<sup>4</sup>

In its original form the open truss must have been an impressive and richly ornamented structure, hardly paralleled for size in English timber-framed buildings. As an indication of its pretensions its clear span of 29 ft. may be

compared with that of such stone buildings as Stokesay Castle and the Old Deanery, Salisbury, with spans of  $29\frac{1}{2}$  ft. and 31 ft. respectively.

parable treatment is apparent in the East end wall, which is divided by posts and a rail into two registers of four panels (FIG. 3, left; PL. XXV, A). Each panel of the upper register has cusped curved braces terminating at a little ogee at the head, and evidently the lower register was treated similarly. A few structural points deserve comment. The arch-braces of the spere-truss are each formed of two pieces of timber held together by buried tenons, the presence of which is revealed by two adjoining peg-holes, one in each member. This feature, though not common, seems to occur in roofs where large members have to be built up from timbers too small for the purpose, such as one or two of the collar-beams in the roof of Stokesay Castle. No doubt it made for the economical use of timber. At Lewknor a third timber, cusped, was attached to each brace by means of both buried and normal tenons. There was also a form of horizontal bracing at the corners of the hall, using large solid brackets laid flat and butting, on the wall side, against a massive cornice which for part of its width rested on the wall-plate. (PL. XXV, B).

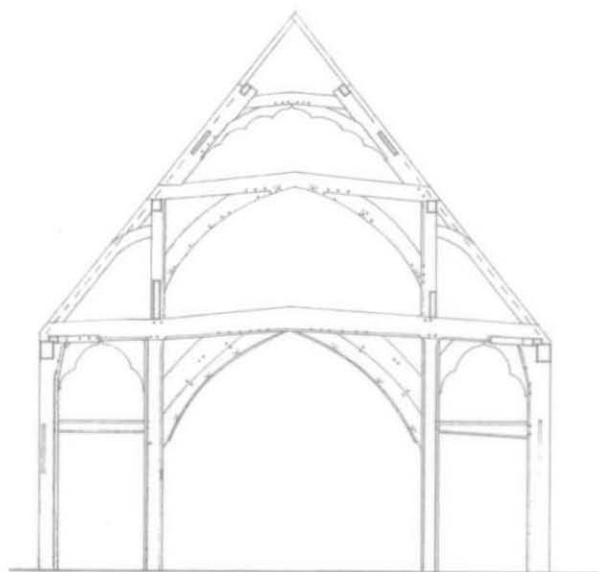
WEST CENTRAL TRUSS FROM EAST.

The spere truss (West central truss, Fig. 4, left) was treated in broadly the same way as the open truss, except that the open panel at the top of each of the flanking 'aisles' had cusped braces forming a small ogee at the apex. A com-

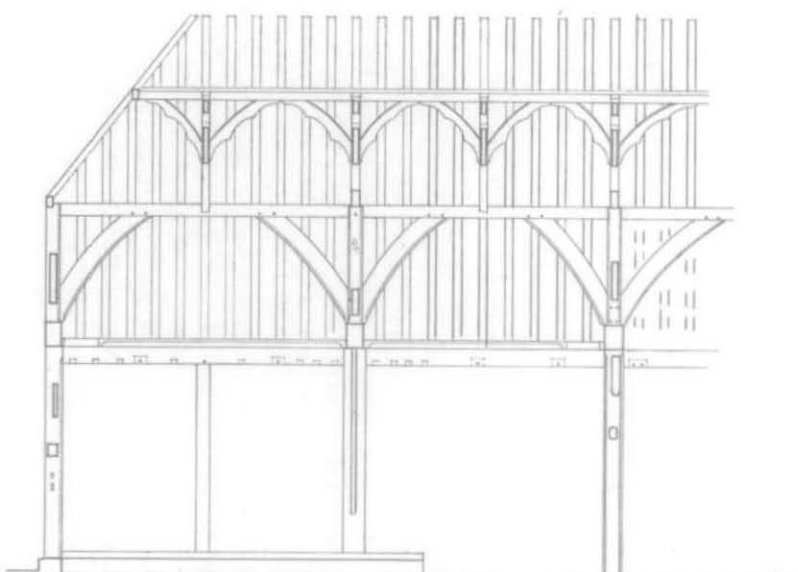
SOUTH WALL.

Unfortunately, it is not possible on the evidence at present available to reconstruct the appearance of the long walls. That they incorporated big braces is clear from the mortises in the principal posts of the trusses, and there were probably two large windows, one on each side of the open truss.
