126 High Street: The Archaeology and History of an Oxford House

By JULIAN MUNBY

SUMMARY

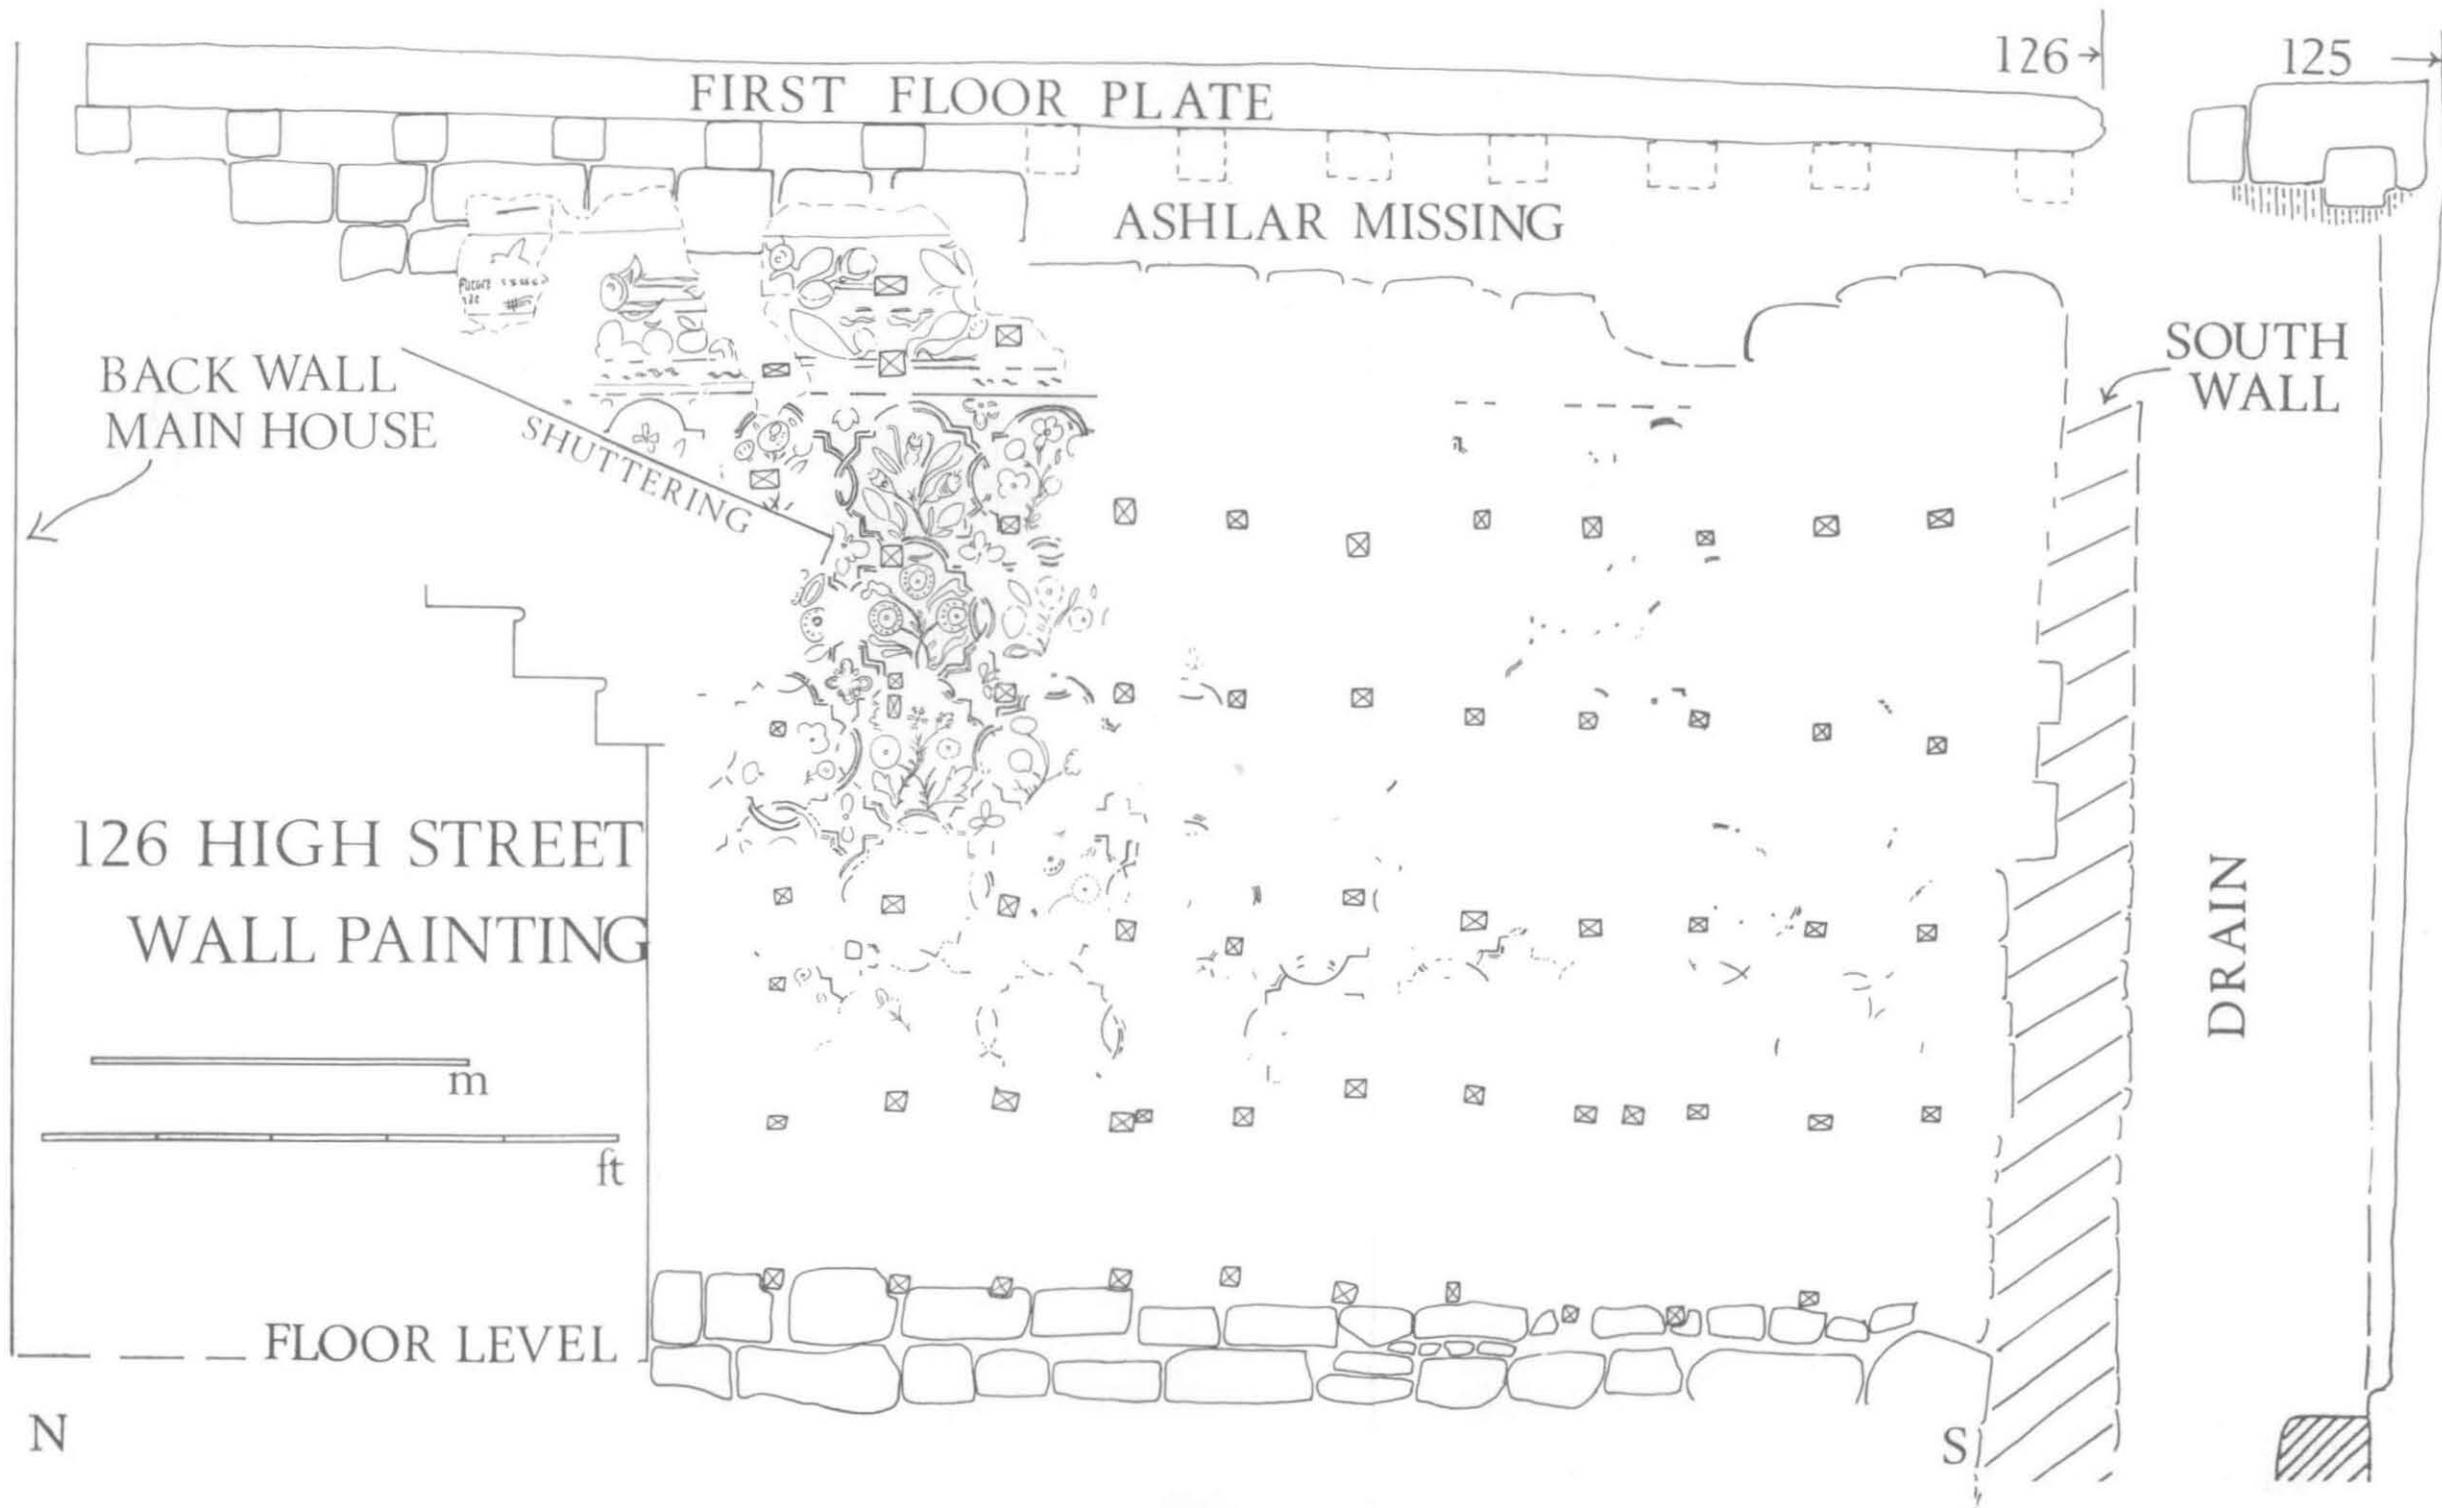
FIG. 4

Sixteenth-century wall painting on east party wall of back wing, showing wooden pegs for panelling and position of later stair.

Description : The east wall of the back wing retained traces of painting for its entire length, but in the southerly portion these were so slight and disjointed that they were not considered to be worthy of preservation. Furthermore the entire surface of the wall was sadly mutilated by the insertion of wooden pegs, and decay in the pigments employed had resulted in changes to some of the colours.

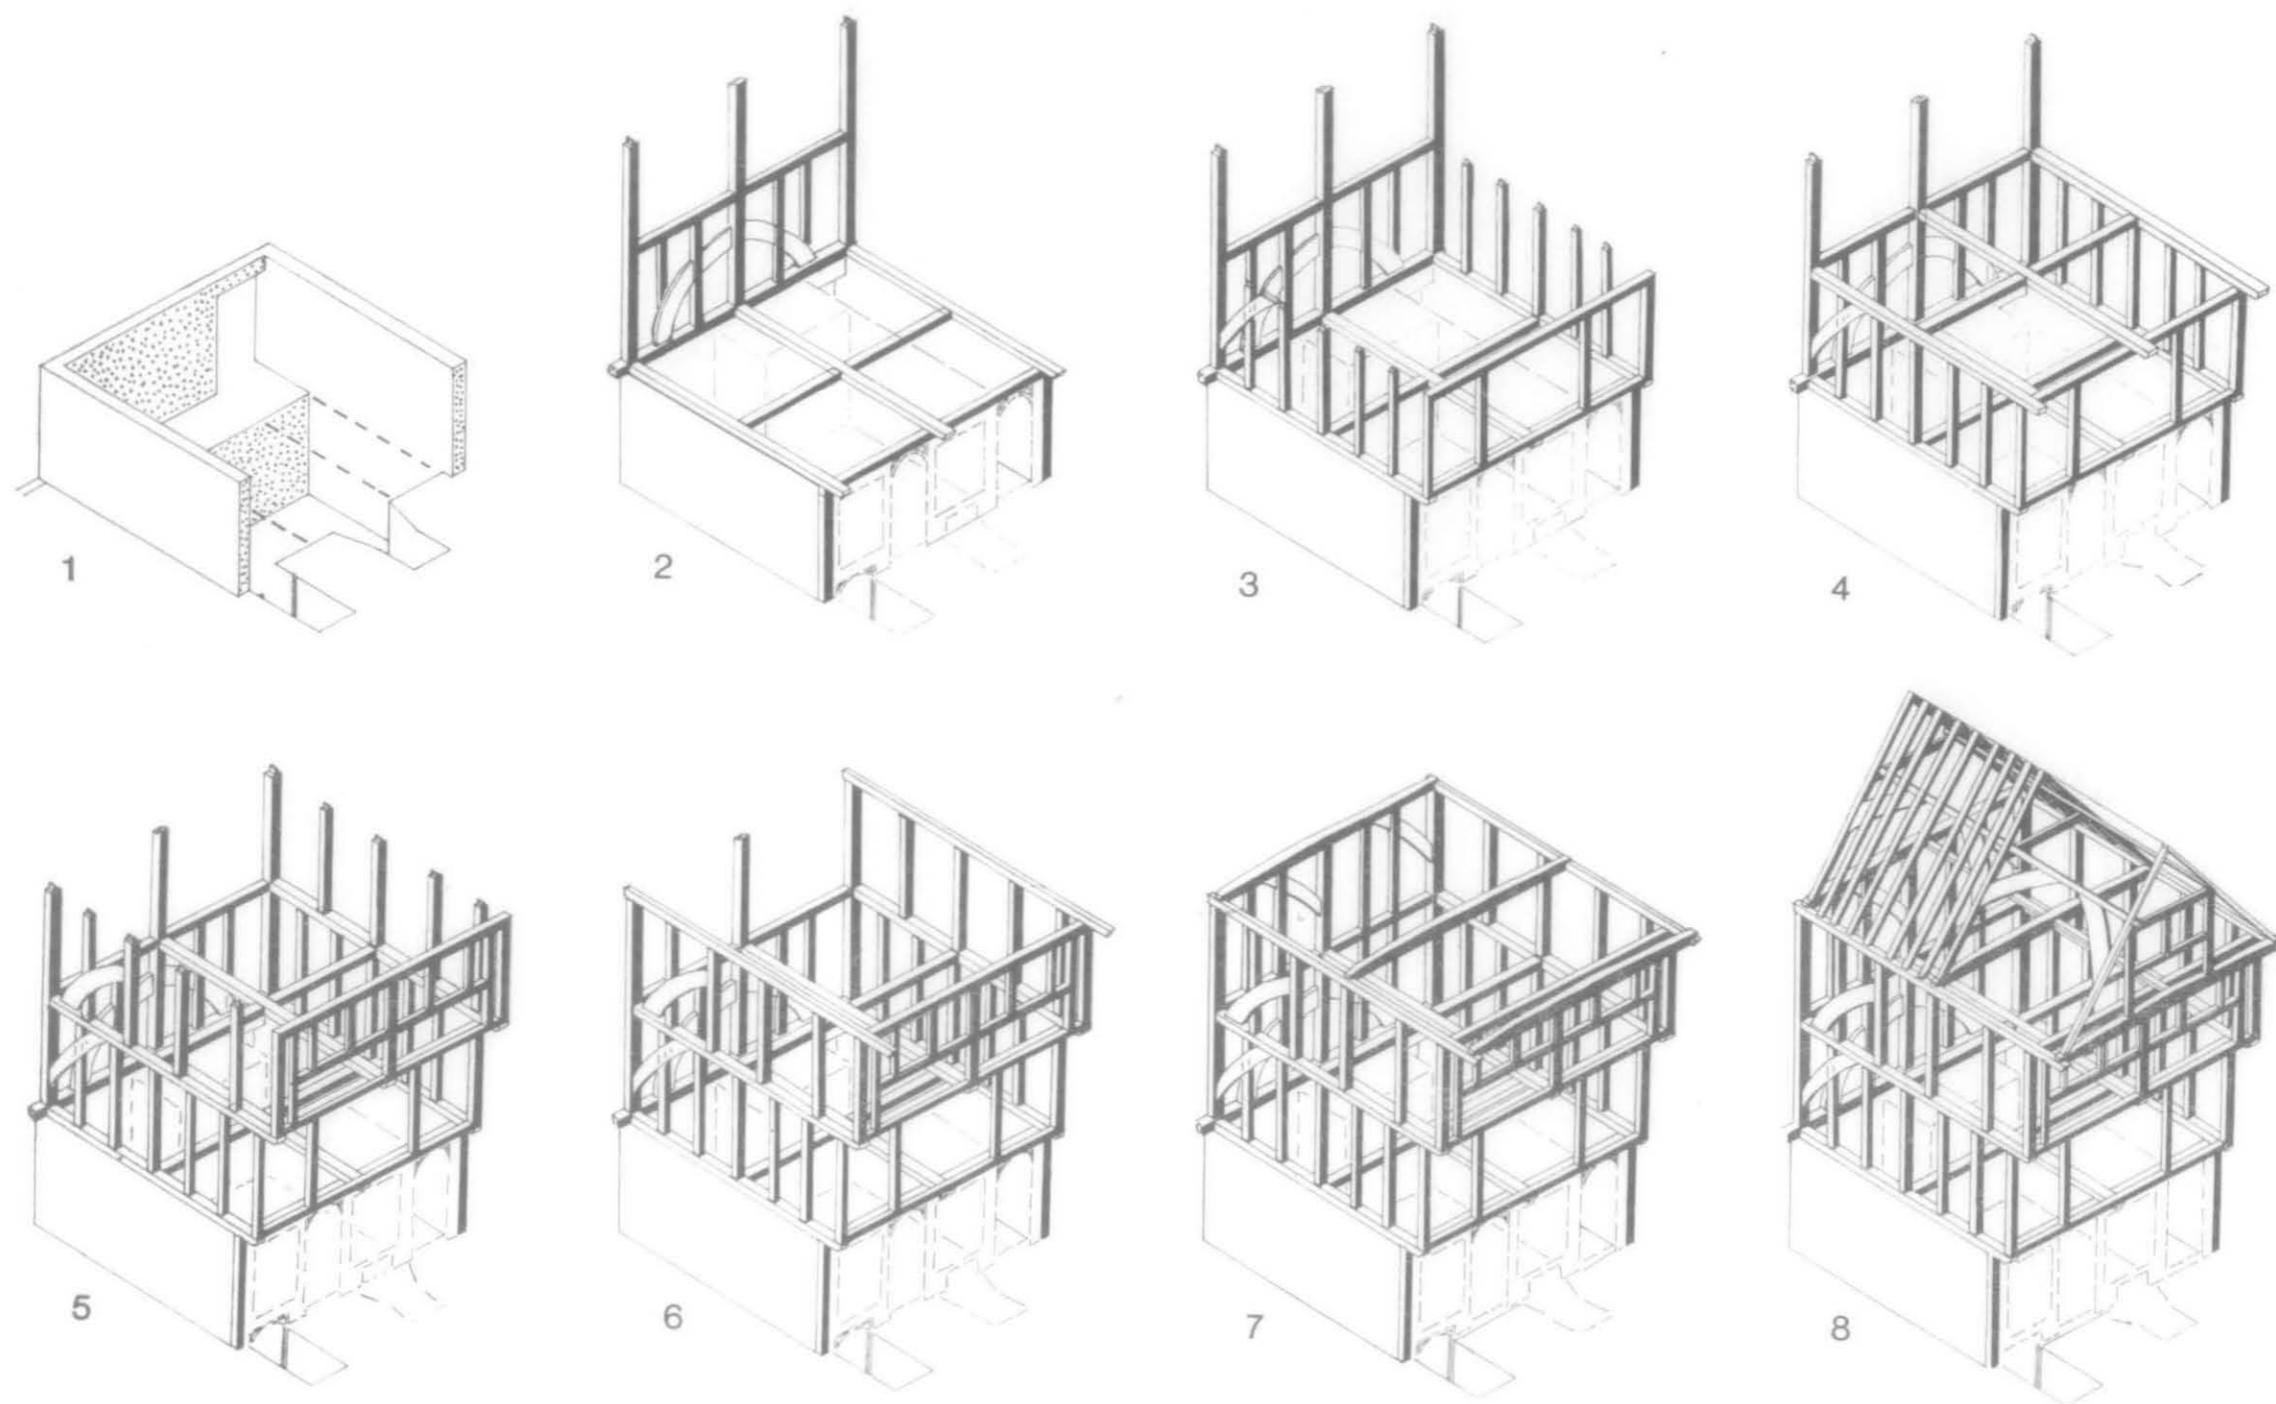
FIG. 3
 Timber frame of front part of 126 High Street ; order of construction. Scale 1 : 200.

The structure is most easily described in the order of construction; since it is not certain whether one half of the building was erected first, or all put up as a unit, the western half only (126) is described. It is to be noted that this form of construction enabled erection on a confined site, which must have been commonplace in an urban setting (see FIG. 3).

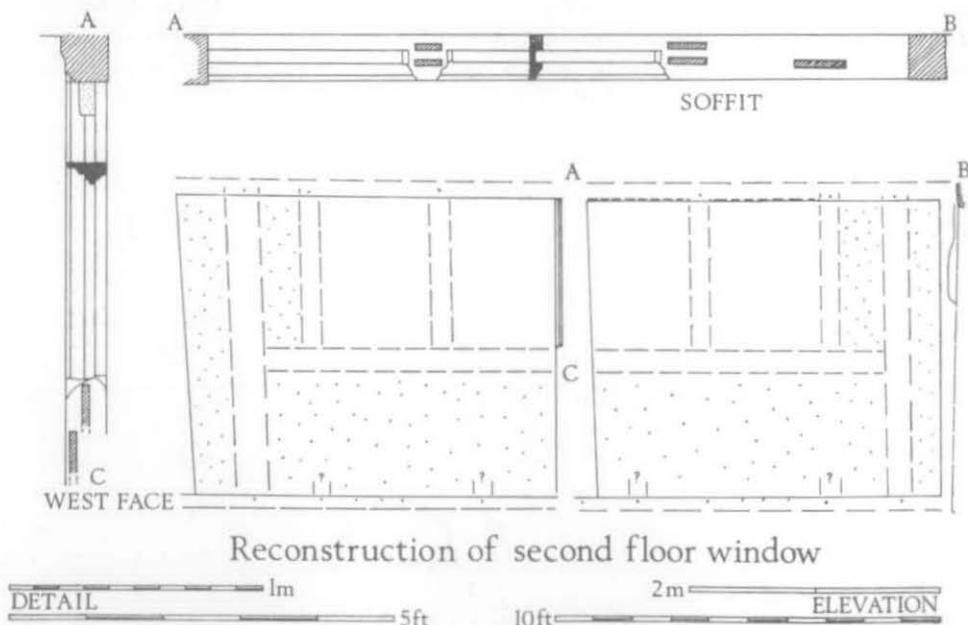
FIG. 6

Front wall of main house, interior elevation and detail of window on second floor.

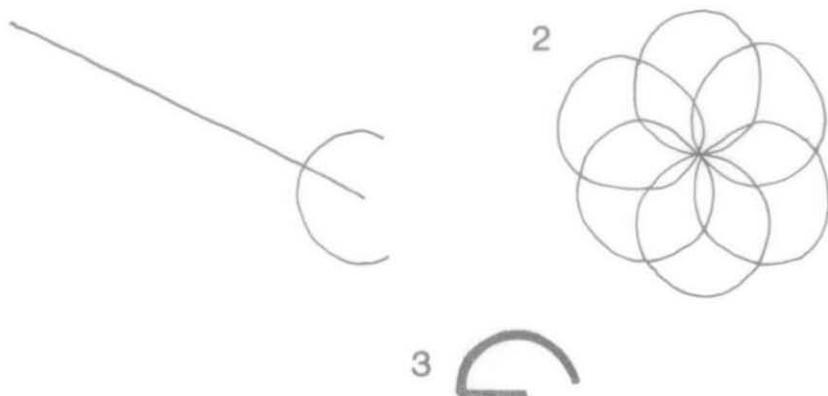
FIG. 7

Carpenters' marks from main house. 1, from east face of post 4 below 4C; 2, from east face of post 4 above 4C; 3, from principal floor joist 4C on east face at south end.

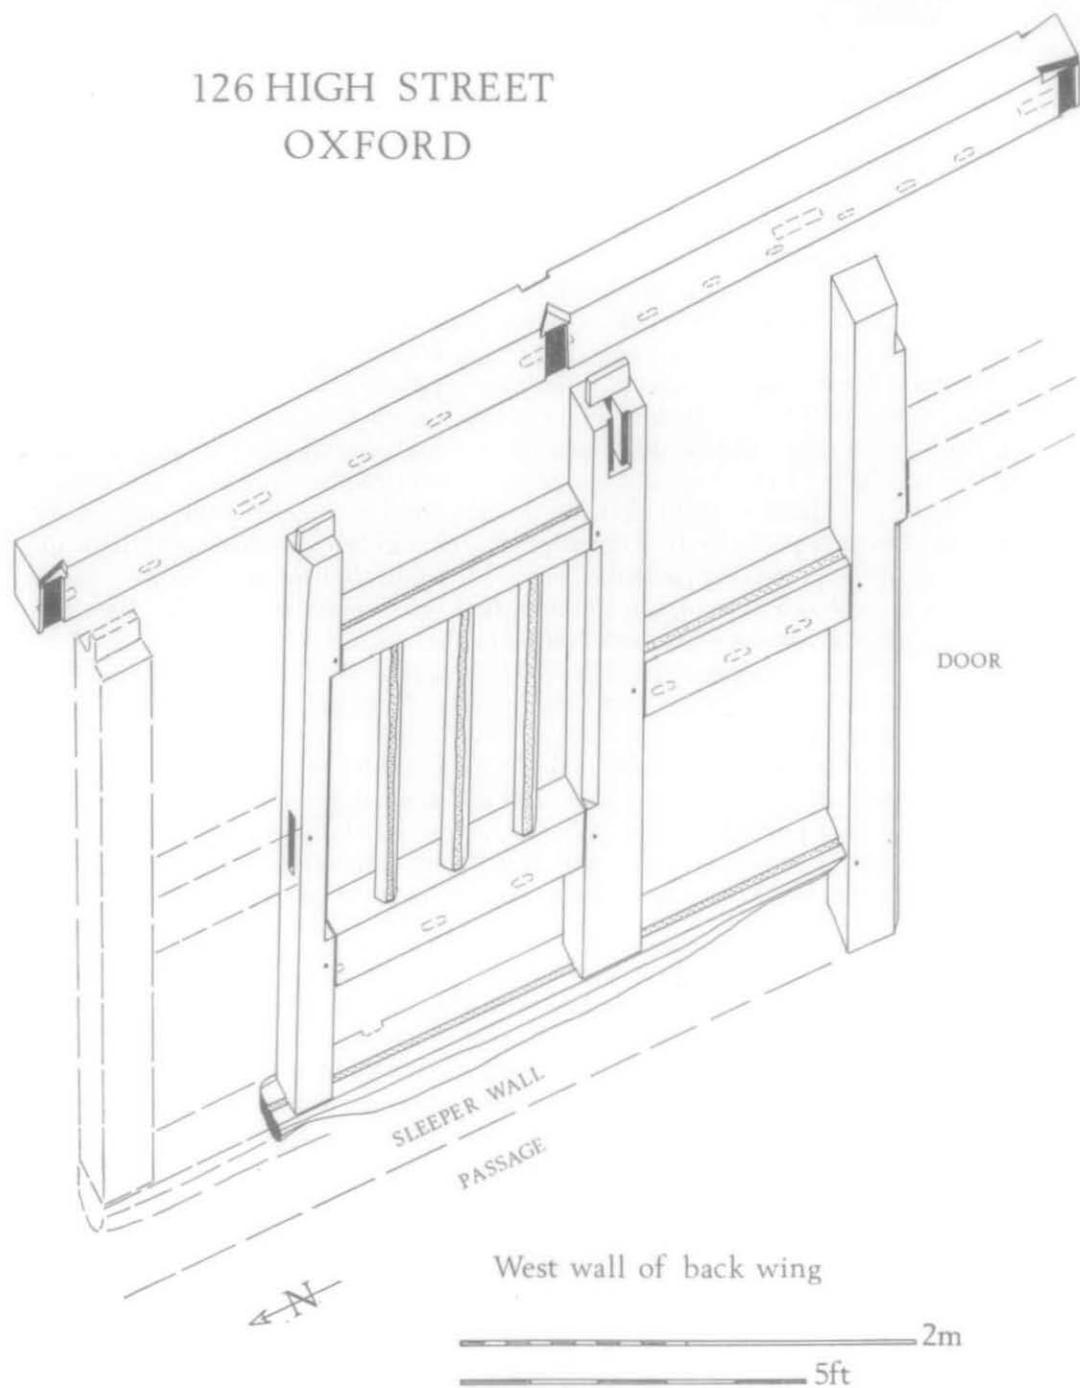
FIG. 8

Axonometric view of west wall of back wing, demolished May 1972, now replaced.

Timber Wall in passage (FIG. 8) : Enough of this wall was rescued (it can now be seen *in situ*) to be able to determine its original form and reconstruct some of the missing timbers above. The complete head plate was recovered with ground sill and three posts ; two more posts were indicated by the soffit of the head timber. The wall had five posts, but the frame was a two-bay structure as is shown by the three principal joists and roof trusses. The corner post next to the main house was removed when the chimney stack was added to the back wing (see below, p. 282). It probably stood on the footing wall, but the next two posts were raised on a sill beam ; this lay on a low wall and had a chamfer on the top outer edge. The first half-bay had a middle rail, the next a window. This was of simple construction, three mullions of square section, turned through 45° and held by shallow mortices in the sill and lintel. No provision appeared to have been made for glass. The next division had a middle rail, and the southernmost a door. The end corner post and door lintel had been removed when the south wall was altered. The door jamb, which may have been reused (to judge from its east face, visible inside the new building), had a plain chamfer and its return for the lintel. The filling of the panels was similar to that of the main frame, with a mortice above and a groove below for each stud. None were recovered.

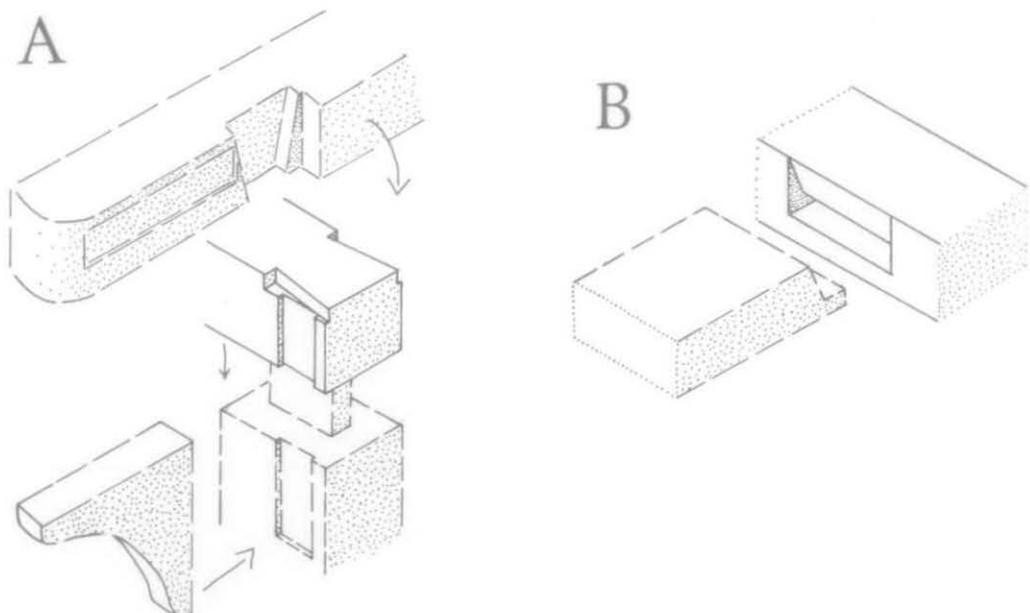
FIG. 9

Carpentry joints used in back wing. A, hypothetical reconstruction of jetty at south end of west wall ; B, barefaced soffit-tenon with diminished haunch at junction of principal joist and D.

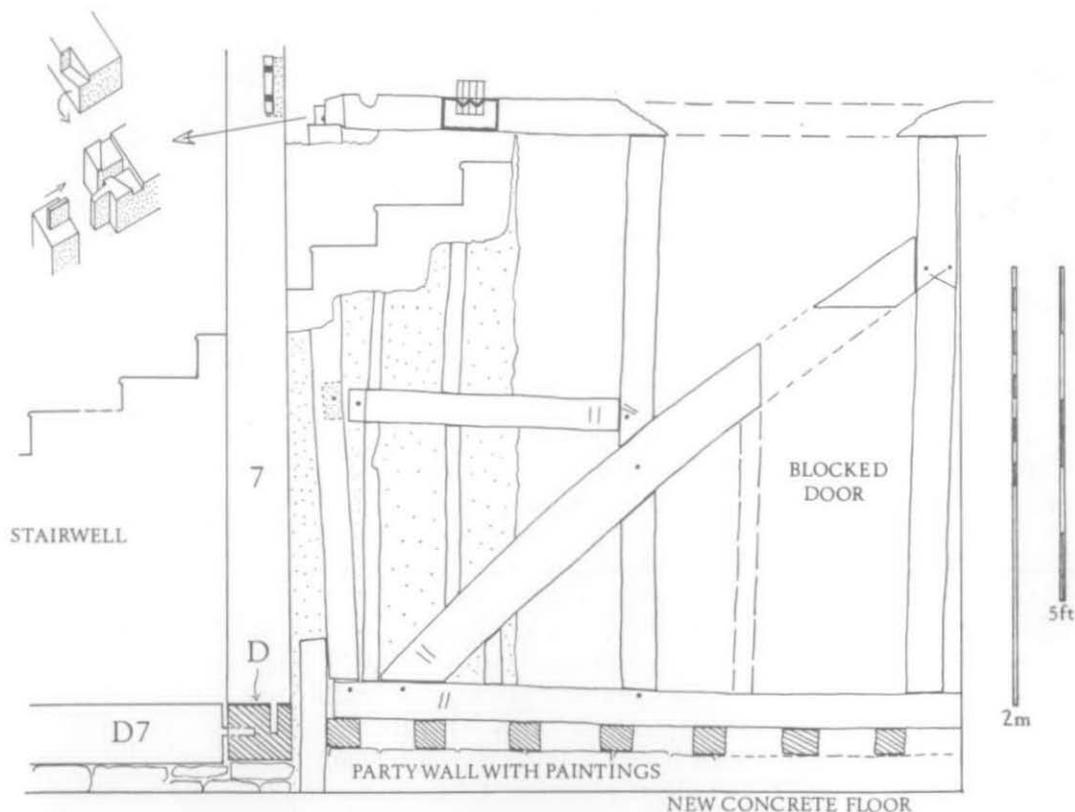
FIG. 10

First floor party wall in back wing, west elevation at junction with main house.

First Floor Party Wall (FIG. 10) : This wall frame, which still survives in the new back wing, and indeed forms the west wall of 125, is of very different construction from the timberwork on the ground floor. Only the northern half was examined in detail, since the other part was covered with plasterboard and later by new brickwork. However, there were indications that both halves were virtually symmetrical. As mentioned above, the lower plate rests on the sawn-off joists which lodge on the ashlar wall. Four posts are tenoned into this plate, with long diagonal braces rising

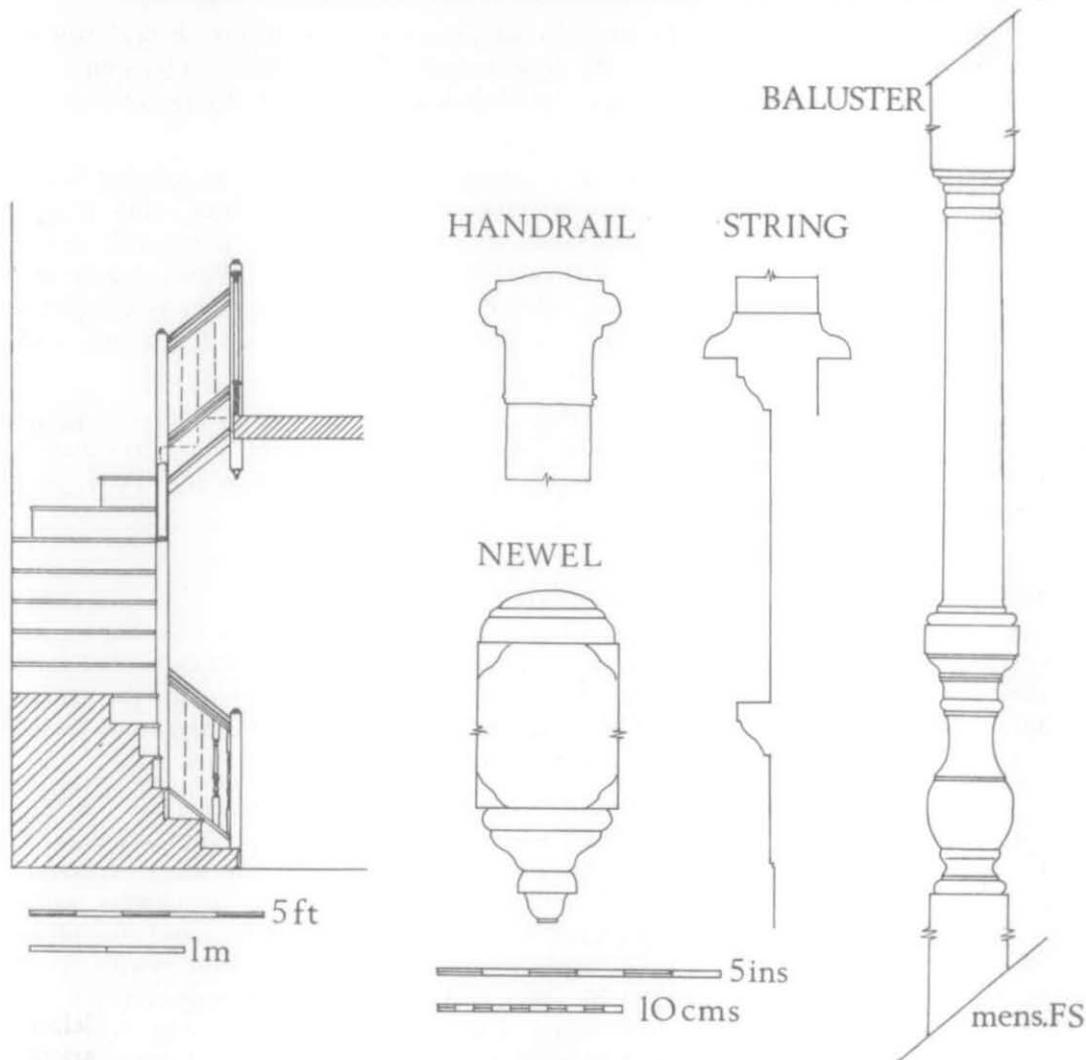
FIG. 11

Stair between front and back part, 126 High Street, stairwell looking east, and details. By permission of K. Stevens and Associates.

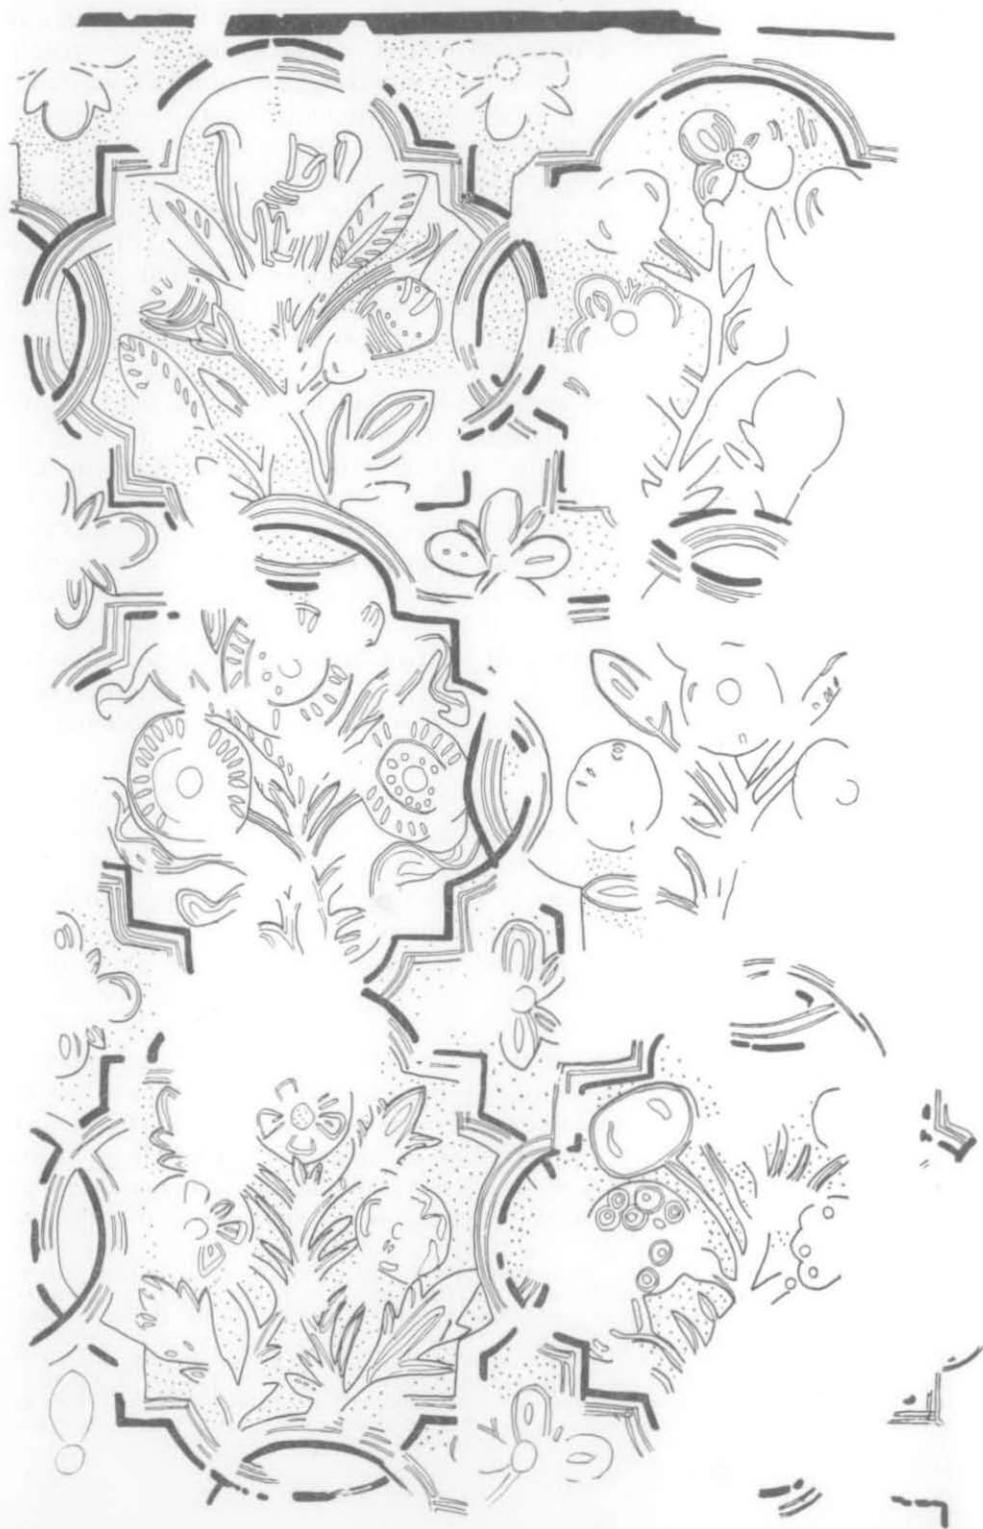
FIG. 12
Sixteenth-century wall painting detail. Scale 1/6.

Main pattern : Below the frieze on an ochre priming and red background was a pattern of formal interlocking quatrefoils, five deep. They appear to be matched in the very similar paintings once in No. 3 Cornmarket, parts of which are now in the City Museum.⁹⁷ Like the one from the (now demolished) back room there, the edgings of the quatrefoils alternated between a grey band with two parallel white lines on the outside and a black line on the inside, and a black edge outside with grey and white within. Between each quatrefoil was a rosette having four petals and a sepal between each (again as on the Cornmarket painting). As has been stated the remains at the southern end were almost entirely lacking and even at the north end the quatrefoils were badly damaged. They each contained a design based on a balanced triangle of three flowers disposed round a single stem, a divided stem or two crossed stems. However some included additional flowers or buds. The splendour to which this simple conception could attain was shown by an especially well preserved example where against the rich red ground were depicted two intersecting sprays each with leaves having five lobes. These were apparently black in colour although the greenish tinge upon the white lines painted on them suggests that they may originally have been dark green. The three flowers each have five petals with reddish centres. Unfortunately the petals seem to have lost most of their colour apart from white edgings, but in this instance there are traces of red. Other quatrefoils depict flowers with three or four petals as well as multi-petalled varieties.

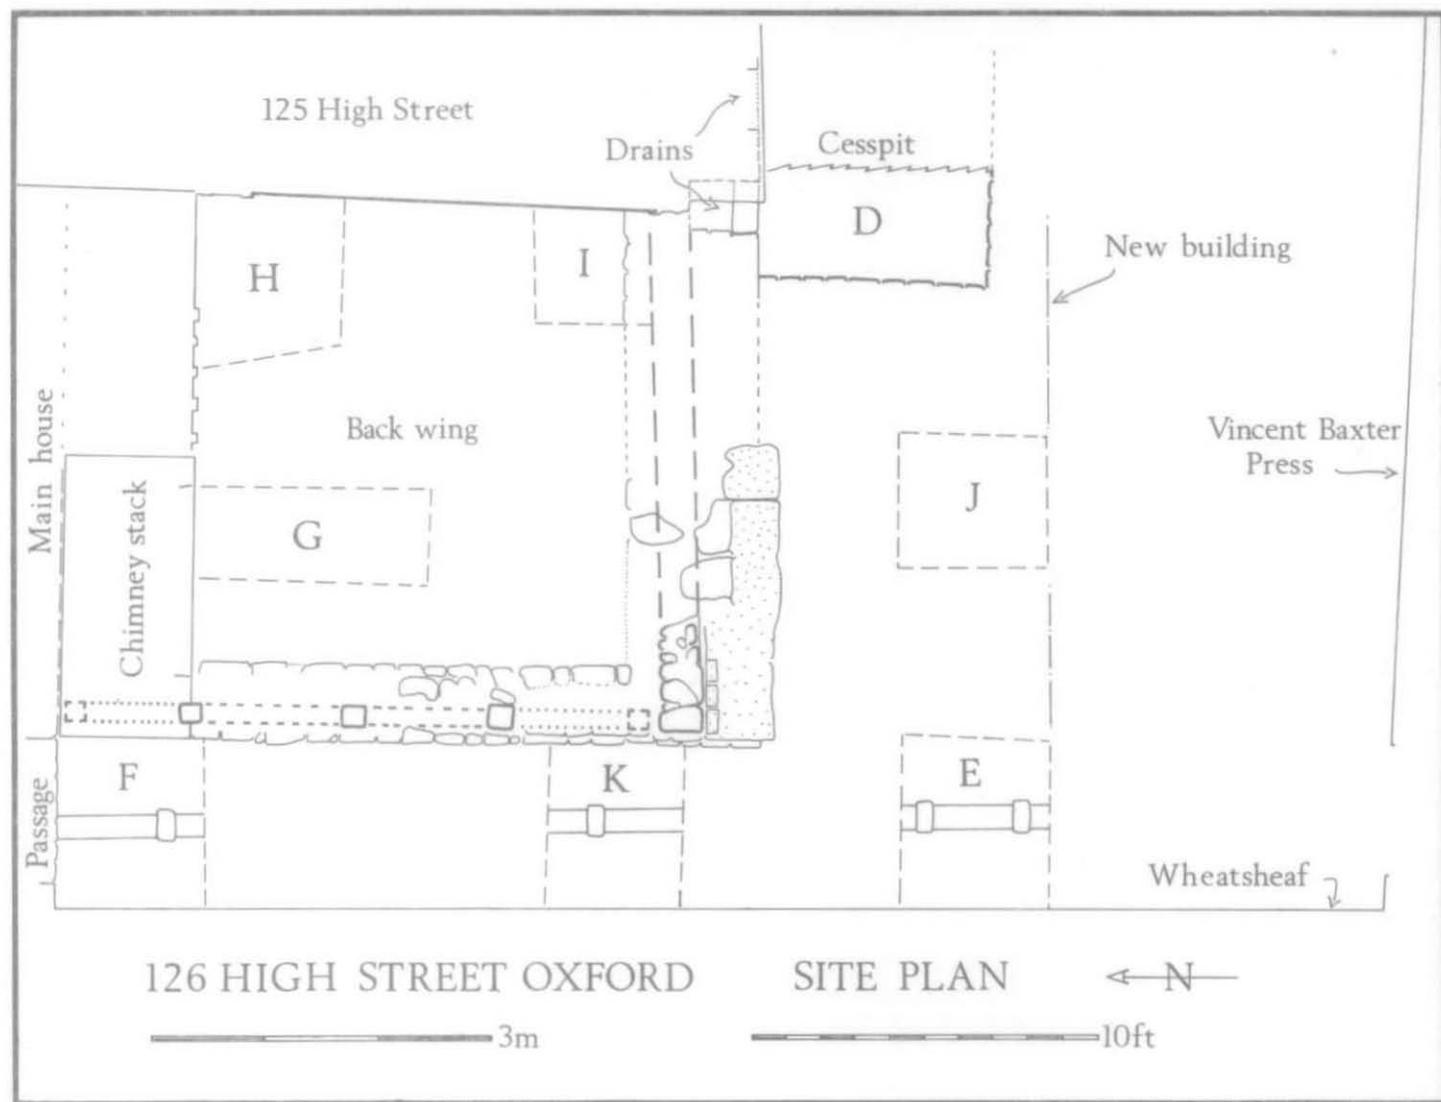
FIG. 13
Site of back wing and trenches.

Footings (FIG. 13) : On the east side of the ground floor there was and still is a substantial rubble and ashlar wall (in line with that dividing the shops at the front) which serves as a party wall with 125, and supports the floor joists on the first floor. On the north there was no separate wall, since the back of the front part was used. The timber frame on the west rested on a narrow sleeper wall over a broader stone footing (1 m. deep and 80 cm. wide) of coursed rubble, which survives beneath the present wall. Beneath the south wall was a much broader stone footing (120 cm. wide) of large stones in a mortar fill. This was continuous with the western footing, but had a straight joint with the east party wall (yet neither appeared stratigraphically to be earlier). Here it also increased in depth to accommodate the cess-pit. Over this south foundation was a rubble wall 40 cm. wide. Although destroyed in later alterations, traces of its footing were noted, as also its bonding into the east party wall, and its western end flush with the outer face of the timber frame onto the passage. It was probably built up to the first floor if not further. For the archaeological context of these footings see Trenches I and K below. They were all dug into the demolition dump of an earlier building.

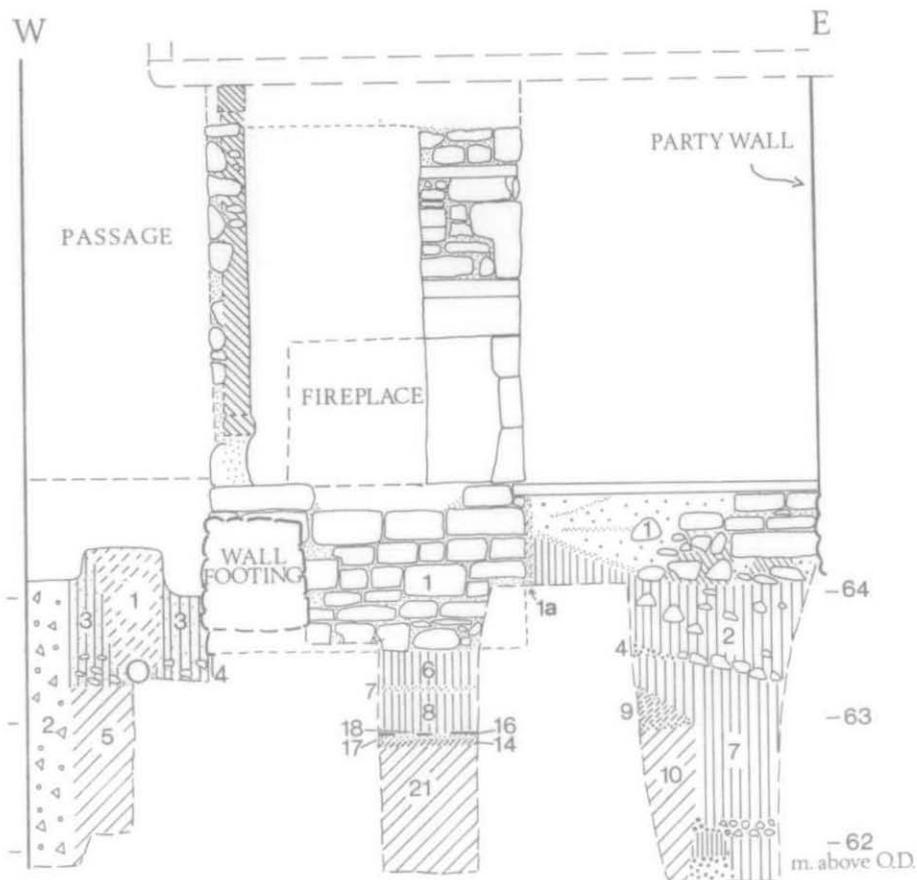
FIG. 14

Main section through back wing and trenches below it, showing south section (reversed) of F and north sections of G and H.

The *chimney stack* (see FIG. 14) was clearly an addition to the original building, cutting through its timber frame and footings, and sealing the interior wall surface at the northern end of the first floor room. Again, only the ground floor portion survived to be examined, and even that was obscured with brick blocking and cement rendering. The construction was of rubble and re-used ashlar (some stones in the foundations had traces of plaster on them) with small horizontal timbers included above the fireplace. The surround was gone, though the lintel was keyed, probably for another stone. Above and around the fireplace wooden plugs had been inserted (the scratched lines for aligning them could be seen); these doubtless held batons to support panelling, or indeed painted cloth. Pantin reported that no original fireplaces were visible, which leaves it uncertain how many there originally were. It is tempting to equate the six fireplaces on Pantin's drawing with the six hearths that Pawling was assessed for in the 1665 Tax, but we cannot be sure without knowing the extent of his holding.

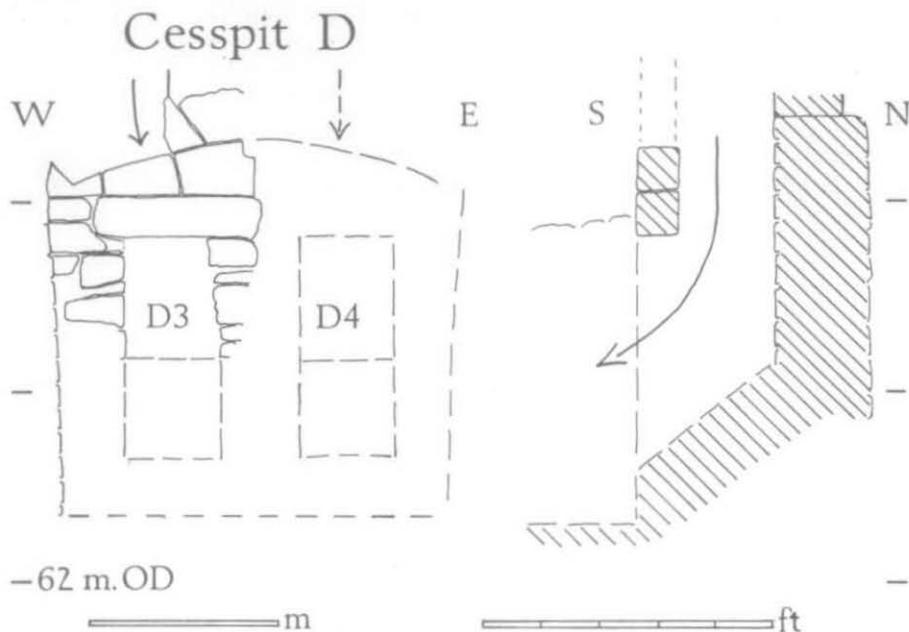
FIG. 15

Cess-pit in back wing, north elevation and section looking west.

2 The cess-pit : This was constructed at the same time as the back wing, the foundations of which were extended down at this point to accommodate it (and serve as its north wall). The south and west sides of the pit were coursed rubble, and the latter was bonded into the

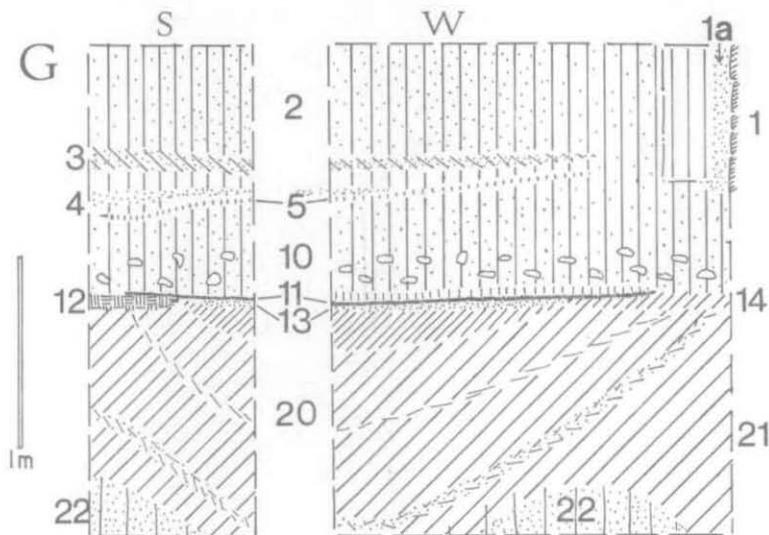
FIG. 16

Trench G, south and west sections. Scale 1 : 40.

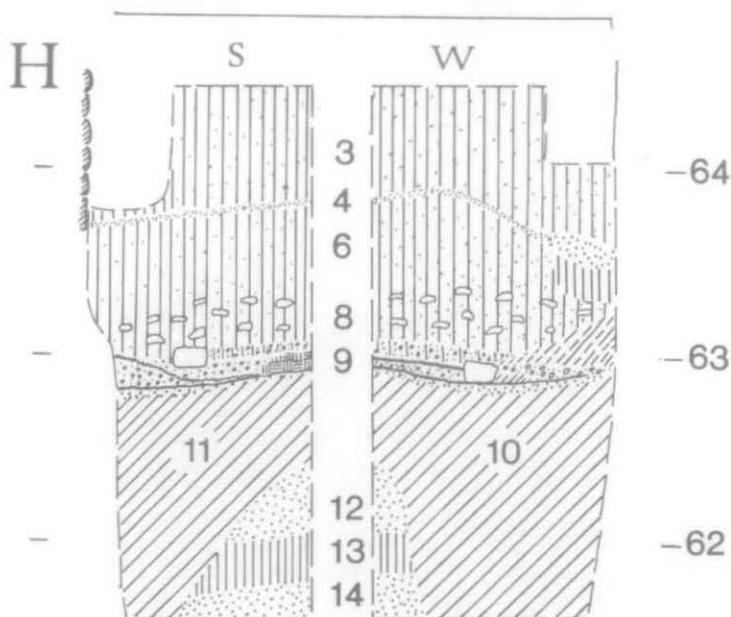
FIG. 17

Trench H, south and west sections. Scale 1 : 40. Height in metres above O.D.

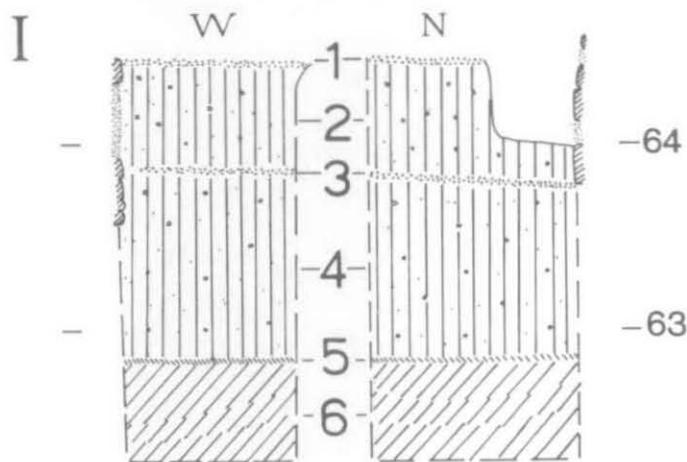
FIG. 18

Trench I, west and north sections. Scale 1 : 40. Height in metres above O.D.

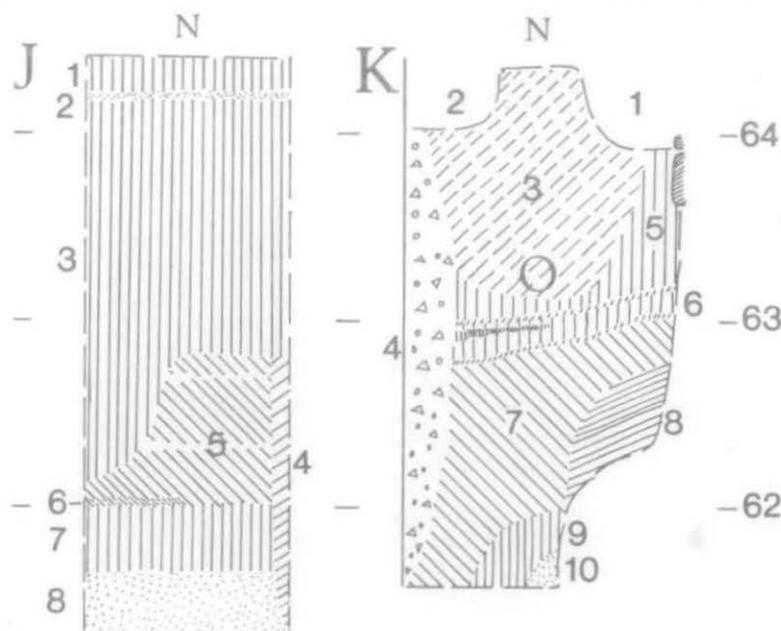
FIG. 19
Trenches J and K, north sections. Scale 1 : 40. Height shown in metres above O.D.

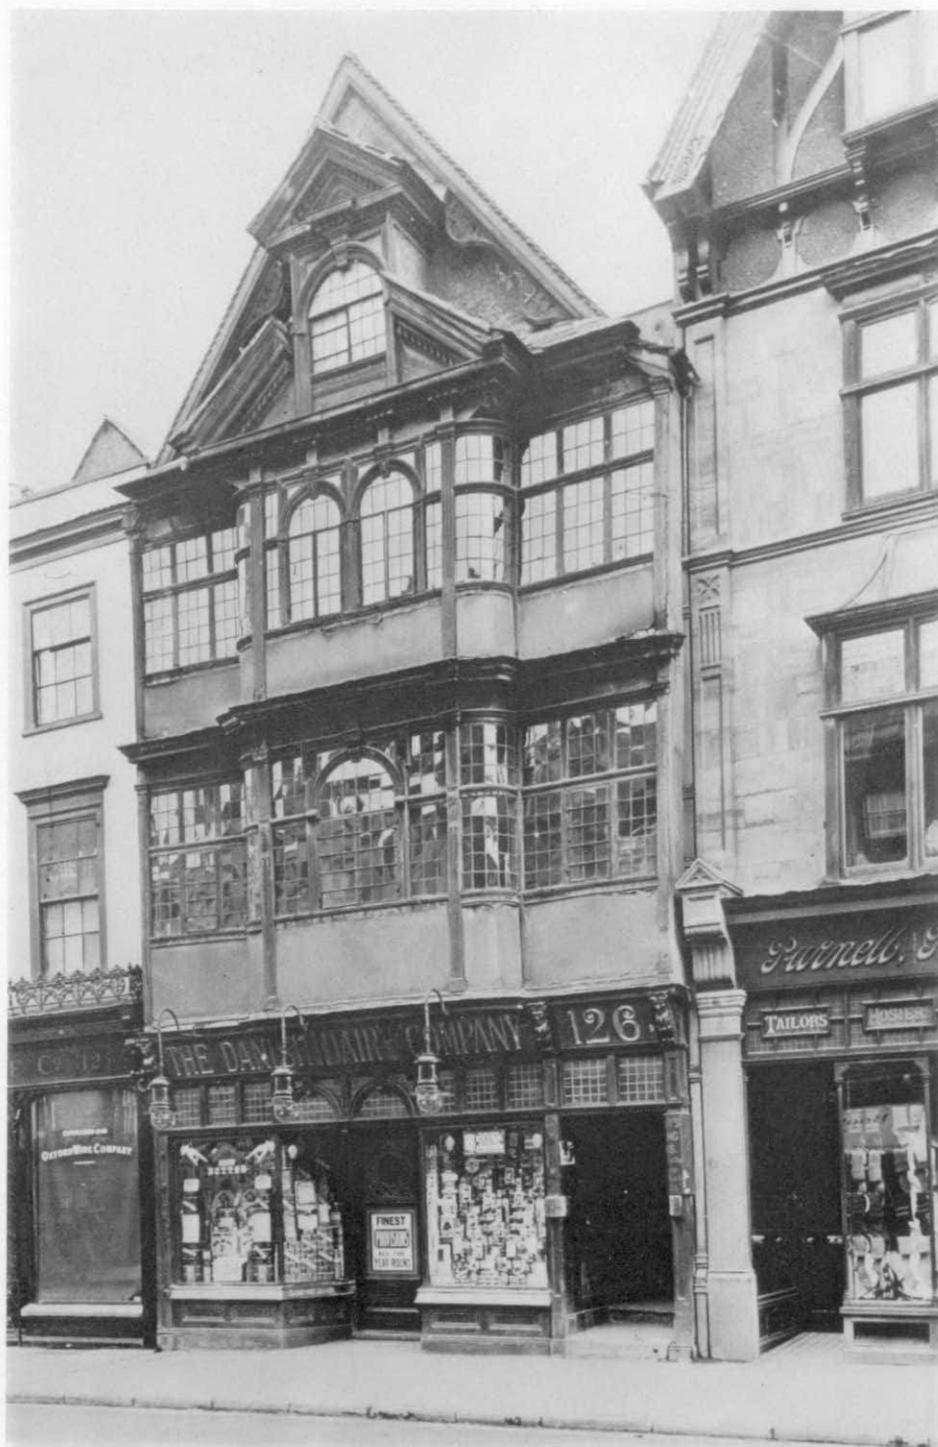
126 High Street in the early 20th century : the 17th-century façade.
