126 High Street: The Archaeology and History of an Oxford House

By JULIAN MUNBY

SUMMARY

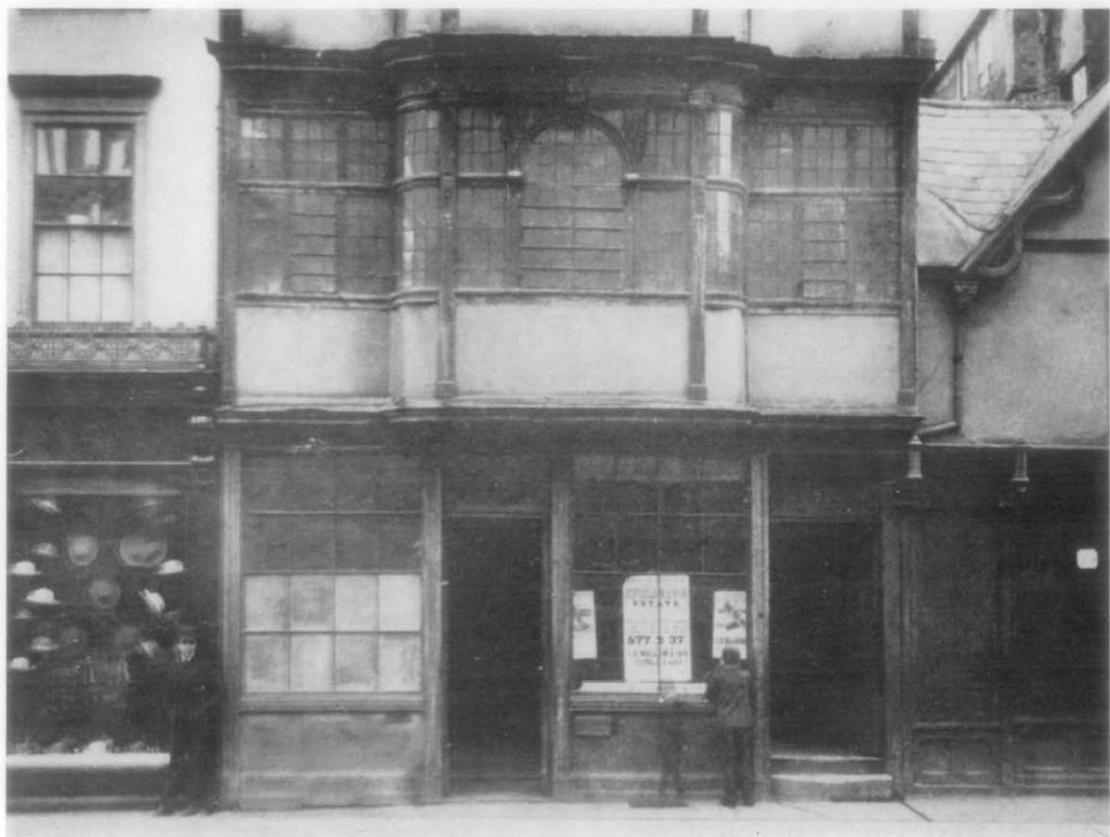
PLATE VIII

A. 126 High Street before 1894 : the Regency shop front.

in early maps of Oxford and views along High Street,¹ it was drawn by Delamotte in 1834 for Ingram's *Memorials of Oxford*² and photographed about the middle of the century (PL. VIII, A).³ H. W. Moore, one of the architects of North Oxford, included it in his *Twelve Sheets of Pen and Ink Sketches of the Old Domestic Architecture of Oxford* (1882).⁴ The notebook of Gilbert Scott in Christ Church Library includes a sketch of the front. Herbert Hurst, the late 19th-century archaeologist and topographer, appreciated its antiquity⁵ and it was included on one of the earliest short-lists of buildings considered 'worthy of preservation' in 1914,⁶ and again in 1936 when a strong recommendation for preservation was made.⁷ In 1947 a brief description with drawings was published in a well-known and important paper,⁸ adding to the notice in the R.C.H.M. Inventory of 1939.⁹ The age of the house was assessed on structural grounds, being assigned to the late 15th or early 16th century, and it was suggested that the back wing might 'possibly have been built at a slightly later date than the front part'. The Provisional List of Buildings of Special Architectural or Historic Interest (1953) included the house and accorded it the distinction of Grade I status.¹⁰

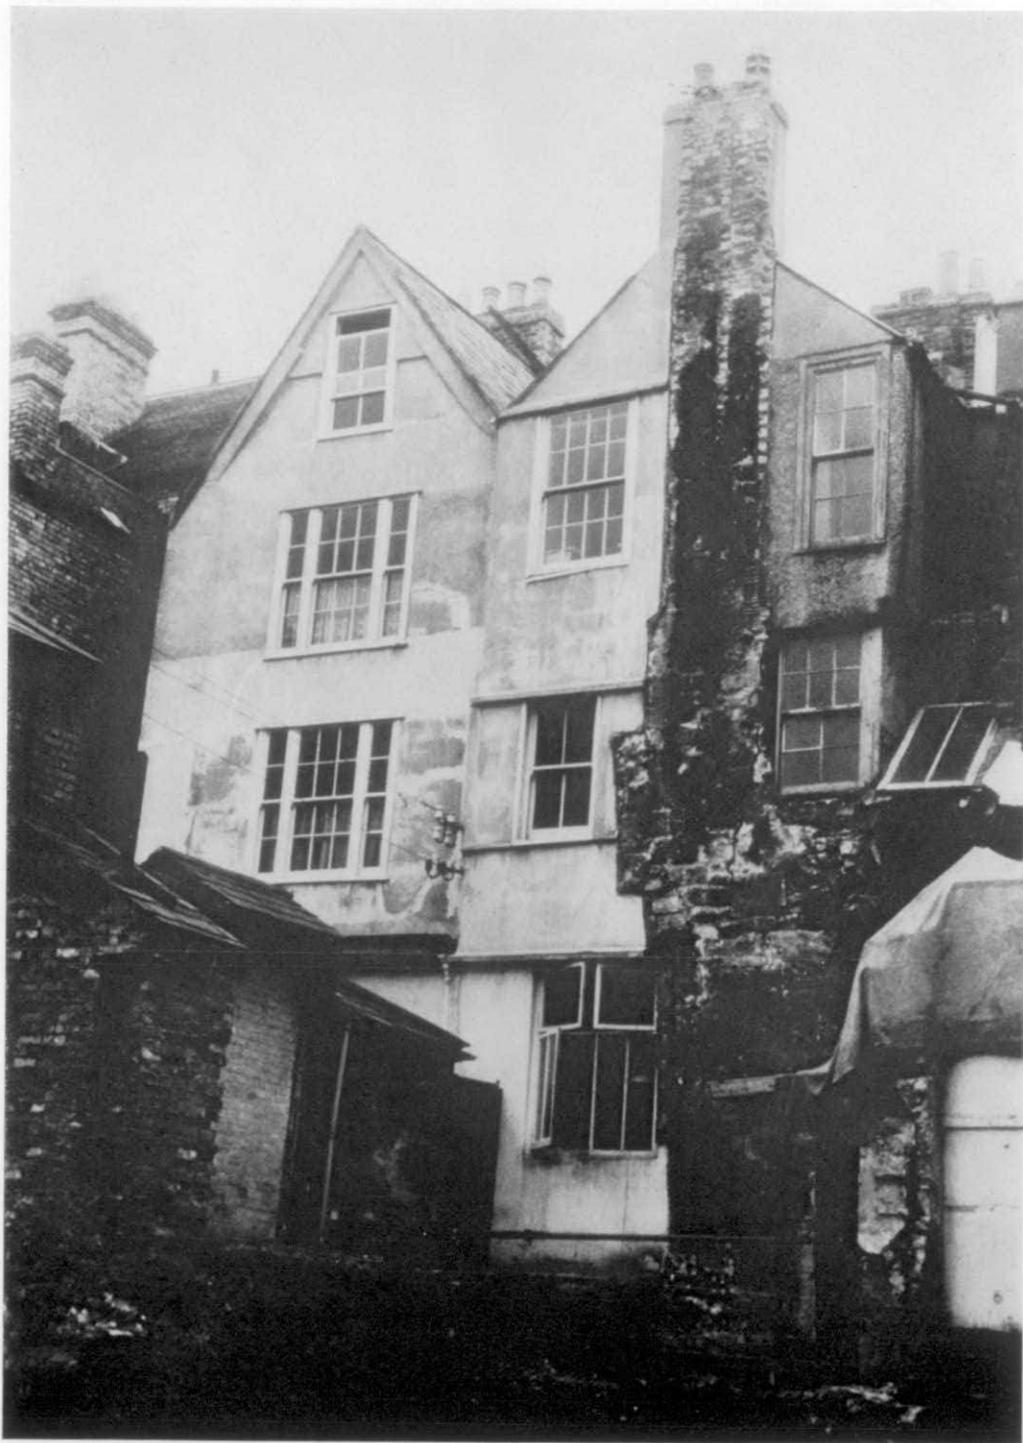
126 and 125 High Street. Back elevation, c. 1961, before alterations.

Apart from the back wall of the main frame (used as an interior wall), part of the timber west wall on the ground floor, and the east party wall on the ground and first floors, no other part of the demolished structure was fully observed. A certain amount of information can be recovered from Pantin's drawings (*cf.* FIG. 2), a set of architect's plans made before demolition and an exterior photograph taken in *c.* 1961 (PL. IX).

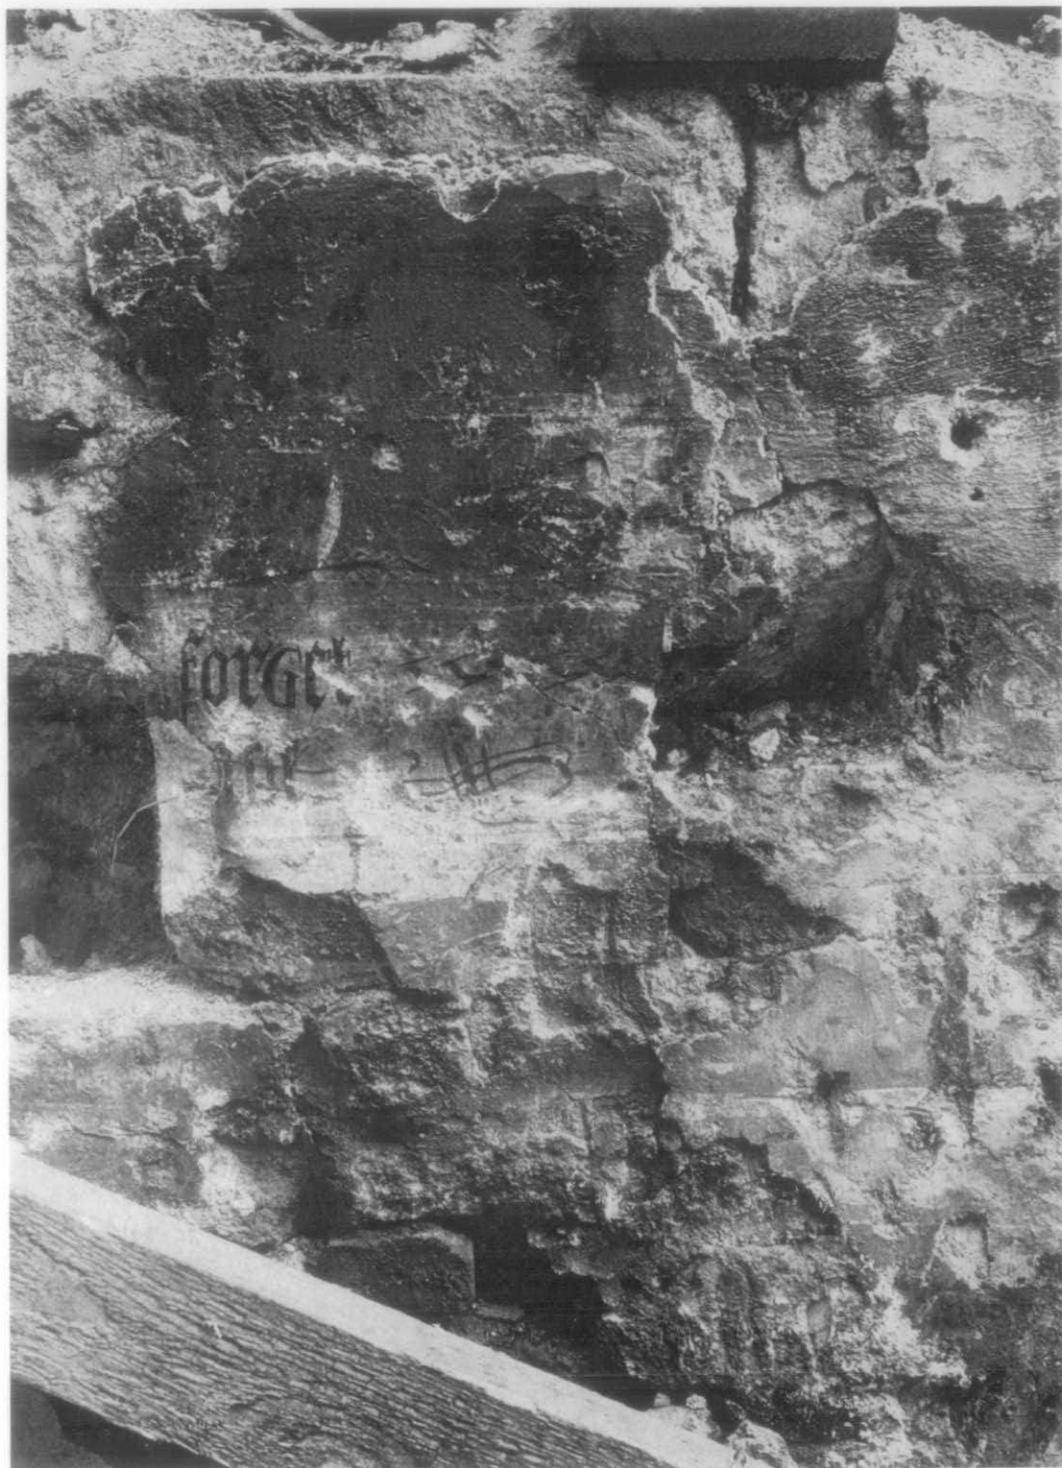
126 High Street. Wall painting inscription and frieze.

After the unrecorded demolition of the sixteenth-century addition to an important fifteenth-century house, late sixteenth-century wall paintings were found and some of the timberwork rescued. Contractor's excavations on the site were observed, revealing traces of occupation back to late Saxon times. A detailed survey of the surviving structure was undertaken, and a full documentary study of the house and its owners made.
