A Monastic Fragment at Wadham College, Oxford

By W. J. BLAIR

A FRAGMENT OF THE AUSTIN FRIARY, OXFORD.

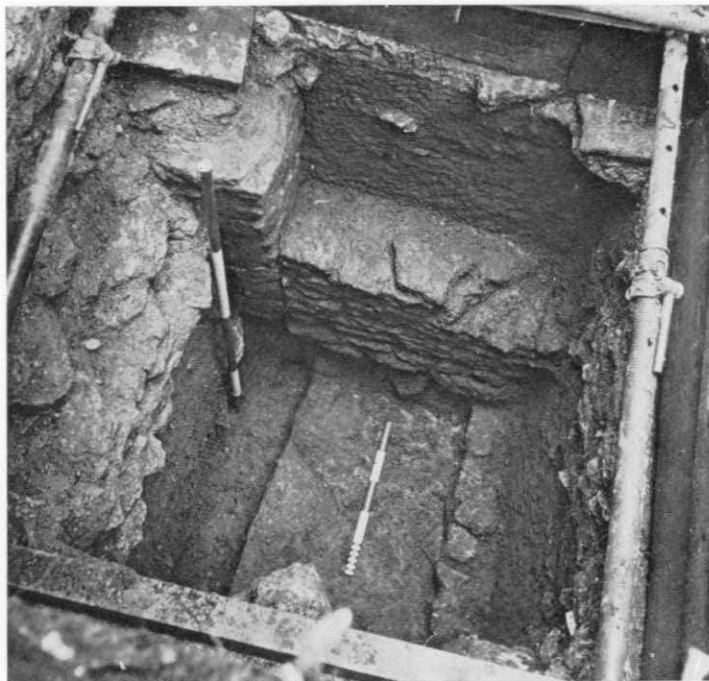
A. St. Helen's Passage, Trench III. Stairwell to postern through the outer city wall.

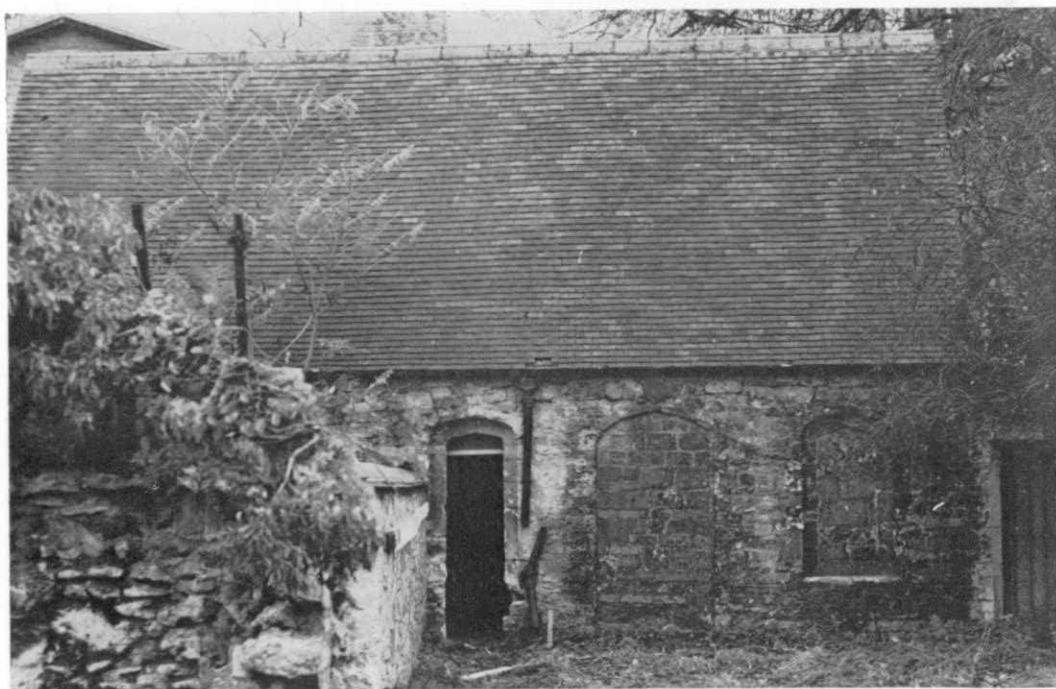
B. The remains of the pre-dissolution east face in 1974, with two original windows flanking inserted door.

The east face (PL. V, B), incorporated in the boundary wall, is more complex. A door and two windows with depressed four-centred heads are visible externally, all three formerly blocked with ashlar but with the blocking recently removed from the southernmost window. The door seems to be merely chamfered, but the windows have wide hollow mouldings on the outside and are splayed internally; the jambs have sockets for seven horizontal and two vertical bars. The window-splays are covered with a skin of fine plaster disguising mortar-filled gaps between the inner quoins and the worked blocks of the outer opening. Parts of two similar windows remain in a free-standing northern continuation of the wall, the first converted into a modern doorway and the second rubble-blocked with a wooden lintel replacing the lost head. A little further north the wall is staggered and becomes thinner, this point being marked by quoins built in on both sides. To a height of about 2.2 m., the length of wall from the southernmost window to the quoins is of smallish, roughly dressed coursed blocks, but above this it has been heightened with rubble, of which its continuations northwards and southwards are also built.
