# Excavations on the Outer City Wall of Oxford in St. Helen's Passage and Hertford College

By NICHOLAS PALMER

*Excavations in St. Helen's Passage and Hertford College by the O.U.A.S. uncovered a postern gateway through the outer city wall of Oxford (FIG. 1). This wall, whose existence was previously known only from documents, is unique among medieval town defences in this country, and may represent an abortive late 13th-century attempt to apply principles of concentric castle architecture to the defences of Oxford.<sup>1</sup>*

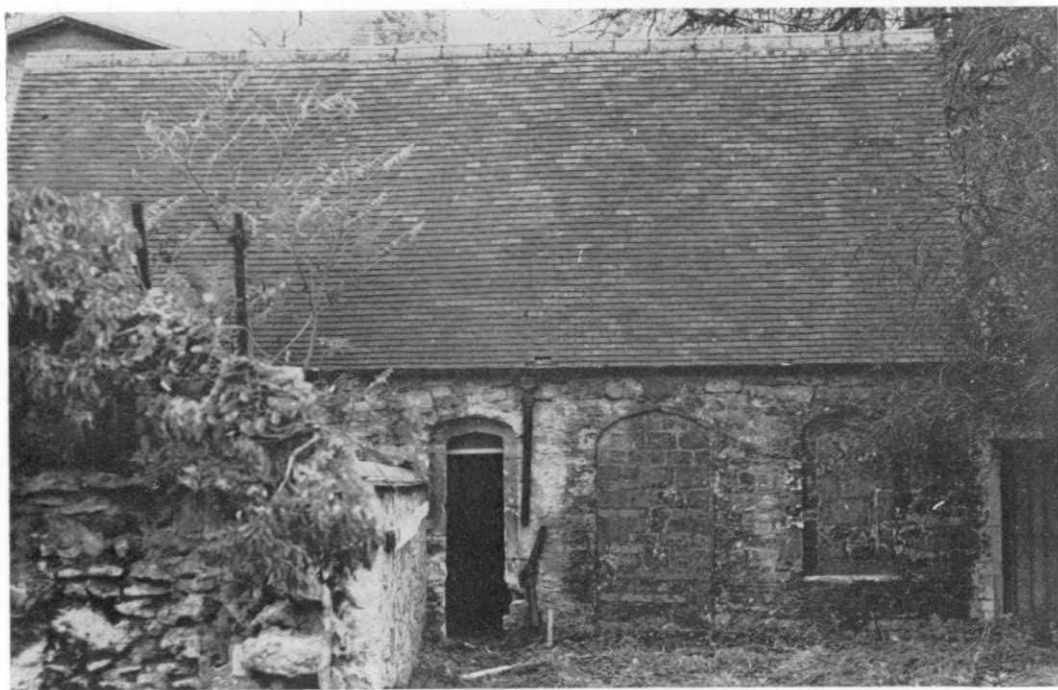
B. The remains of the pre-dissolution east face in 1974, with two original windows flanking inserted door.
