Excavations on the Site of Banbury Castle, 1973-4

By K. A. RODWELL

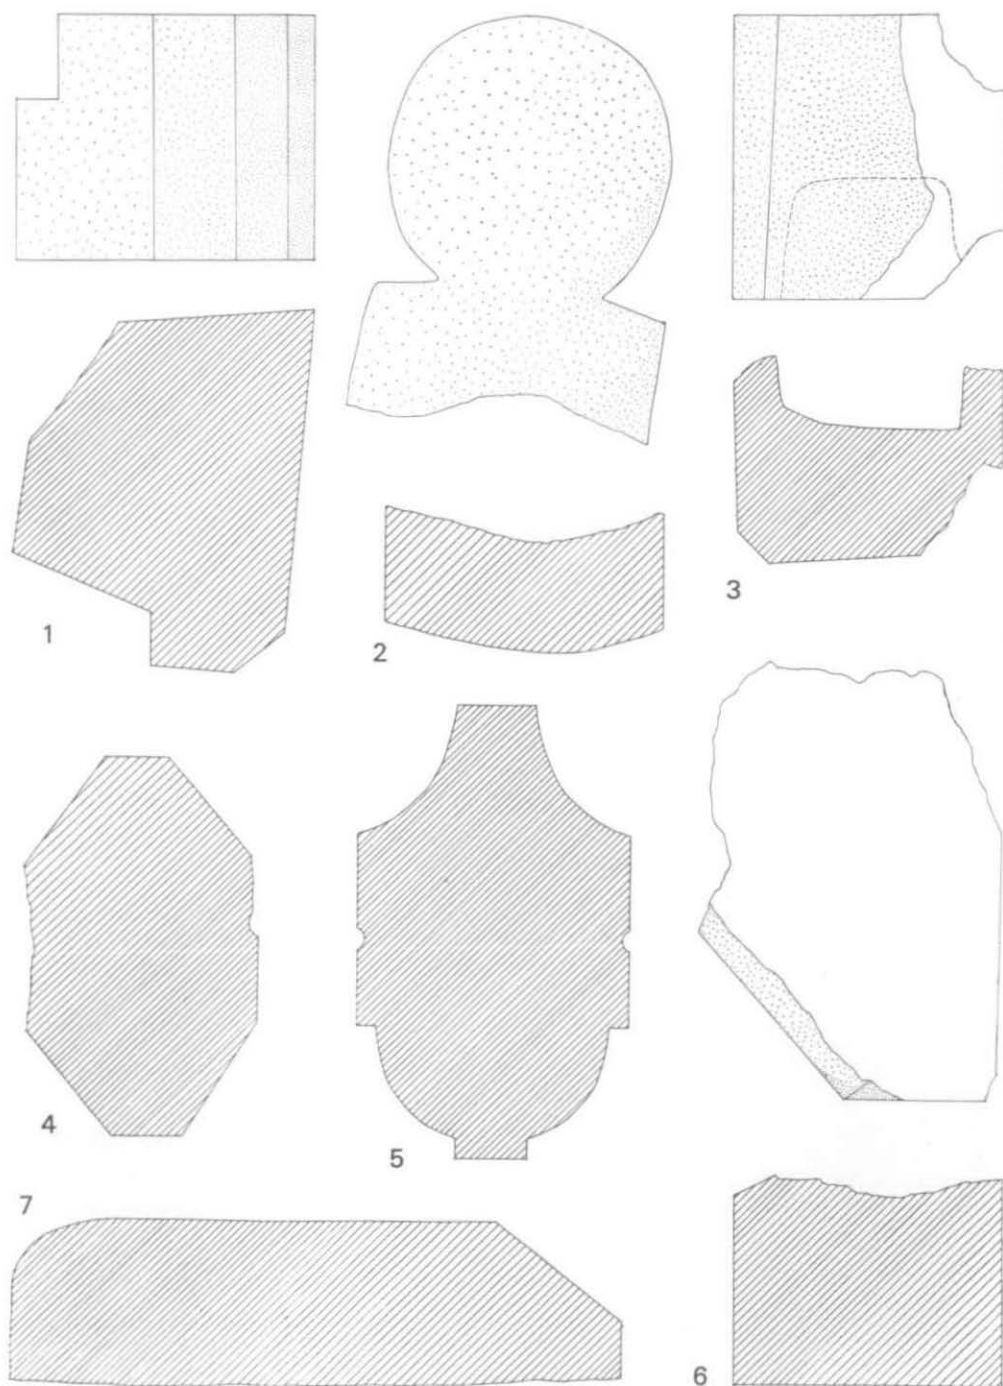
FIG. 21

Structural stone. Scale $\frac{1}{4}$ except for 1 and 2, 1 : 8.

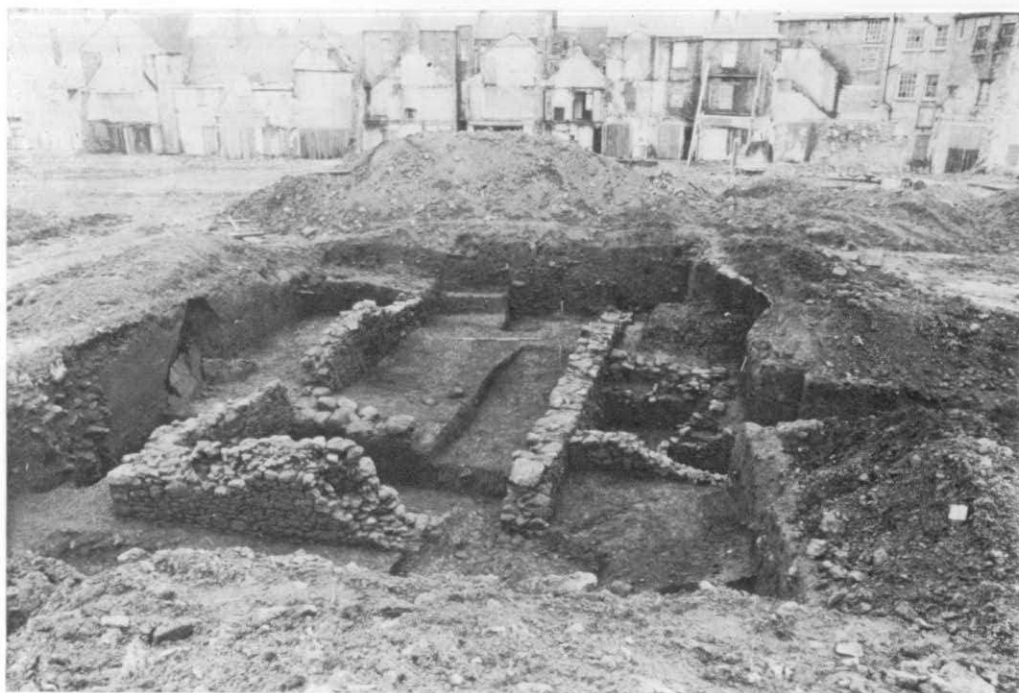
A. 12th-century building, Area II, from the north.

The building was erected in the extreme south-western corner of the castle enclosure. It was aligned on the curtain wall and stood hard against the back of Bank 57. The ironstone metalling, 123, was laid up to its north and east walls. It was 4.6 m. wide internally by at least 10.7 m. long, but its southern end was destroyed by the Period 2 outer ditch. The two long walls 53 and 54 were 0.5 m. wide with trench-built foundations 0.4 m. deep (below Period 1 ground level). The north wall, 96, was thicker (0.7 m.) and had a deeper foundation (0.6 m.).

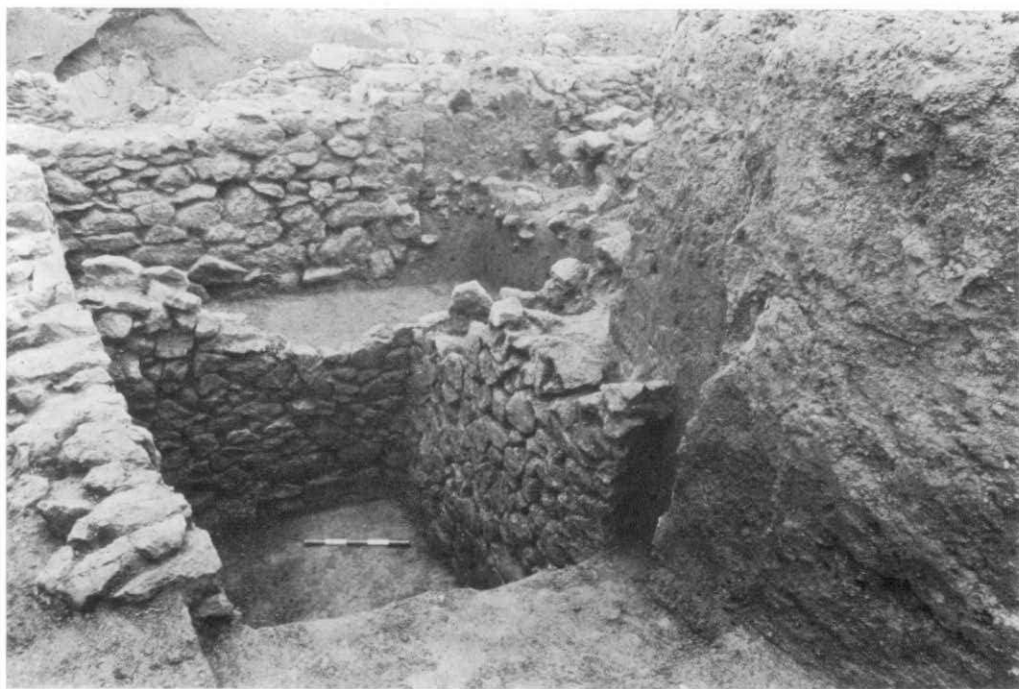
B. Garderobe chamber, Area II, from the west.

On the west side of the building a garderobe chamber (PL. IV, B) was added with access from a new door in Wall 54. The chamber was constructed within Bank 57 and had a floor level 0.15 m. higher than the floor level then in use in the main room. The walls (56, 273, 98), which were butted against 54, were 0.5 m. wide and dry-stone built with roughly dressed blocks at the south-west corner and at the junction between 54 and 273. Wall 98 was in a poor state of preservation. The walls had no foundations, being constructed directly from floor level. A cess-pit, 99, was built into the north-west corner of the room by excavating a pit 1.9 m. by 1.3 m. through the bank (57) and the buried soil (61) to the natural sand beneath, and facing it with ironstone rubble on all but the west side. The north side of the pit was bonded into the bottom of Wall 56, but the other two sides seem to have been finished at floor level with a course of pitched rubble, retained by a row of flattish
