# Oseney Abbey, Oxford: Archaeological Investigations, 1975-1983

By JONATHAN SHARPE

*Salvage recording, excavations in advance of development and fieldwork have provided evidence for substantial shifts in the precinct boundary in the late 12th and 14th/15th centuries. Two phases of water-frontage were recovered, the earlier lying 30 m. east of the later, together with evidence for associated domestic buildings within the precinct. Historical research has suggested the location of industrial areas outside the precinct, and has provided scope for a reinterpretation of the site topography, whilst excavation has demonstrated the survival of floor-levels despite the 18th-century ploughing of the site (N.G.R. SP 504 588, C.S.M.R. 79).*

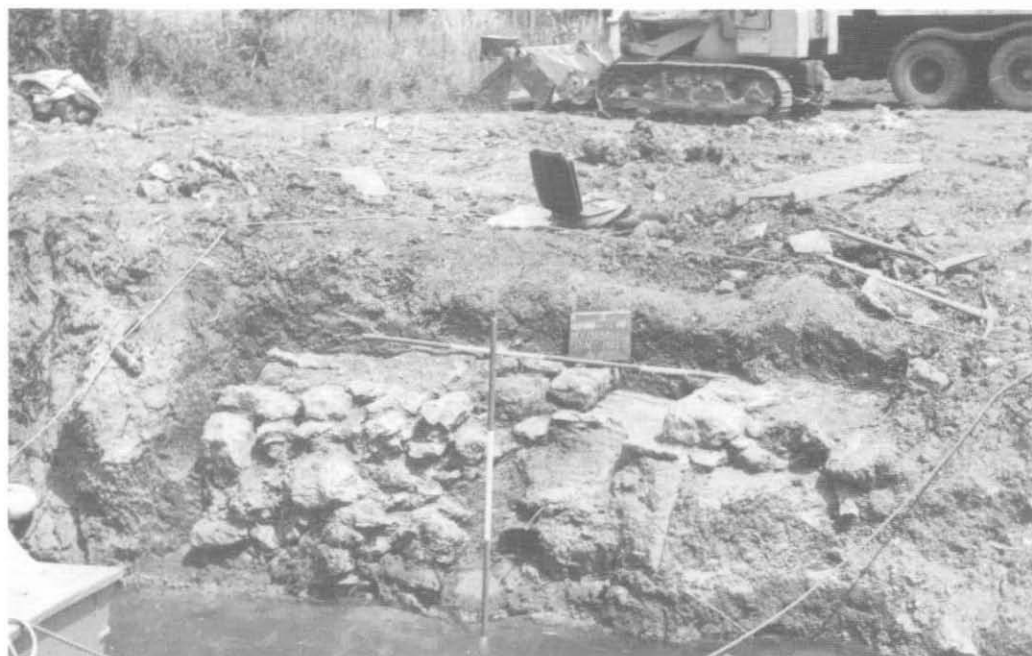
Plate 1 Oseney Abbey, 1975, Site A: F1 and F2 viewed from west.

No floors were seen in association with F1, which stood on 'a massive rubble footing', 1.3 m. wide. The wall-face on the south was stepped back 20 cm. from the footing. F1 was not seen in the stream bank before excavation of the marina, and presumably it terminated between the stream and the point 4 m. behind the bank where it was first noted. No junction with wall F7 was seen nor was there any indication of a return on that part of F1 seen by the excavators. The only reasonable interpretation of F1 is that it marked an important boundary. It is in an identical position to the substantial precinct wall shown on Agas's map of 1578.<sup>3</sup> Hollar's map indicates that the west part of the wall shown by Agas has been demolished by 1643.<sup>4</sup> A date for construction is less certain, although since F1 cuts the 14th-century building A I, it cannot have been built before c. 1300. On the limited evidence, a late 14th- or early 15th-century date seems most probable for the construction of the wall in this part of the precinct.

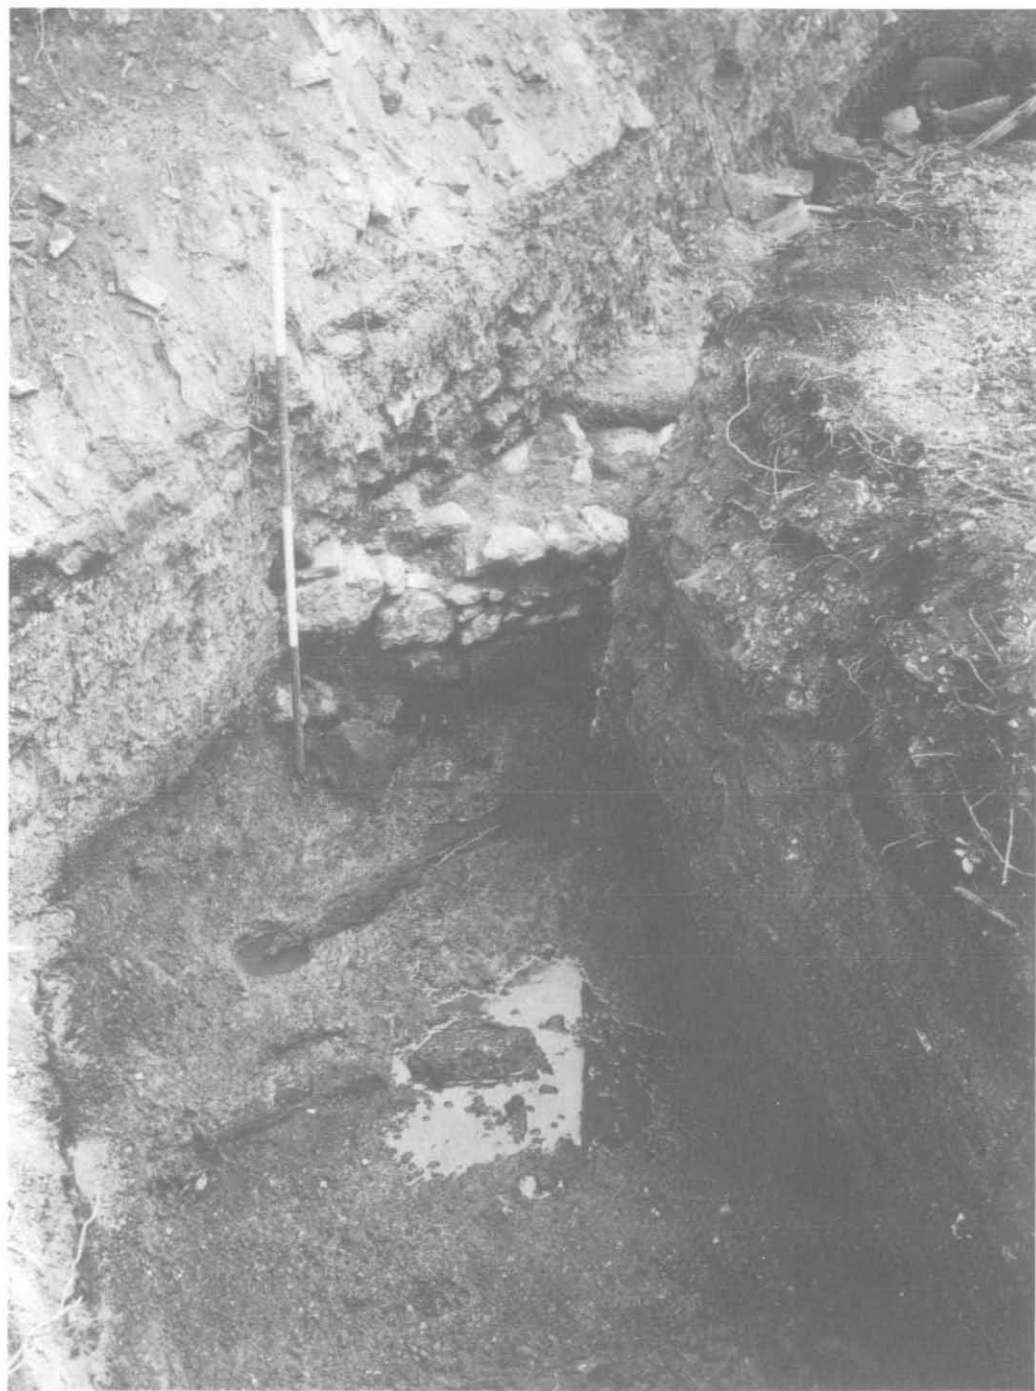
Plate 2 Osney Abbey, 1982, Site *B*: channel F1, looking eastwards towards the waterfront revetment F2.

specifically to retain the reclaimed land. L1/2, an accumulation of deep silt containing 12th- to 13th-century debris, greatly restricts the channel F1; this suggests that the Abbey lacked interest in this channel as a functioning water-course.

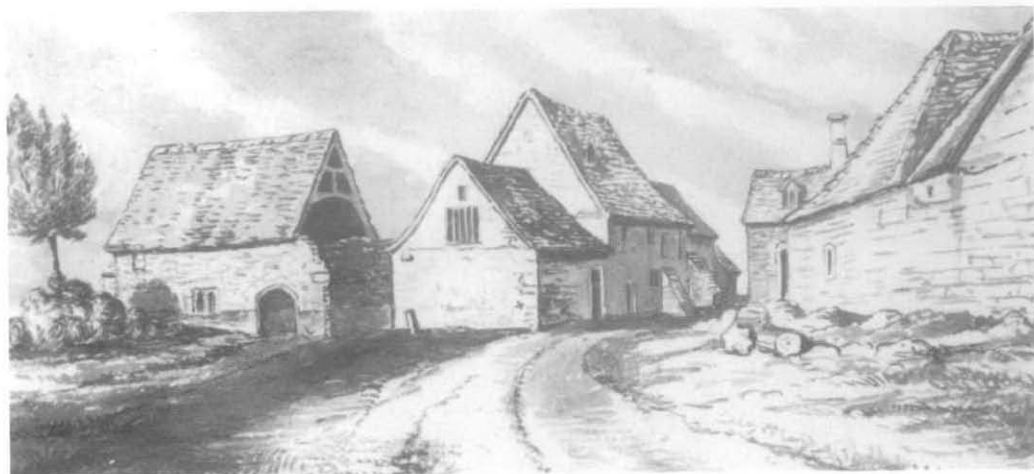
Plate 4 Oseney Abbey, 1815: surviving buildings in the mill area (from the E) prior to an extensive 19th-century reconstruction of the mill. The range extending southwards of the mill is shown in detail in Plate 9. Bodl. MS Top. Oxon. c.313, f. 82. Reproduced by permission of the Curators of the Bodleian Library.

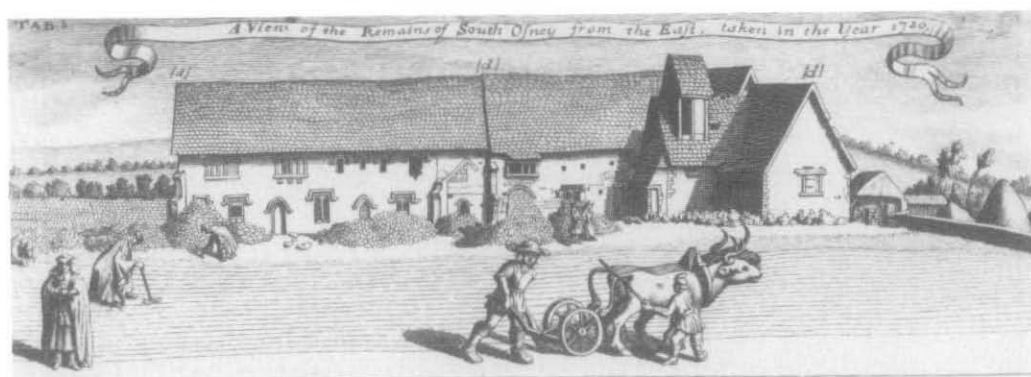
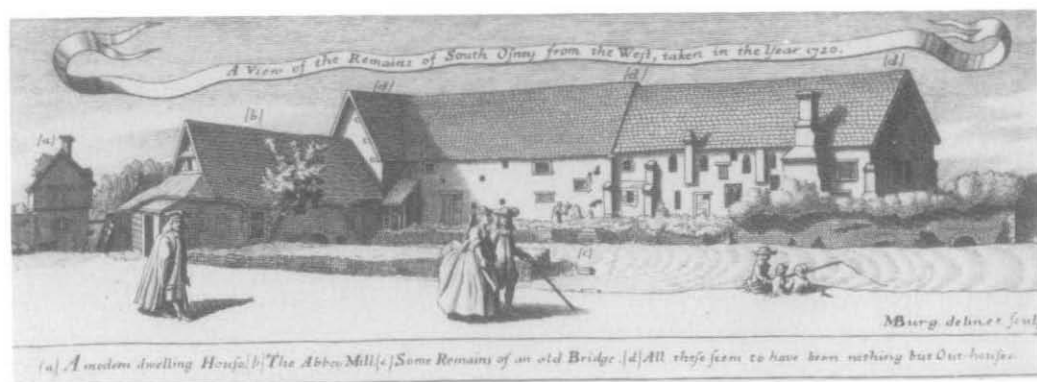
Plate 5a–b Oseney Abbey, 1720: these views (above from E, below from W) illustrate the relation of the waterfrontage and the mill site to the sequence of buildings in the claustral area discussed in the text. Bodl. MS Top. Oxon. c.688, f. 138. Reproduced by permission of the Curators of the Bodleian Library.

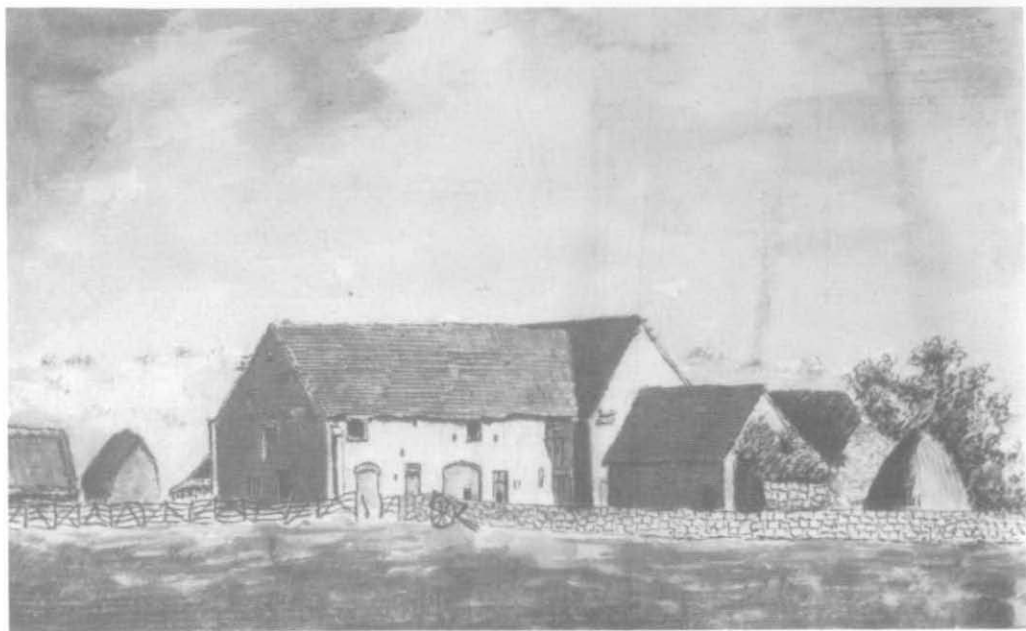
Plate 6 Osney Abbey, 1777: these drawings (above from SW, below from SE) show that parts of the ranges surviving in 1720 had been demolished by 1777. Of particular interest are the sketched buildings shown on the mill-island in the south-east view. Bodl. MS Top. Oxon. c.300, f. 23. *Reproduced by permission of the Curators of the Bodleian Library.*
