Zacharias's: a 14th-century Oxford New Inn and the origins of the medieval urban inn

By JULIAN MUNBY

SUMMARY

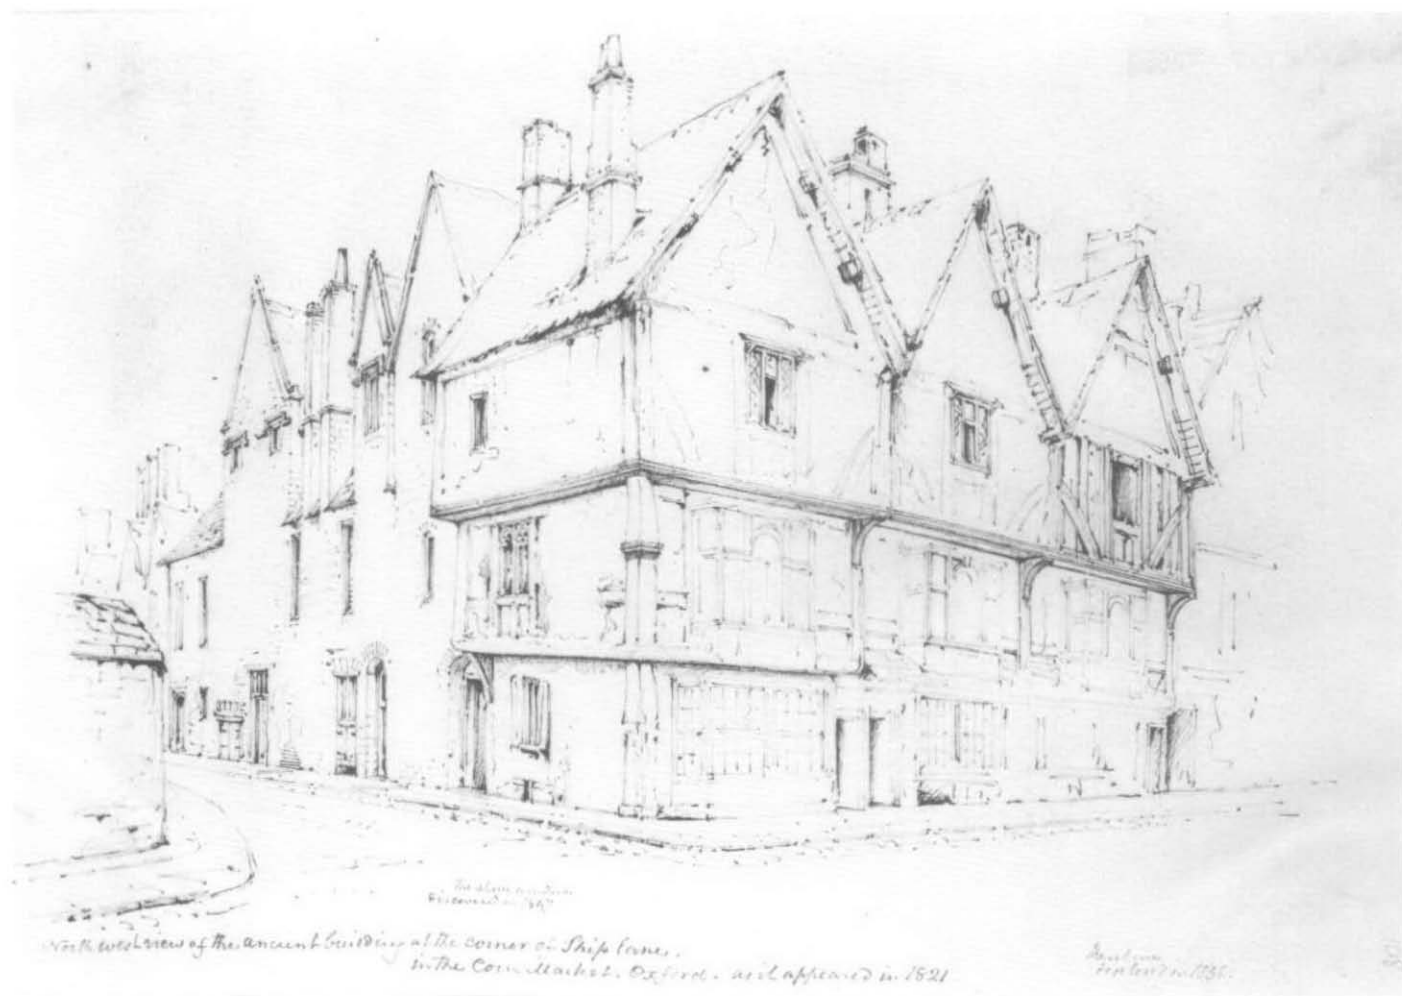
Fig. 4. Buckler view from north-west in 1821, also showing later discoveries. (British Library).

Early views of the Cornmarket front show bay windows on the first floor with arched central lights (Fig. 4), that is 'Ipswich windows' of late 17th-century type. In the course of the 19th century these were removed when a new front was dropped from the top floor, obscuring the jetty and removing most of the original front walls. They were replaced by plain sashes in No. 26 (perhaps the occasion for Buckler's drawing in 1856) and the large display windows were added in 1894 to No. 27, but the remnants of one of the previous windows had survived on the first floor of No. 26, boxed in when the front of the building had been moved out. It was the side light of a square-profiled bay, did not appear to be of any great antiquity, probably of 19th-century date, and has now been removed.

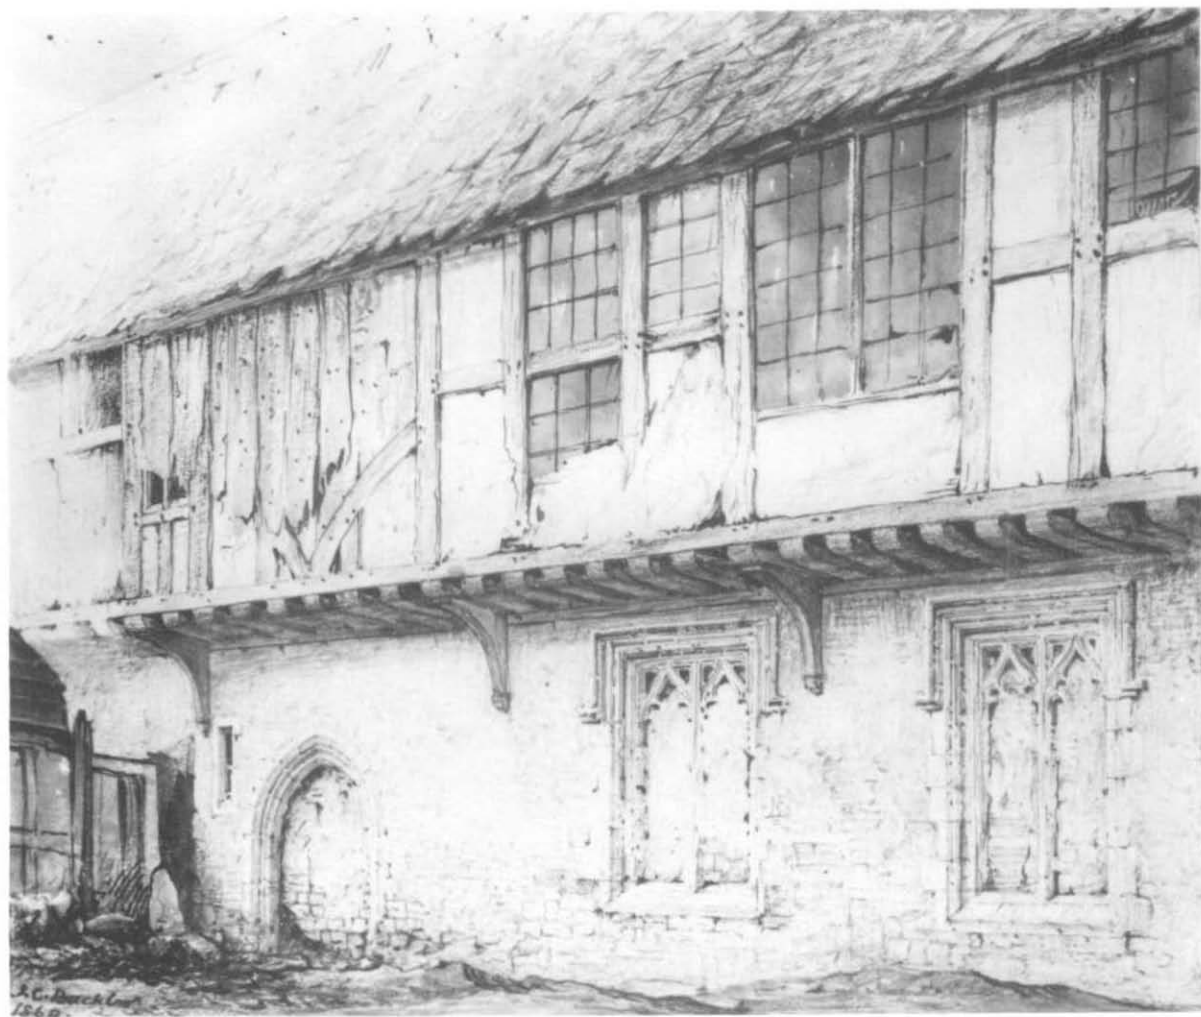
Fig. 5. J.C. Buckler view of courtyard from south in 1864, showing stone windows demolished in 1911. (OAHS, Bodleian Library).

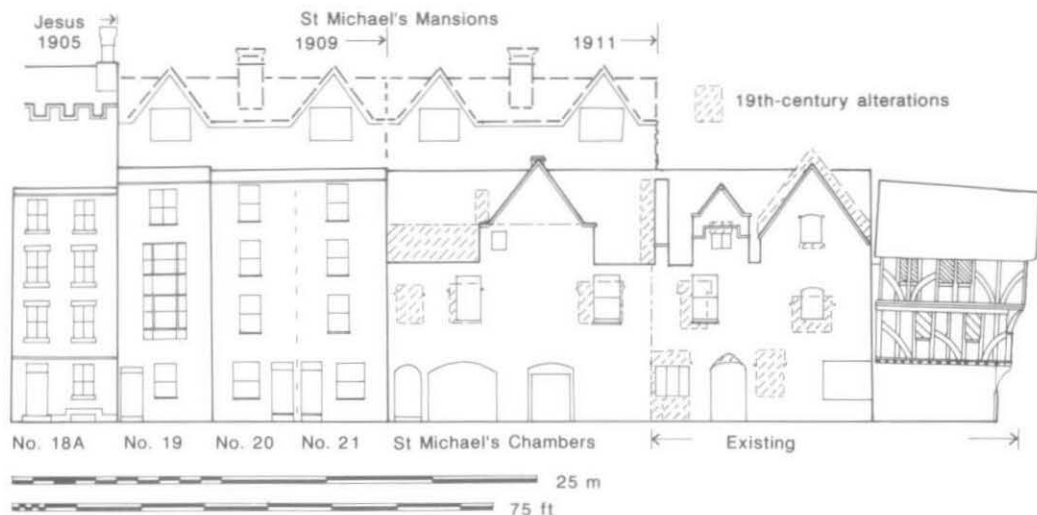
Fig. 9. Ship Street elevation: composite view showing exterior of north range (with alterations) and adjacent houses, with outline of Jesus College buildings (from photographs, Parker drawing and as existing).

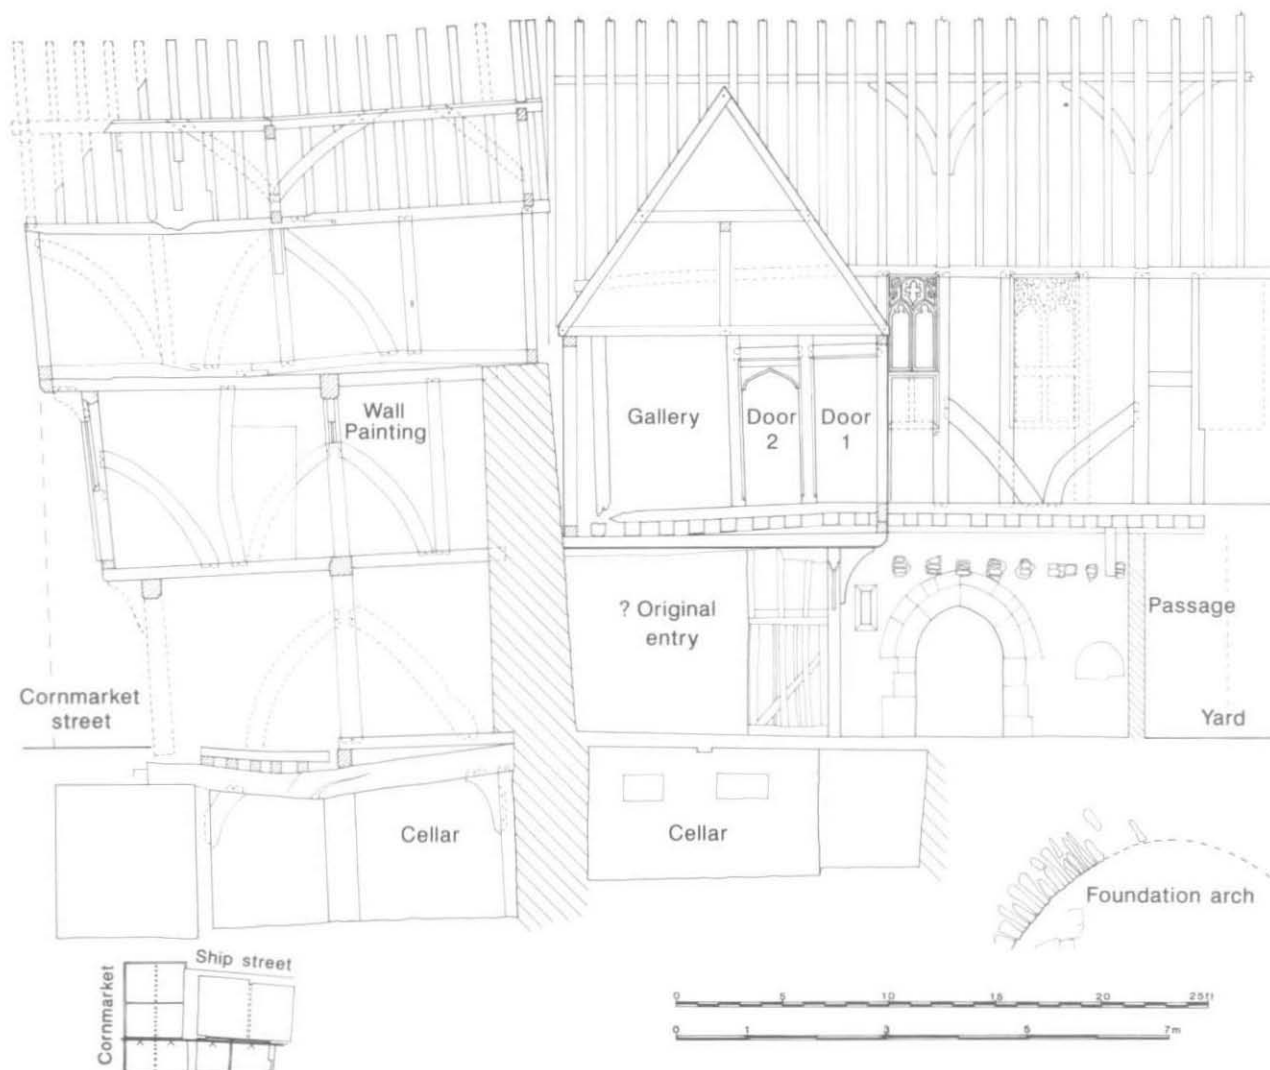
Fig. 13. The New Inn, 1984: section looking north through Cornmarket shops, gallery and cellars, with south elevation of north range. (N. Joyce and OAU).

The first floor (Figs. 13, 21, 23)

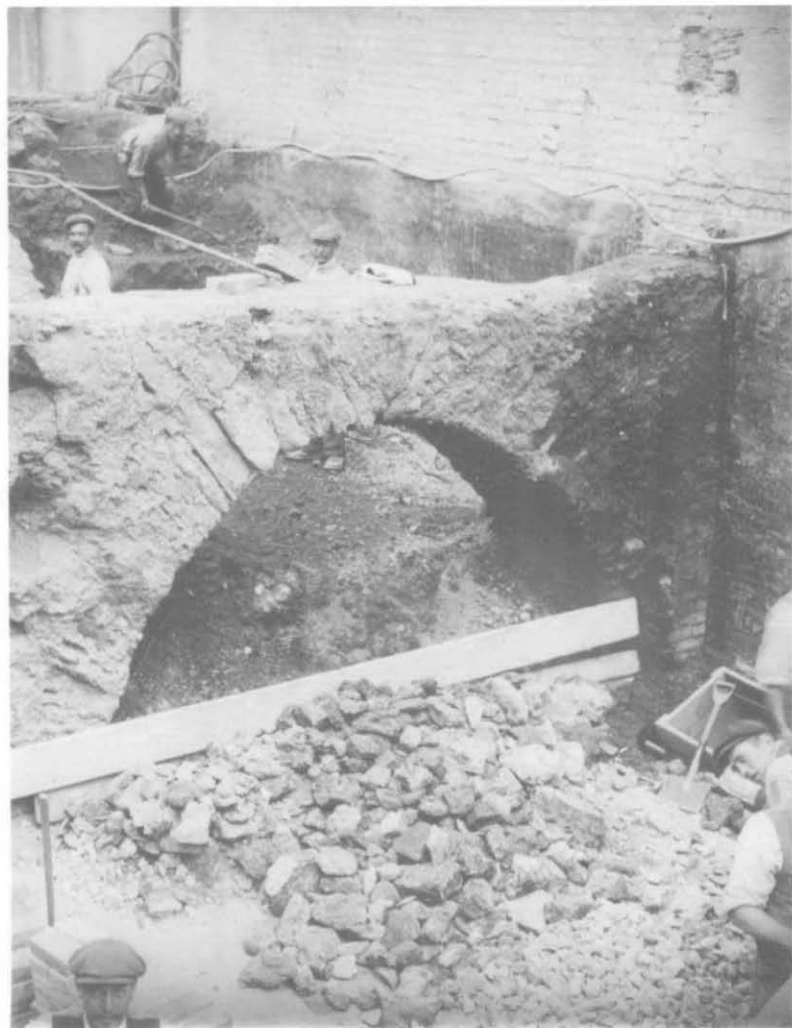
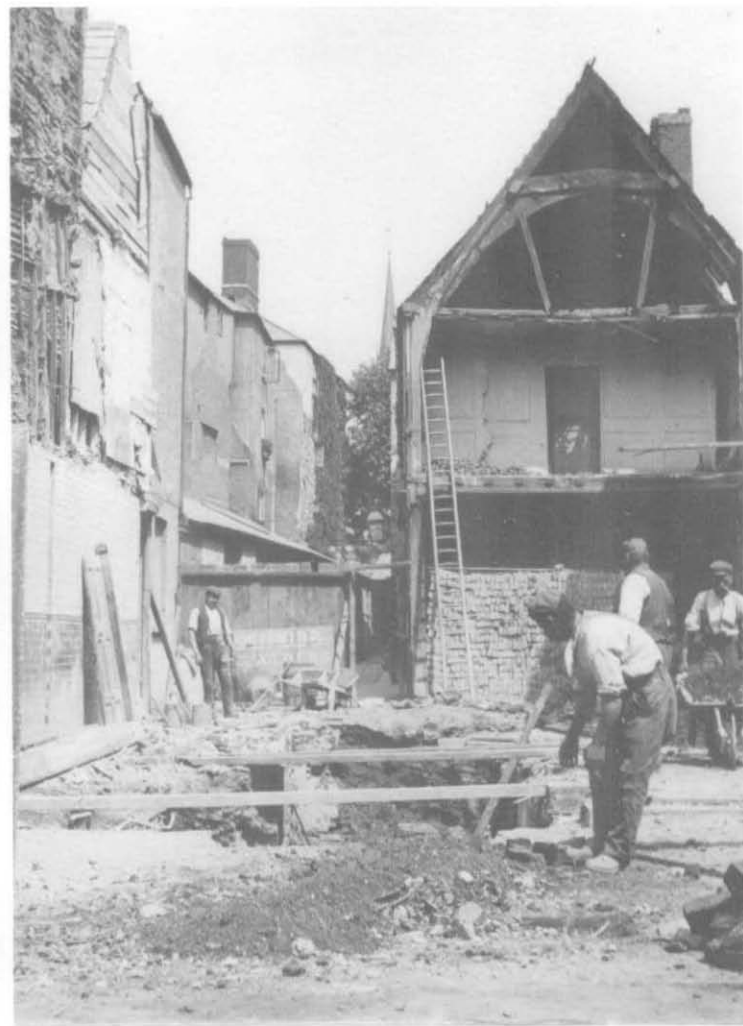
Fig. 19. *Left*: North range: view of relieving arch in foundation during demolition in 1911. *Right*: South range: view of west end during demolition in 1904, showing arch-braced roof. (Minn, Bodleian Library).

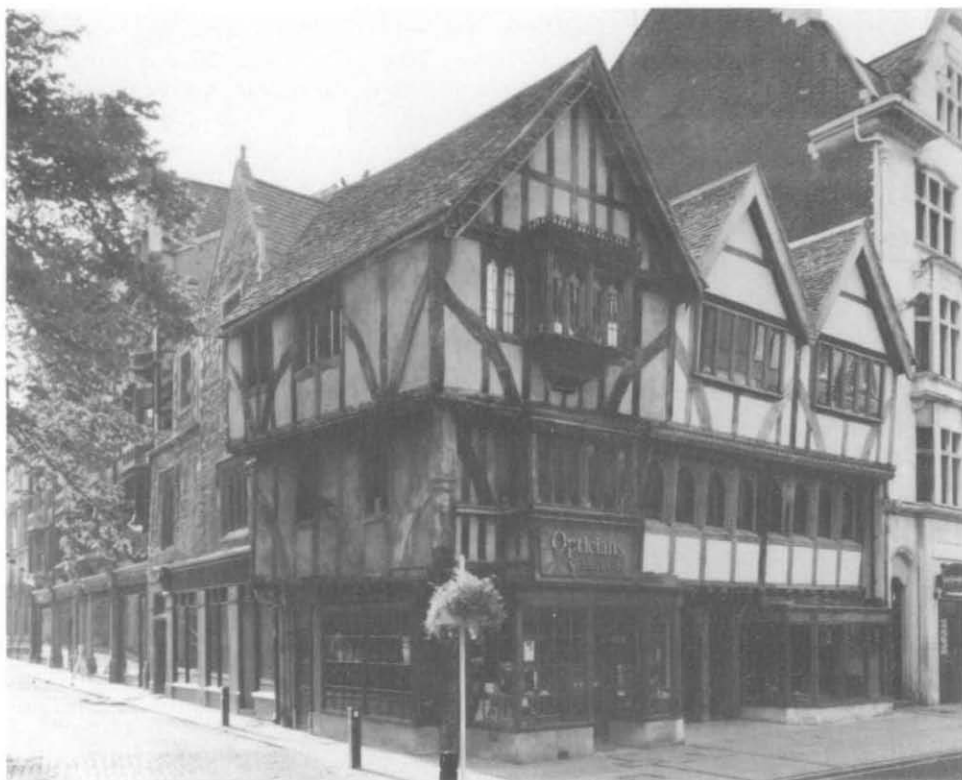
Fig. 27. 26–28 Cornmarket after restoration. (B.J. Harris).

Of the building contract itself a little more should be said. An important part of the medieval building was outside the Zacharias curtilage. No. 28 Cornmarket was indeed a striking contrast, set on the corner of Ship Street, following its repair and flamboyant restoration by the architect antiquary Thomas Rayson between 1950–2. Rayson worked in situ using oak but stabilised the leaning building with internal steel supports and his work presents a pioneer example of scholarly restoration. The *Architectural Review* of the time was however perplexed by this example of Oxford quaintness, particularly as the Randolph Hotel had just completed its Wilkinson Gothic extension.¹⁹ Rayson was not a purist and indulged a certain freedom in his decorative detail for windows and barge boards, and added two bay windows that cleverly give support to attic floor and gable. However the bay windows obscure the undoubted fact that the medieval fenestration was achieved as continuous bands across the whole front. Charles' reconstruction is purist and has not restored detail unless the surviving fabric provides clear evidence. Where such evidence did not exist, as can be observed at a higher level of the front elevation, plain windows and plain barge boards were adopted. When viewing the completed restoration it will be seen that the building leans into the street. It was not possible to erect the restored facade vertically as its position was dictated by the need to continue and link into No. 28 Cornmarket which had been stabilised but not rebuilt by Rayson. The apparent fossilised picturesque quality of the restoration is entirely practical in origin and a testament to the skill of the site carpenters (Fig. 27).
