# Four Saxo-Norman Churches near Wallingford

By DANIEL SECKER

*This paper describes the primary fabric and details of four local churches of 11th- and early 12th-century date in the vicinity of Wallingford: St Michael, Aston Tirrold, All Saints, Aston Upthorpe, St John the Baptist, South Moreton and St Mary, Upton. The surveys were carried out on visits to the churches at various times between 2002 and 2005. They do not cover every architectural phase of the buildings, only the extant primary fabric and details. For this reason, only the primary phase was recorded on the plans of the churches. An exception to this is St Michael, Aston Tirrold. Unlike the structures at Aston Upthorpe and Upton, where the primary plan has hardly been altered (Figs. 14 and 18), Aston Tirrold is a complex, multi-phase building. Here, an un-phased plan was made of the entire church (Fig. 5).*

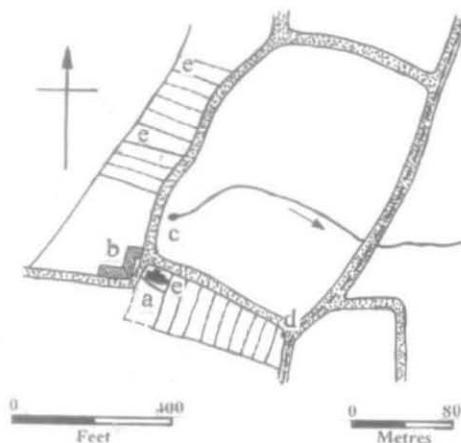
Fig. 13. Aston Upthorpe, church and settlement.

Topographically, Aston Tirrold and Aston Upthorpe form the bifocal settlement of Aston, a mere 500 metres separating the two. The church of All Saints, Aston Upthorpe (SU 5525 8618; Fig. 13, a), stands adjacent to the 17th-century manor-house (b). Both cluster around a spring (c). This water-source may have initially attracted settlement here. At the foot of Spring Lane, and on the parish boundary with Aston Tirrold is a Sarsen orthostat (d). It is unworked, about 1.5 m. high and stands on the western side of the road. It is possible that the church was aligned so that the east end pointed towards the Sarsen (J. Blair, pers. comm.). This would suggest that the latter is earlier. While the orthostat would therefore appear to be at least as old as the 11th century, there is no evidence that it is prehistoric. The relationship between the church and the stone at Aston Upthorpe might be compared with that of church and yew tree at South Moreton.

There were several reasons for the emergence of rural local churches in the 10th and 11th centuries.<sup>26</sup> These were: Firstly, privatization of undeveloped ritual foci. Secondly, devolution from minster communities. Thirdly, the emergence of proprietary chapels attached to manorial centres and fourthly, divided proprietorship. None of these categories is mutually exclusive, and origins of local churches may be more complex than is immediately apparent. At South Moreton, the later 11th century church is immediately adjacent to the castle-motte (p. 17 and Figs 9-10). This might suggest the church was a proprietary foundation, but immediately east of the church is an ancient yew-tree which appears to pre-date the church. The triple foci of tree, church and manorial centre is paralleled at the excavated site at Ketton, Rutland.<sup>27</sup> Aston Upthorpe and Upton were apparently established as subordinate chapels of Blewbury, but the church at Aston Upthorpe is aligned towards a Sarsen orthostat (p. 51 and Fig.13). This, again, may hint at an earlier ritual focus.

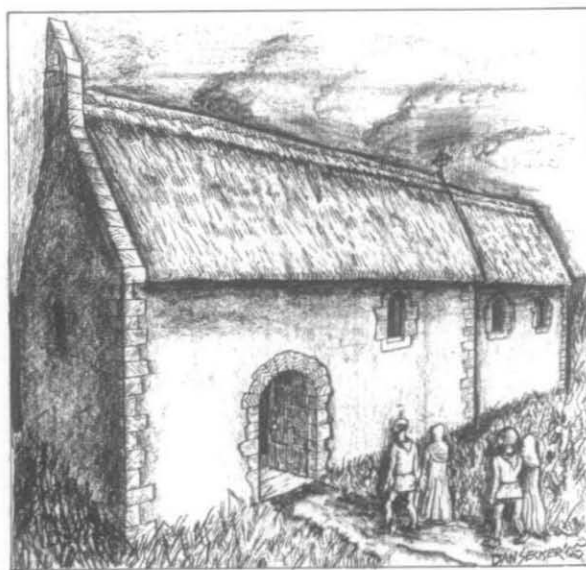
Fig. 25. Reconstruction of St Mary, Upton, c.1150. The windows of the south wall of the nave, and the south-western window of the chancel are based on the surviving original window in the north wall of the nave. The western gable and bellcote are based on the arrangement suggested at the early 12th-century church at Holy Trinity, Bradwell-Juxta-Coggeshall, Essex.<sup>88</sup>
