Post-medieval buildings and medieval features at Adderbury House, Adderbury, 1996

by STEVEN D. G. WEAVER, with an introduction by NICHOLAS ALLEN

SUMMARY

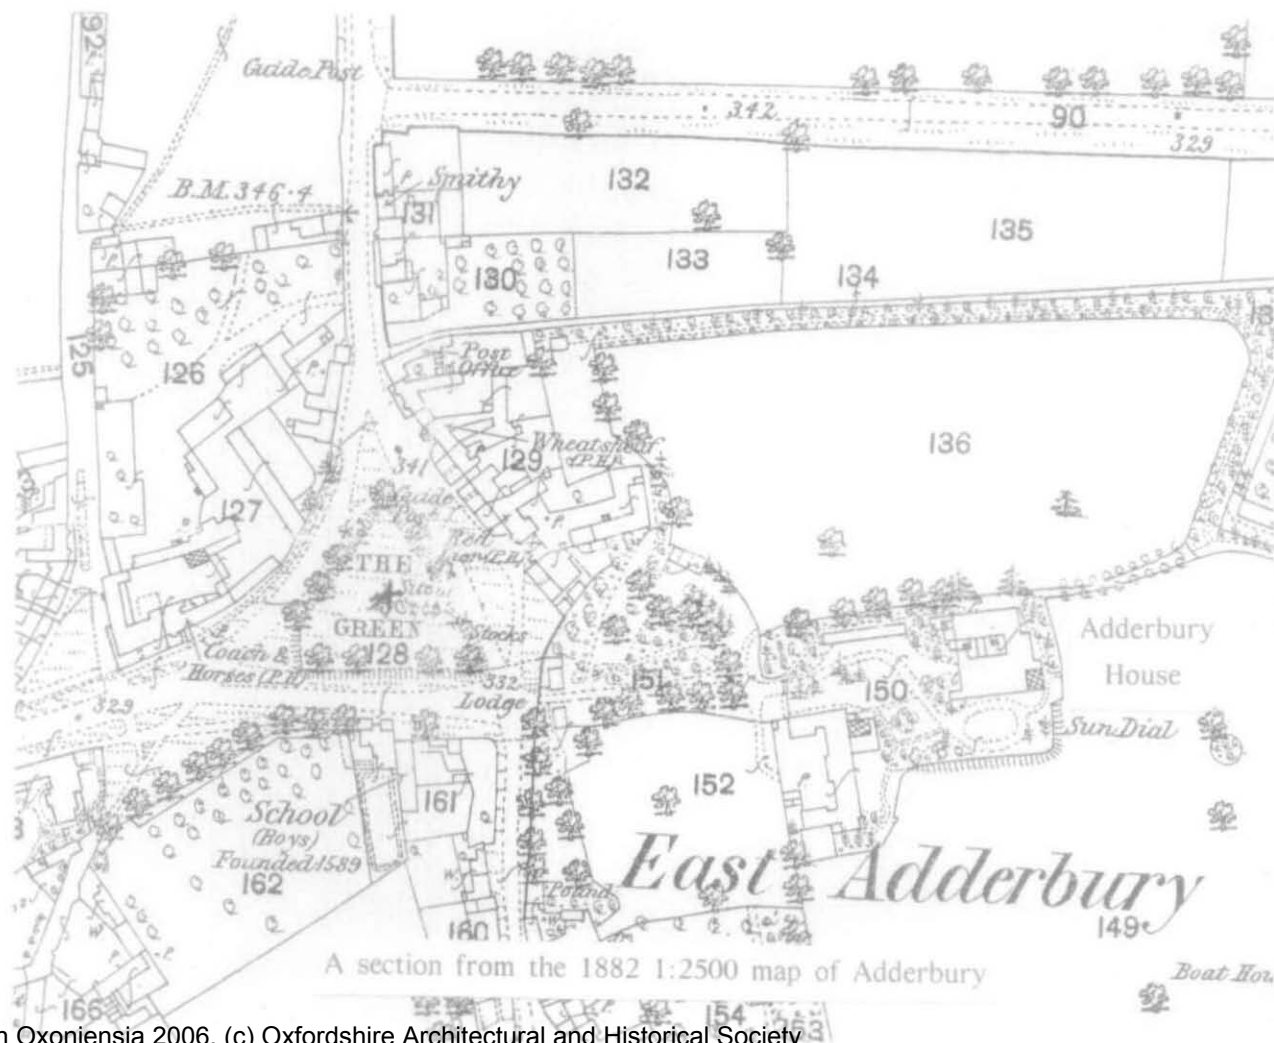
Fig. 3. Detail from First edition OS map of Adderbury, 1881

Later cartographic sources such as the First Edition Ordnance Survey of 1881 (Fig. 3) and the Second Edition of 1900 show no structures within the excavated area. One possible explanation for the lack of buildings on later maps is that they were demolished as part of the emparkment, at some time between 1768 and 1796. The later north-south boundary wall may be the boundary between Davis' proposed location of Adderbury House and a group of buildings to the east. Later post-medieval activity on the site was represented by a series of rubbish pits aligned along, and to the north and east of, the boundary wall, and the incorporation of a hearth within the wall. The pits contained large

The rubbish pits fell out of use when the later boundary wall was demolished. The exact date of this demolition could not be ascertained during the excavation, although it must have occurred before 1881 as no boundary wall is indicated on the First Edition or Second Edition Ordnance Survey maps. If further buildings were also present along the eastern boundary of the site, these too had gone by 1881.

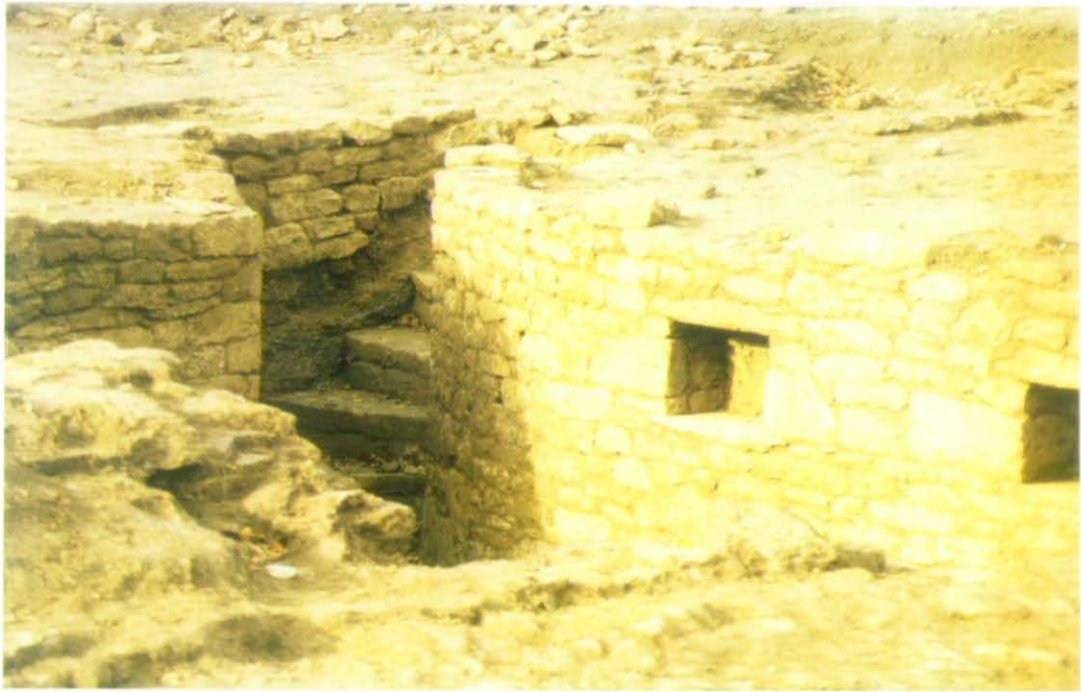
Plate XXIV. Cellar with stairs as in fig. 2 on p. 418. Photograph by Nick Allen. [Adderbury p. 417]

The evaluation revealed that the site had been subject to modern disturbance from the allotments, services, engineer's test-pits, and what appeared to be quarrying in the north-west corner. Nevertheless, features recorded in the remaining trenches included medieval ditches, medieval and post-medieval pits, a series of walls, possible postholes and a metalled surface. The excavation consisted of an archaeologically supervised topsoil strip of five areas, totalling 1420 sq m. (Fig. 1). The archaeological features and deposits revealed were generally well-preserved. They consisted of a series of stone-walled structures with associated floors and hearths, a sunken-walled trackway, metalled surfaces, a stone boundary wall, a well, pits, postholes, hearths, stone drains, and ditches. The foundations were of varying depths and walls survived from one or two courses up to 0.60 m. high. The well-preserved remains of a 1.83 m. deep cellar were discovered in Area A (Fig. 2, Pl. XXIV).

Structure 2 consisted of a stone cellar with a spiral staircase leading down from an above-ground structure. Construction of the southern and western cellar walls incorporated large stone blocks and incorporated three recesses, probably for lamps. The spiral staircase was constructed of large dressed stone blocks. A second access point to the cellar was a delivery chute. The above-ground structure was represented by partial remains of foundations, with no floor surfaces, hearths or upper walls surviving, and its northern extent is not known due to the limited area of excavation and truncation by later features. Demolition deposits within the cellar produced a small number of 18th- and 19th-century pottery sherds and a modest quantity of undecorated wall/roof plaster, window lead and glass fragments, possibly suggesting a structure of reasonable status.

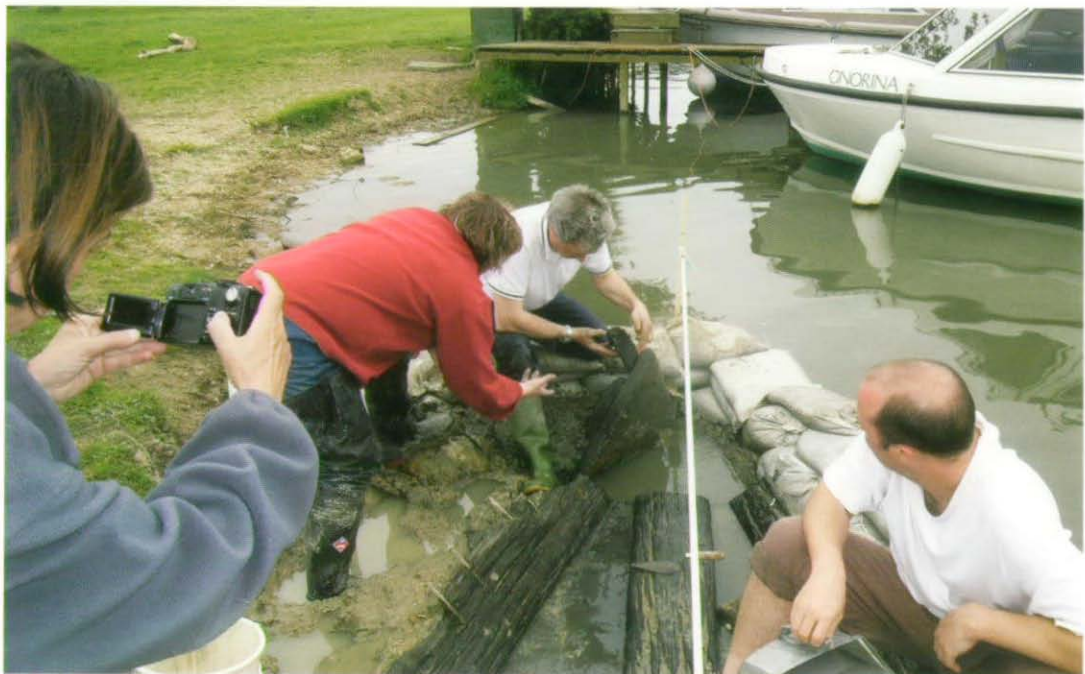
Plate XXV. Port Meadow Boat Trench 1 from north: timber sampling by English Heritage specialist staff. Behind are the modern moorings that may be affecting flow. [Durham p. 435]
