# Appleton Manor: A ‘Most Remarkable Mansion’

## SUMMARY

*This article presents the findings of a survey of Appleton Manor carried out in 2014–16. New light is shed on the remarkable survival of early medieval elements of the house, on its subsequent development, and on its moated site. The research drew upon an investigation of the estate’s ownership from the Middle Ages onwards that was set alongside the findings of new architectural and archaeological surveys. Examination of the house and its grounds is the first part of a larger landscape history project on the development of Appleton.*

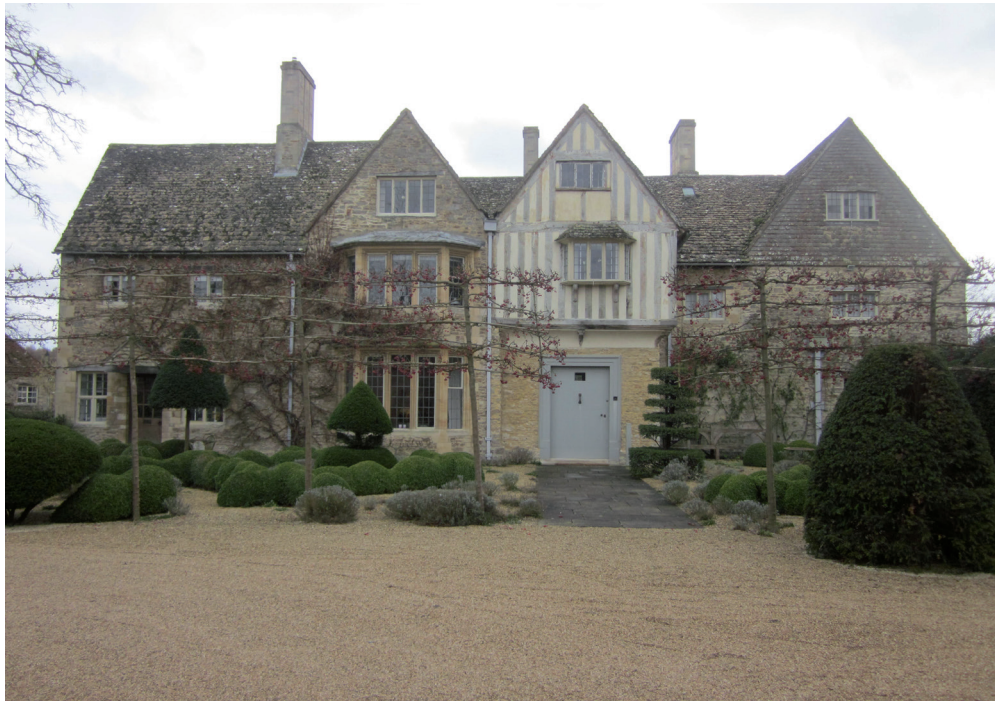
*Fig. 1. Appleton Manor, north elevation. Photograph by David Clark.*

The north elevation of Appleton Manor (Fig.1) gives some idea of the complexity of the building.<sup>58</sup> To the left (east) side of the porch is the rebuilding in 1924 by Blow and Billerey. Slightly to the right of centre is the porch, the lower storey of which is in roughly coursed limestone – mostly oolitic – with some iron-bearing stone. There are ashlar quoins to the north-east corner, but not to the north-west. Its east and west walls are 584 mm (23 inches) thick and have splayed arrow-slit windows. Straight-joints in the stonework show it was added on to a pre-existing structure. The front doorway is probably early nineteenth century and the door itself appears to be early twentieth-century in date.

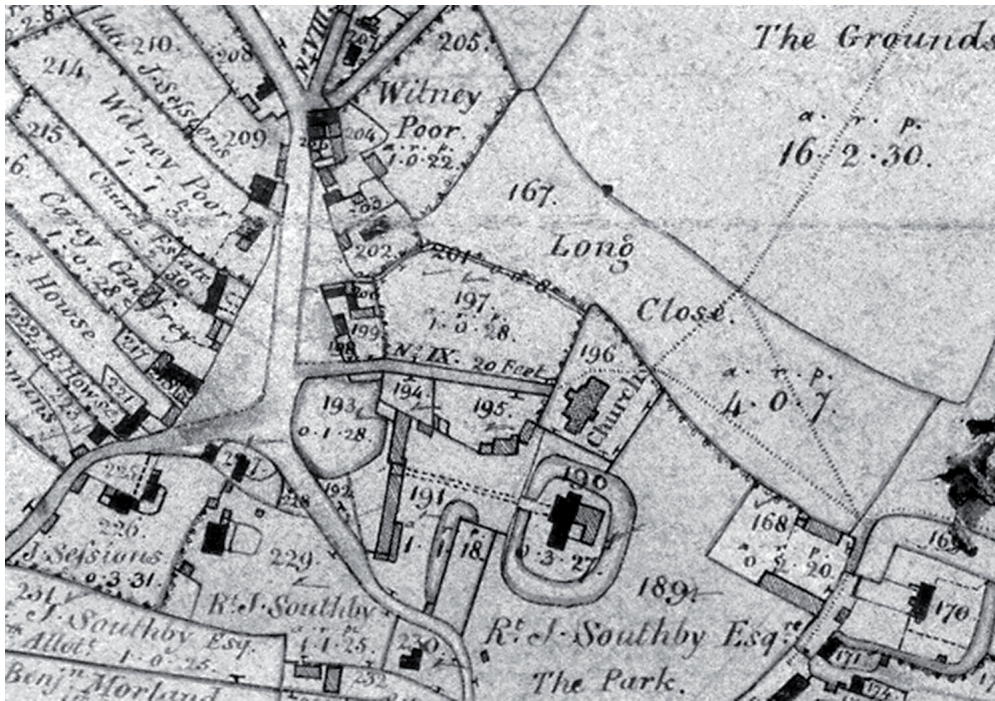
Fig. 3. Appleton village on the 1831 inclosure map. Key: 190: Appleton Manor; 170: Tyntens Manor; 229: Manor Farm.

At Appleton Manor a wide, deep moat is still prominent around the north-east, south-east and south-west sides of the building. The outline of this surviving portion is clearly depicted on larger-scale Ordnance Survey maps published since 1876. The remainder of the moat must have been filled in around the middle of the nineteenth century, since it is shown in its entirety on the enclosure map of 1831, surrounding a rectangular island with rounded corners, and with a bridge or causeway entrance in the middle of its north-western side (Fig. 3).

The earthwork survey found no evidence for the former existence of any subsidiary moats or fishponds at Appleton Manor itself. However, the 1831 map does show a small 'L'-shaped pond immediately to the north-west (Fig. 3, within the land parcel numbered 191), which is not shown on later maps. This is now difficult to discern on the ground, but the possibility that it did form part of a secondary moat or a fishpond cannot be ruled out.

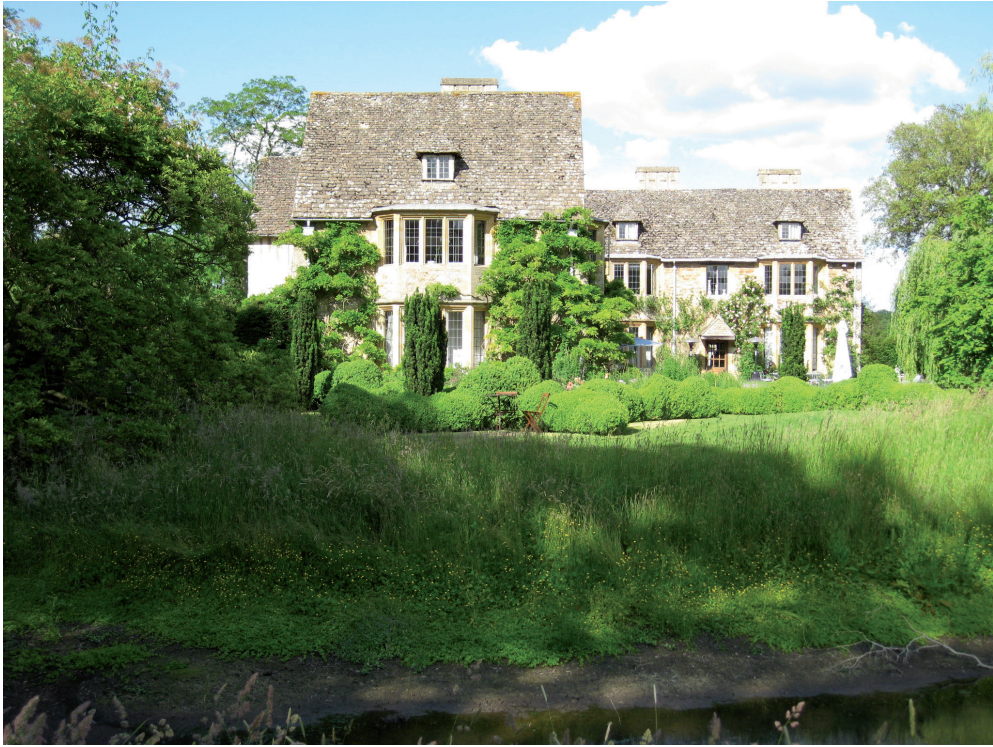
*Fig. 6. West elevation. Photograph by David Clark.*

In the west elevation (Fig. 6), the northern range has a double-height bay window (dating from the 1924 renovations) and an attic roof dormer above. The east wing (to the right) has similar features and a central doorway. At the south-west corner of the building is a

twelfth-century roll-moulding running up the full height of the corner from a point 2,020 mm above the present ground surface. Faced stone continues down a further 970 mm, culminating in a stone (Fig. 7) 220 mm deep which has a chamfer and bar-stop.<sup>59</sup> Below this there is a stone plinth of 830 mm.

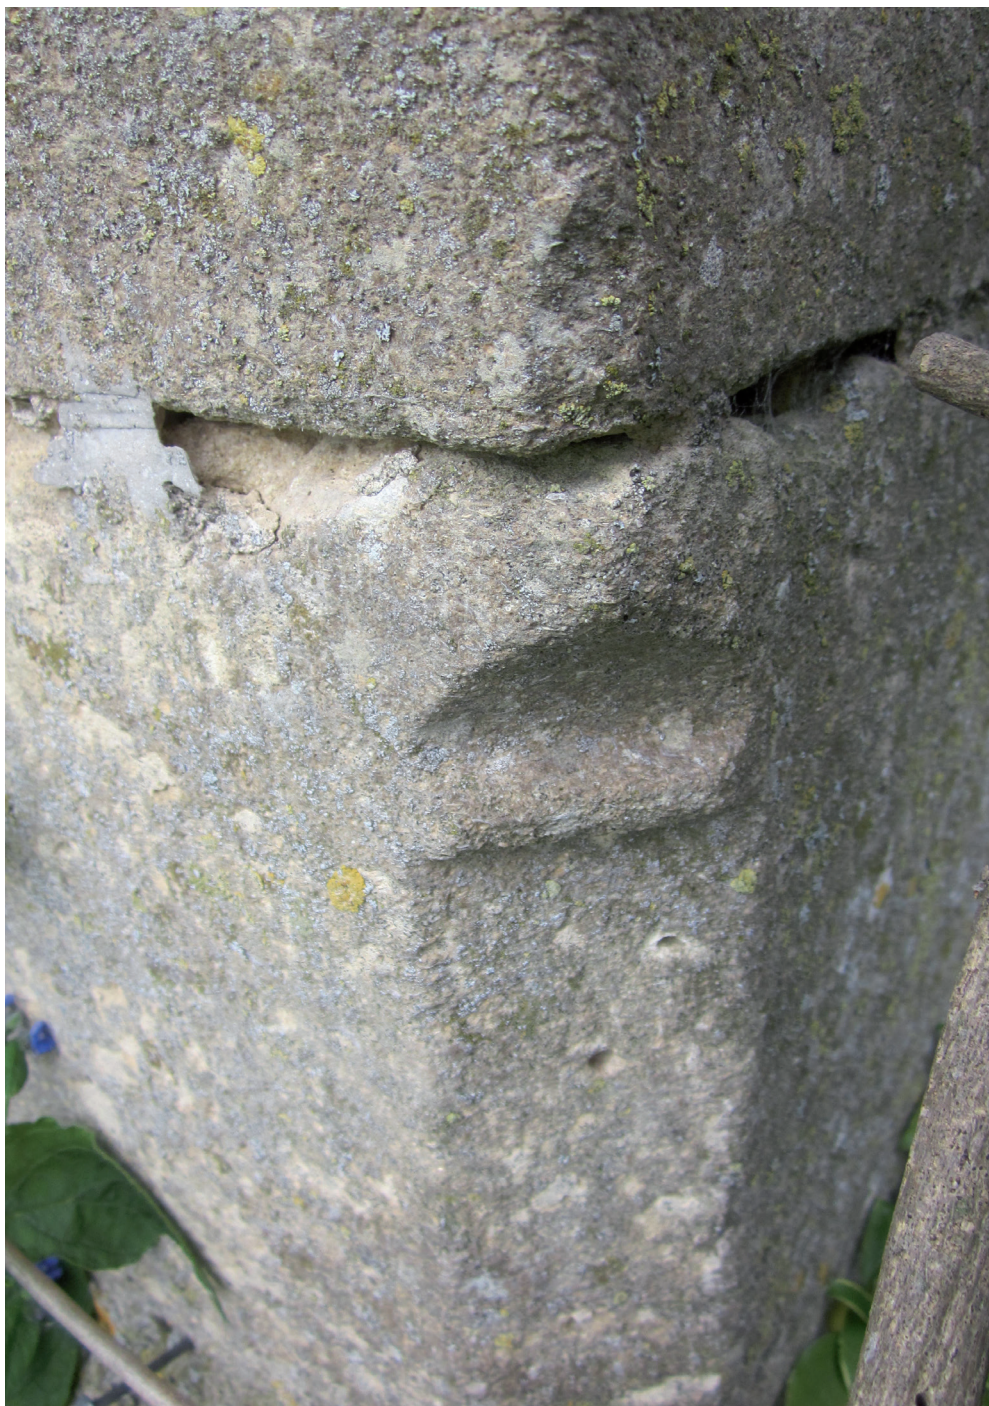
*Fig. 7. Moulded stone at south-west corner. Photograph by David Clark.*

The next phase of the house included the rebuilding of the hall and the addition of the porch. Moulded stone from the earlier building was reused at the south-west corner and some was also used to build the drawing room fireplace, thus dating the insertion of the main chimney-stack also to this phase. The fireplace is typical of that of a large farmhouse of the late sixteenth/early seventeenth centuries. The burn-mark on the bressummer is again probably of this period. Recent research has shown these burn-marks to have been applied deliberately to historic timber using tapers, perhaps as part of a ritual to protect the building from fire damage, but the fact that it was applied here before the timber was installed in the fireplace is unusual.<sup>79</sup>

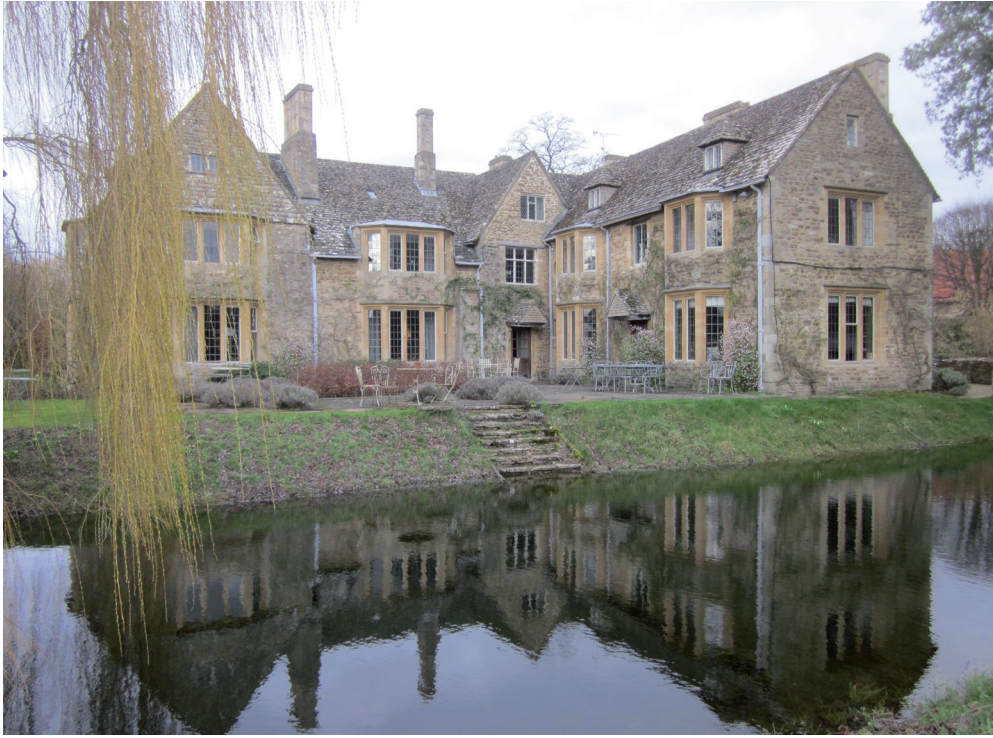
Fig. 8. South elevation. Photograph by David Clark.

The southern elevation of this range (Fig. 8) also has a two-storey bay window and a casement to the attic room. There is a further two-storey bay window to the next bay to the right, inserted in 1924 when a window (previously a doorway) opposite the front (north) door was removed. To the right (east) of this, there is a change in building line. This part of the house has a number of puzzling features which will be considered below. The east range resulted from the comprehensive remodelling in 1924 of an earlier building and was not investigated.

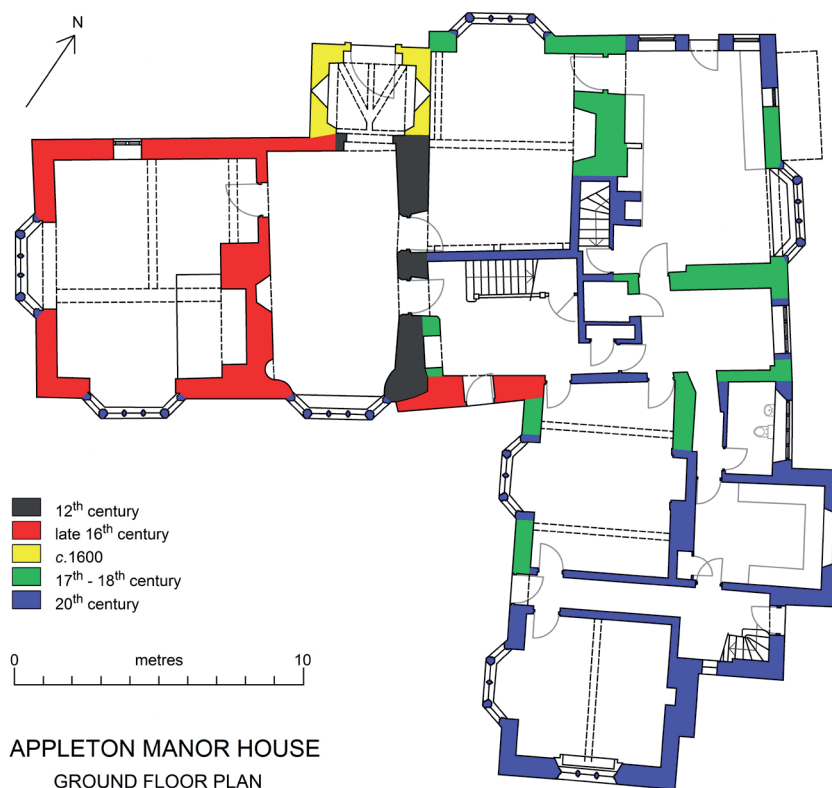
Fig. 9. Ground floor plan. Drawn by Tina Bond.

The ground floor plan is shown in Fig. 9 below, with suggested phasing which will be discussed later. Inside the porch is a round-arched portal (Fig. 10) – 1580 mm wide, 2840 mm high, complete with jambs and a higher rere arch inside. The west side has a considerable, long-standing outward lean; the door reveal has been re-cut to the vertical, to allow the door to close. All the stone jointing runs across the mouldings, with no sign of disruption or

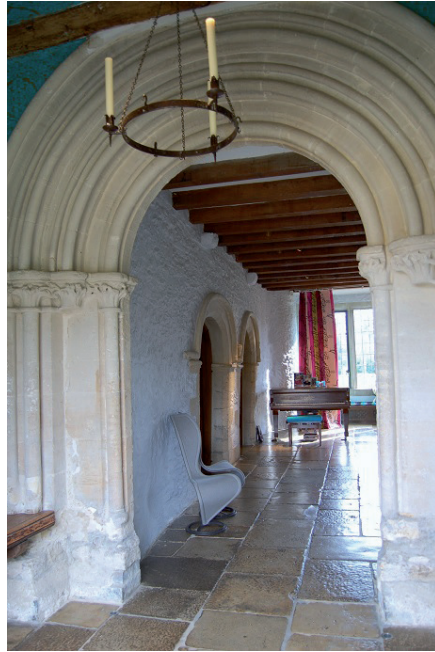
*Fig. 10. Front portal and entrance hall. Photograph by Trevor Rowley.*

irregularity. There are three orders of mouldings with very worn stiff-leaf capitals of c.1190.<sup>60</sup> On each side one of the colonnettes (nook-shafts) is missing and on the stone so revealed are some finely scratched circles. On the right-hand (west) side is a circle 3½ inches in diameter on the return facing east, with a centre point but no other obvious features. On the stone below it on the north face is a segment of a similarly-sized circle. On the east side on the north face behind the position of the missing column are two concentric circles 265 mm (6½ inches) and 184 mm (7¼ inches) in diameter respectively with radii (mostly at 45 degree angles) and a centre point. This also extends over two of the stones forming the door-jambs. Above it on the same face is a simple circle with a centre point. There are traces of limewash (some layers with pale yellow ochre colouring) adhering to the doorway in a number of places.

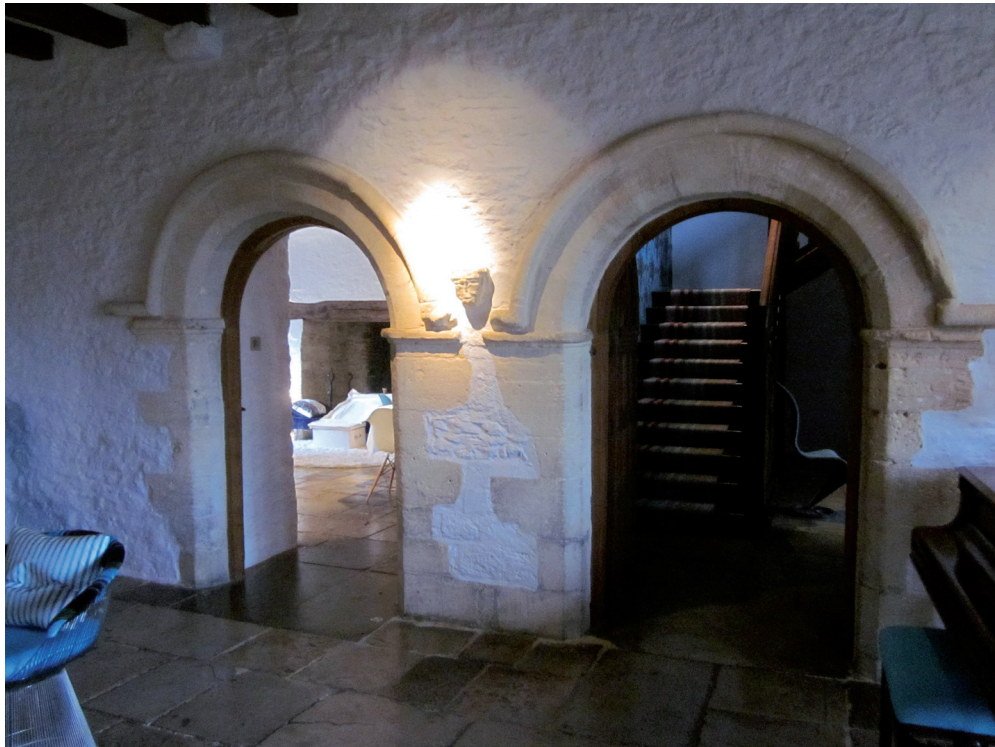
*Fig. 11. Service doorways in entrance hall. Photograph by David Clark.*

The portal leads to the entrance hall. To the left are two round-arched doorways (Fig. 11) with roll-moulded hoods, and moulded imposts. The bases of the jambs show signs of replacement or reworking. Each doorway is 1190 mm wide and now 2050 mm high (original height c.1850 mm). Between the doors is a carved head, weathered, but which appears to be contemporary. Some 1180 mm to the right of the doorways is a vertical line of ashlar quoins

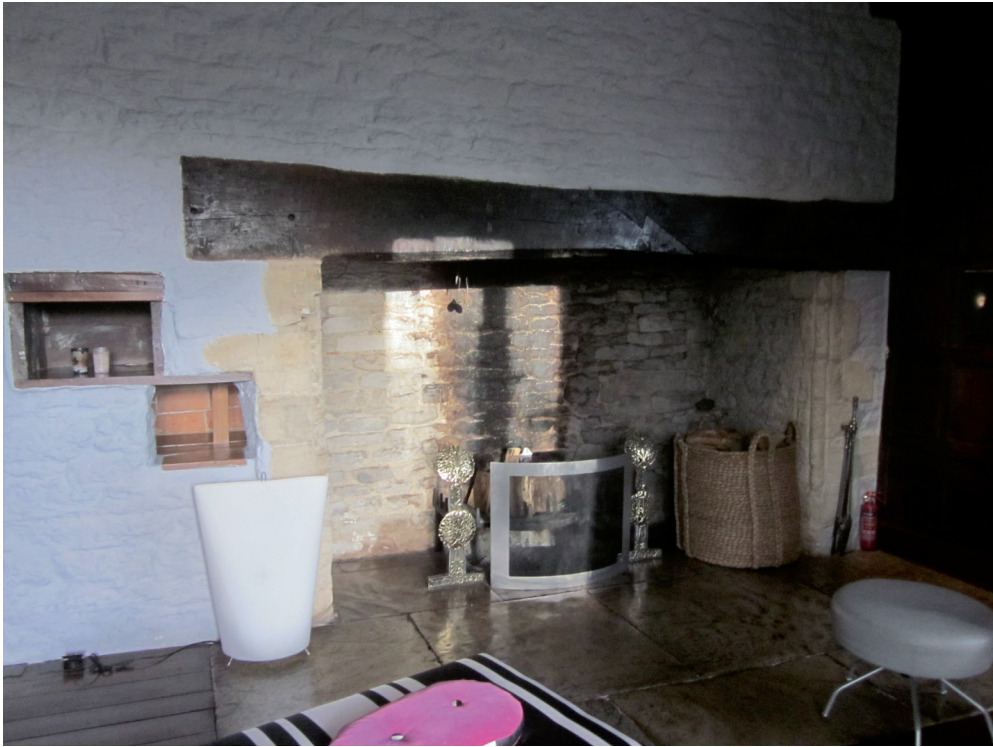
*Fig. 12. Drawing room fireplace. Photograph by David Clark.*

The drawing room to the west is dominated by a large farmhouse-style fireplace (Fig. 12) in a massive stone stack, with vestigial evidence for an oven and spice cupboard to the left, and iron bars within for holding pots or smoking meat. From one of these bars hangs a pair of metal pulleys, again perhaps from some earlier cooking equipment. The bressummer is in two sections, joined by a trait-de-Jupiter scarf joint to make a total length of 3.86 metres (12 ft 8 inches). It is 393 mm (1 ft 3½ inches) deep with a 51 mm (2 inch) chamfer. The section to the right of the joint is the later – probably twentieth-century. The surface to the left has various types of graffiti, including the initials 'IH', scratches of various kinds including crosses, and burn-marks. The burn-mark to the lower left-hand side of the bressummer seems to be truncated at its lower edge, suggesting that it was made before the beam was inserted on the

jambs. The fireplace has moulded stone jambs similar in profile and dimensions to the roll-moulding at the south-west corner of the house described above.

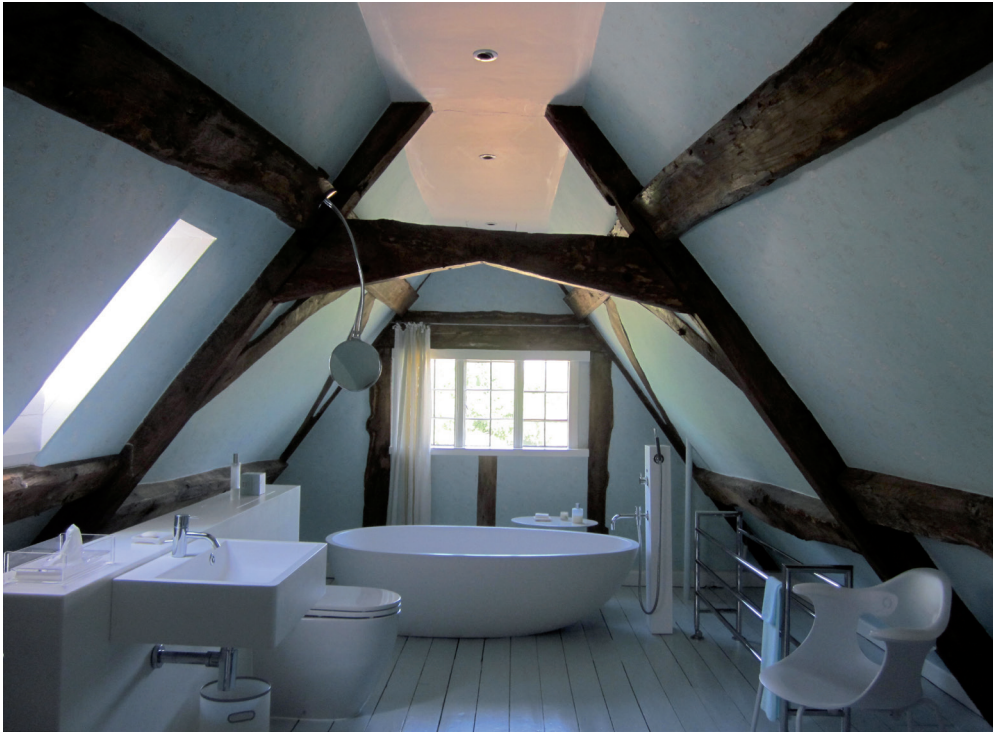
*Fig. 13. Attic room over porch. Photograph by David Clark.*

At second floor level the attics have been opened up for domestic accommodation but their geography is complex. Thus although the attic room of the porch always seems to have been usable – with a primary oriel – it is not clear where the access was.

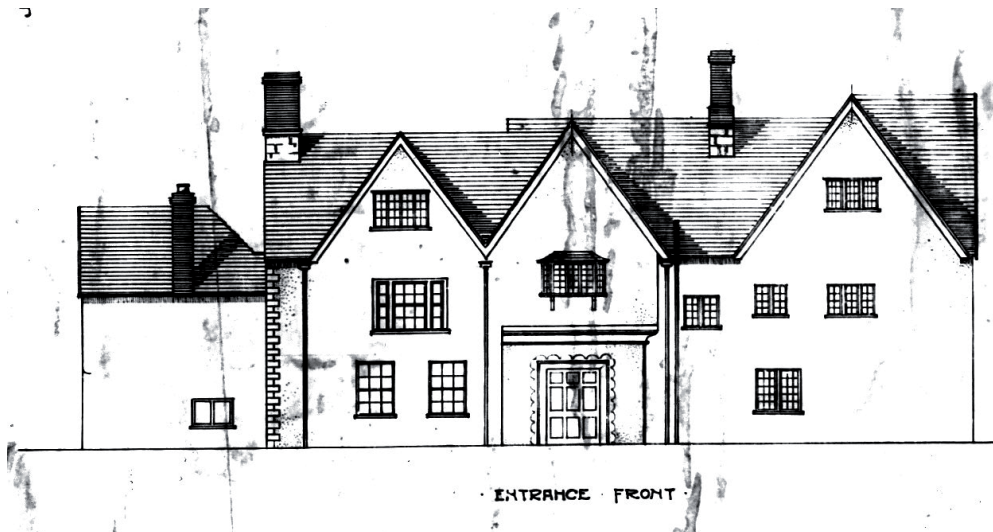
Fig. 15. Entrance Front. RIBA Collections T.422. Survey drawing no. 2, 20 August 1923.

Drawings prepared by Detmar Blow and Fernand Billerey in preparation for a major remodelling of the house in 1924 survive in the RIBA collection.<sup>62</sup> They show the layout of the earlier building and the proposed alterations so are important as evidence for the development of the building. Also relevant to these developments are pre-1924 photographs of the house, for example Fig. 14 which shows the gabled west elevation. Before works were carried out a set of drawings was made of the house as it was in 1923. These will be considered in turn, starting with the front (north) elevation (Fig. 15). This shows the western gable of Fig. 14 with a higher roof-line than the ranges to the east, and the windows in the hall range that were subsequently blocked in. It also shows the earlier eastern extension, which was replaced by a new building against the eastern stack of the earlier house but continuing its roof-line. The ground and first floor sash windows of the adjacent range next to the porch were replaced by the present two-storey bay window. The drawing does not show the attic window in the porch, which was presumably blocked in.

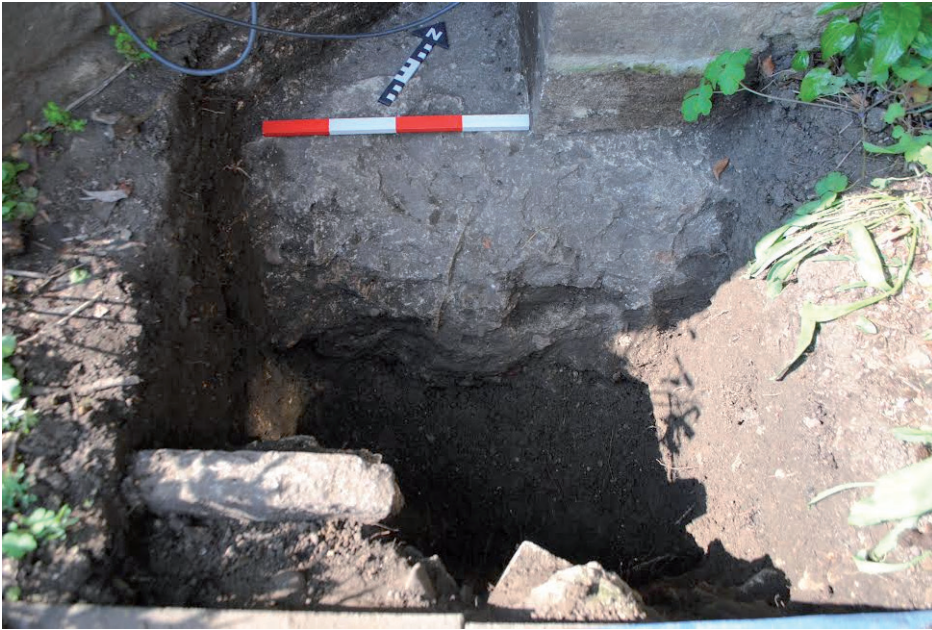
*Fig. 21. Test Pit 3 showing limestone dogger beneath house wall. Photograph by Jane Harrison.*

It was difficult to be certain without further investigation, but the built foundations seen in test pit 3 may also have incorporated more than one phase of building. Both test pit 2 and test pit 1 produced some medieval pottery (almost entirely residual) and also evidence of a persistent boundary, running north-west to south-east, which may once have lined up with a door in the south-east wall. Otherwise the pits evidenced massive earth-moving work – once again probably the result of Blow’s remodelling – which had obliterated any remains of earlier buildings, outbuildings, surfaces or landscape features. After their removal the ground had been levelled-up, partly using what was most likely silty material dredged from the moat, along with some midden-type material containing residual medieval pottery sherds, worked stone fragments and oyster shell. Subsequently a sequence of yard and garden features had been cut into this levelling material, to be filled-in and re-cut in their turn. In both test pits layers of earlier stone paving were uncovered just below the modern concrete slabs, including, in test pit 1, a curved stretch which may have been part of a circular or semi-circular plant-bed surround.
