Swalcliffe: a New College Barn in the Fifteenth Century

By J.T. MUNBY and J.M. STEANE

SUMMARY

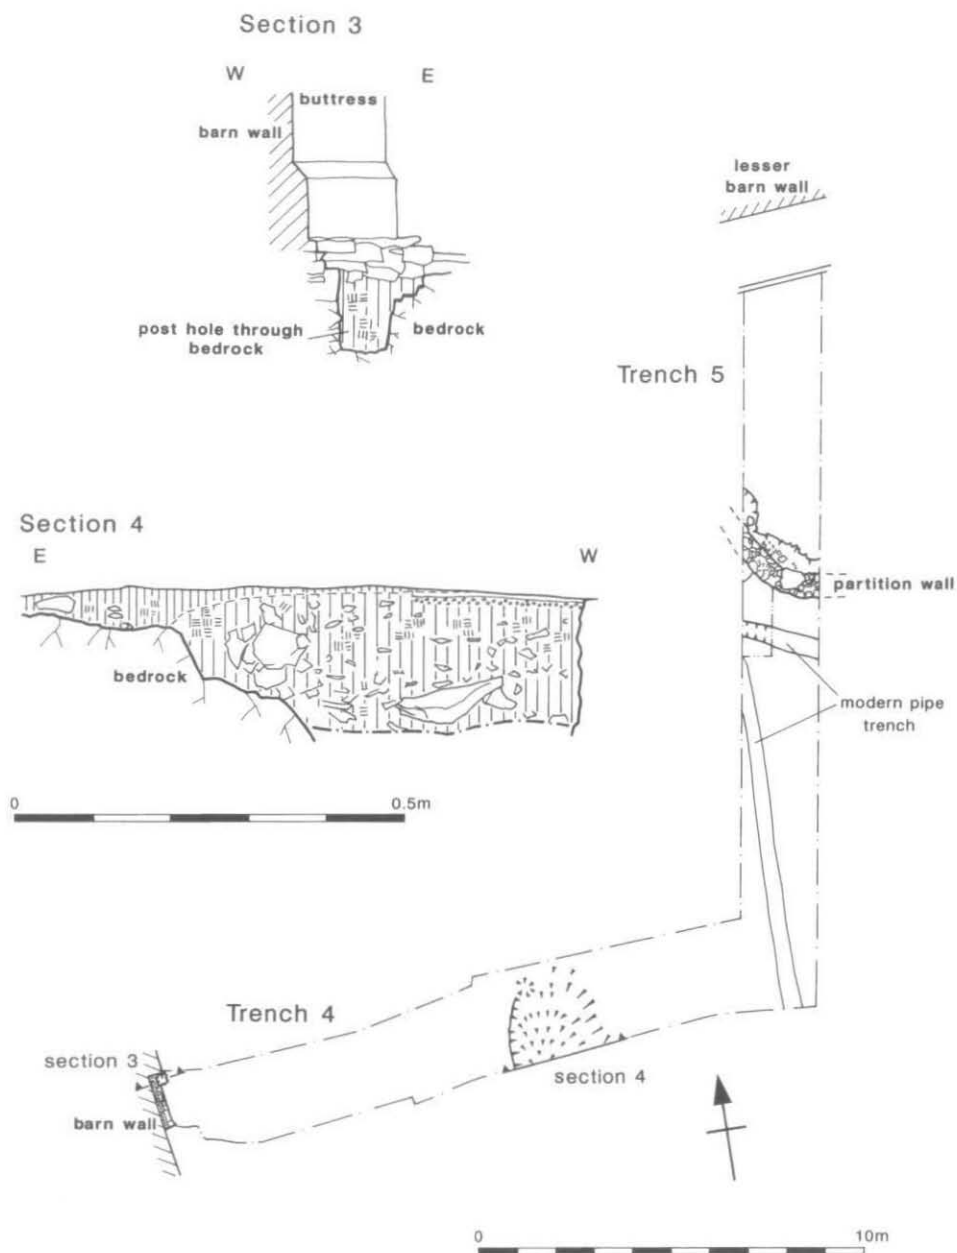
Fig. 5. Excavation: plan of Trench 4-5 and Sections 3 and 4.

The external face of the foundation for the east wall of the great barn was of soil bonded ironstone rubble laid on bedrock to a depth of 0.3 m. (Section 12, Fig. 7) and similarly beneath the buttress (Section 3, Fig. 5).

Twelve metres east of the great barn an irregular, ironstone rubble-filled feature extended outwards and downwards south of trench 4. Undated and capped with concrete, this is perhaps the lip of a quarry or infilled wall (Fig. 3 and Fig. 5, Section 4).

Although two service trenches crossing trench 5 were clearly modern (Fig. 5) an unmortared, 0.7 m. wide, ironstone rubble foundation course from an E-W farmyard partition wall 8 m. south of the lesser barn remained undated. Between the wall and the lesser barn there was virtually no covering over the smooth bedrock surface also found in trench 6 and the northern end of trench 7. South of the partition wall lay the compacted rubble surface of the centre of the farmyard.

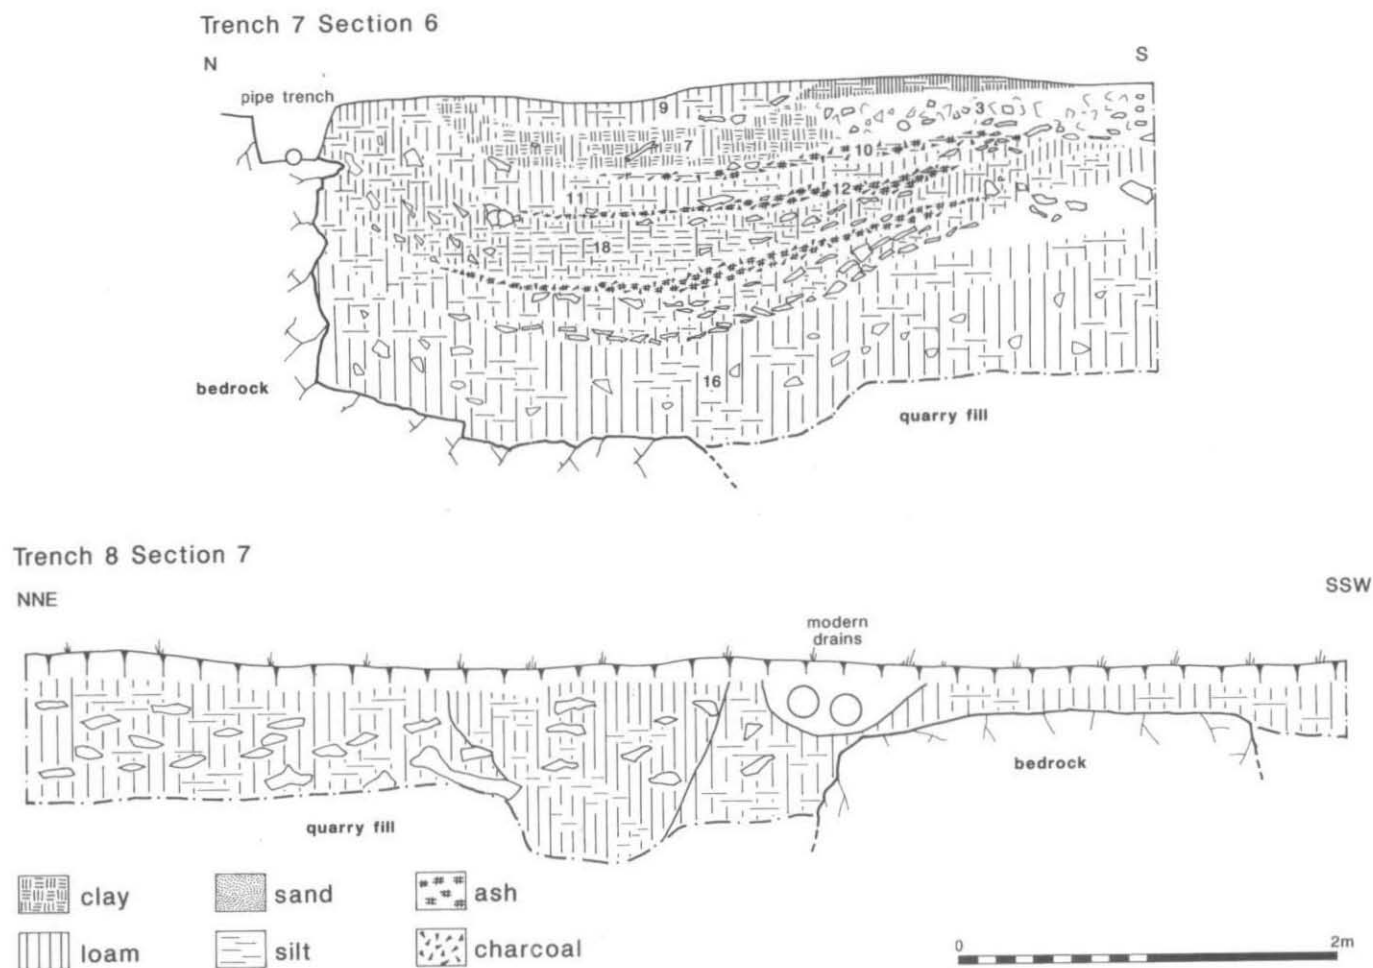
Fig. 6. Excavation: Sections 6 and 7.

Two modern service trenches also cut trench 7. The bare bedrock yard surface of the northern half of trench 7 continued southwards as compacted rubble metalling over medieval quarry infilling which appeared to extend into trenches 8 and 9. The top 2.0 m. of quarry filling was sectioned (Fig. 6, Section 6) to reveal quarrying waste continuing downwards and southwards beyond the trench (layer 16). This quarry remained as a hollow gradually accumulating 15th- to 17th-century kitchen waste (layers 14, 12 and 10) until it was built over in 1719. Quantities of lime wall plaster, lime mortar, daub and fragmentary stone roofing slates were present in the bulk of the infilling (layers 10, 18, 11 and 7). Neither in trenches 8 or 9 was the quarry fill emptied beyond 0.7 m. in depth.

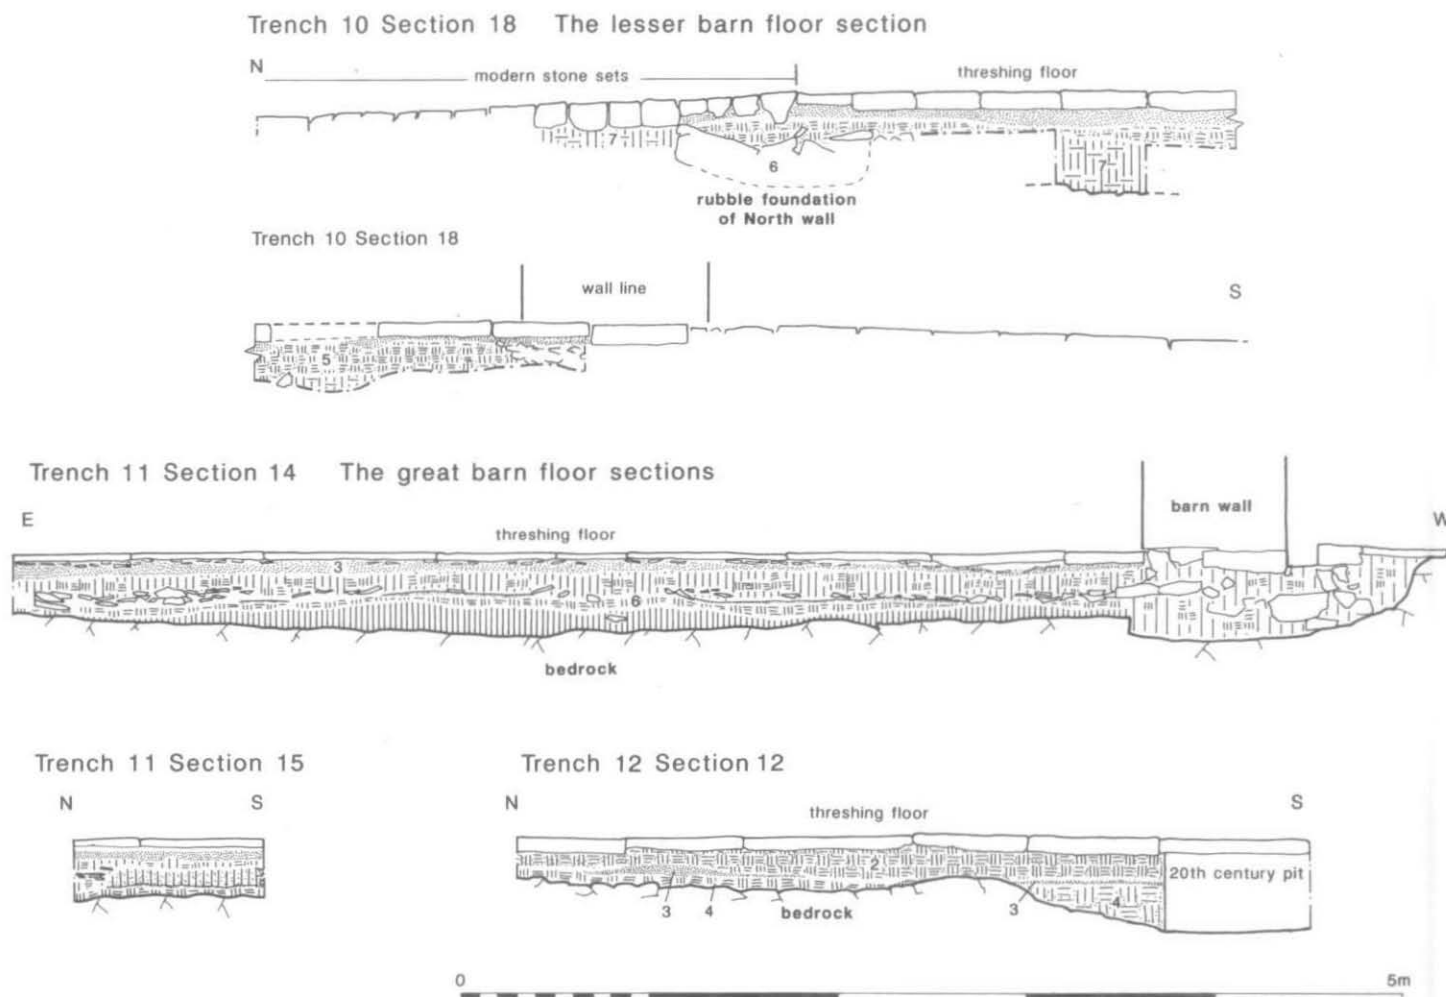
Fig. 7. Excavation: Sections 12, 14, 15 and 18.

In the recent past the floor of the great barn had been sectioned across its width in two places by trenches for modern grain augers. Removal of their concrete linings revealed sections through the existing flagstone floors along the centre line of each pair of opposing doors. As with the flagstones in the lesser barn, the flagstones beside trench 11 were laid on a bed of yellow sand (Fig. 7, Section 14, layer 3). The sand sealed several spreads of soil and clay containing chips of building stone and roofing slate. Each layer was uneven and patchy. A compacted level of dark, rich reddish-brown ferruginous soil, layer 6, overlain by thin spreads of lime mortar, layer 5, demonstrated the existence of a former occupation surface – although some 0.2 m. below the lowest course of dressed masonry of the inside wall. The flagstones in the northern end of the great barn differed as they were bedded onto a thick layer of compact orange-brown silty sand, layer 2, over the vestige of an earlier clay surface (Fig. 7, Section 12, layer 4). Thin lenses of lighter yellow sand, layer 3, sealed this surface.

The ruinous lesser barn had undergone major alterations and extensions since the Middle Ages and it is likely that the opposing central doors and flagstone threshing floor are a post-medieval addition as the north wall continued beneath the north entrance, (Fig. 7, trench 10, Section 18, layer 6). The threshing floor of thick ironstone flags was cleared of rubble, thatch and roof timbers and a line of flagstones lifted to provide a N-S section across the barn between the doors (Fig. 7, Section 18). The local ironstone flagstones were bedded on light yellow sand (2) which may have sealed the remnants of a previous clay floor (5). The almost stone-free red-brown sandy silty clay was homogeneous, clean and gave no clue to the previous use of the barn. There was no staining from urine or trace of any former central drain. The impression was that this layer had been protected, probably by flagstones, during the duration of the life of this barn. Layer 5 sealed natural decayed limestone subsoil (7) over bedrock.

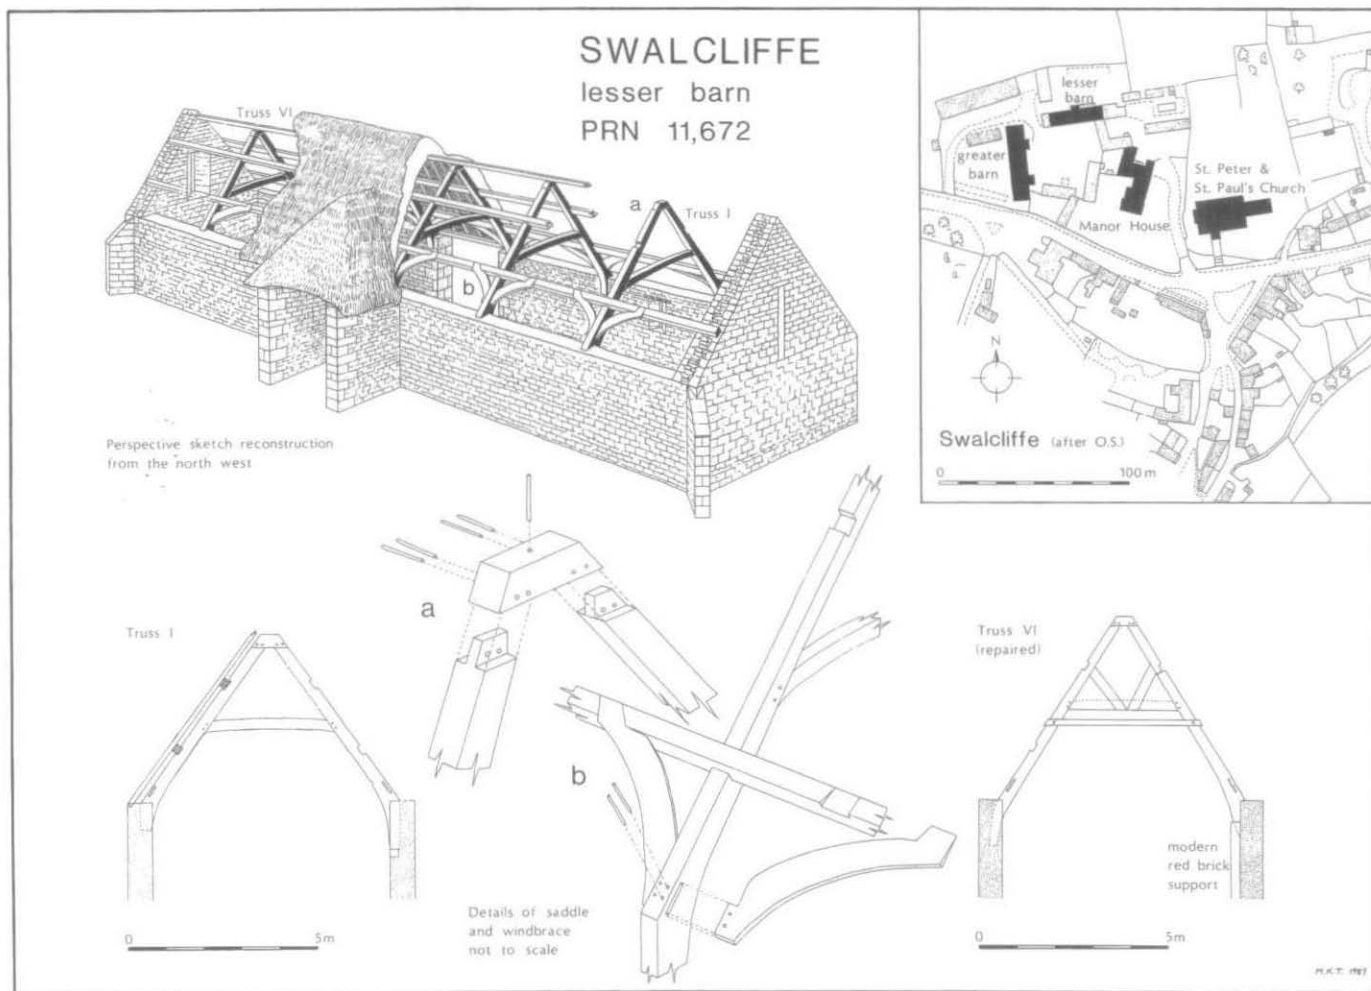
Fig. 19. Lesser barn: reconstruction and timber details (Copyright Oxfordshire County Council Department of Leisure and Arts: Sites and Monuments Record).

In the Centre for Oxfordshire Studies collection of photographs from Packer and Simms of Chipping Norton, a pre-war photo of Swalcliffe showing the lesser barn in the background does indeed show thatch and a hipped roof to the waggon porch on the north wall of the barn, as surmised in the reconstruction drawing (Fig. 19). The waggon porch, though not actually bonded in to the north wall, may still be contemporary with the construction of the barn or added shortly after. Later additions to the building included a shelter shed abutting immediately to the west, added probably in the 19th century (at which time a former central buttress in the west gable may have been removed). A small outshut was

built against the outer face of the north wall and against the east cheek of the waggon porch probably in the 20th century. As truss VI failed in later years, fracturing close to the trenching for the upper purlin, the base of the southern cruck blade was buttressed by a modern red brick support. Various openings have been punched in the barn walls in later years (see Fig. 20) to create windows and doorways probably reflecting a change of use in the barn in the 18th and 19th centuries.
