Chapel of the Blessed Trinity, Stonor

DAVID CLARK and JOHN STEANE

SUMMARY

Recent renovation work provided the opportunity to carry out in-depth building recording at the Chapel of the Blessed Trinity at Stonor in the south Oxfordshire Chilterns. This article presents the findings of the structural analysis and of documentary research in the archive at Stonor House. A new tree-ring date confirms the building's fourteenth-century origins as a family chapel belonging to the locally prominent Stonor family. It is shown that the tower, probably started in the early fifteenth century, was the first major addition, perhaps associated with adjacent accommodation for the six chaplains employed by the Stonor family. The chapel continued in use after the Reformation, used clandestinely for Catholic worship by the recusant Stonors. The authors' detailed study of the roof structure shows that towards the end of the sixteenth century there was a major rebuilding of the chapel roof. The old roof was largely removed, and the four eastern bays were provided with a new crown-post roof which supported a lath-and-plaster ceiling. Finally, in the 1790s, when Catholic places of worship were given leg

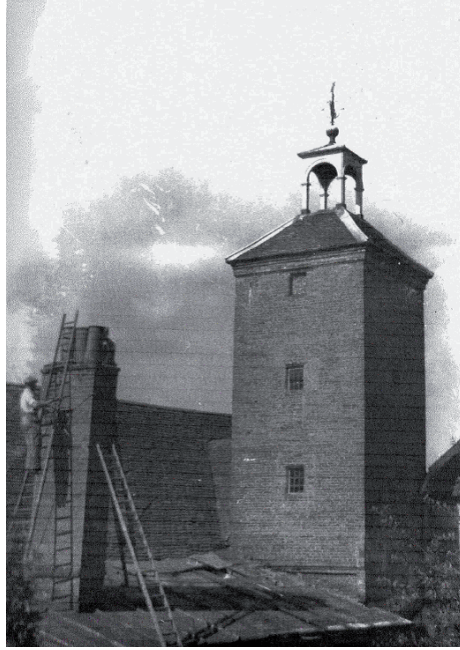
Fig. 7. Mr Sherfield on the stack at the 'priests' houses', 1956–57 (copyright Stonor Settlement Trust).

A number of photographs survive showing the buildings to the north of the chapel before their demolition in the 1950s. They clearly had a shallow pitched lean-to roof and a tall brick stack with at least three flues (Fig. 7) suggesting domestic use. By 1959/60 when Fig. 8 was taken, the demolition was complete, apart from a structure that was retained as a boiler house.

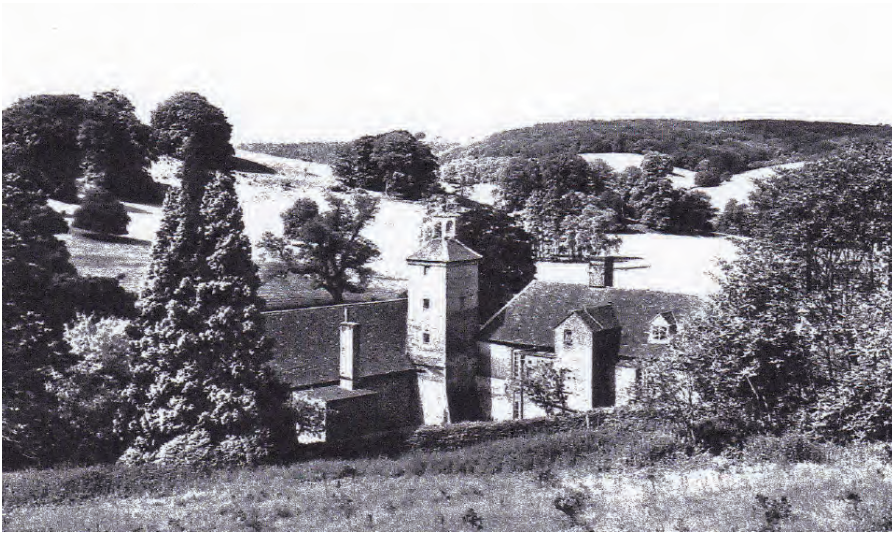
Fig. 8. View from the north-east following demolitions in 1959–60 (copyright Stonor Settlement Trust).

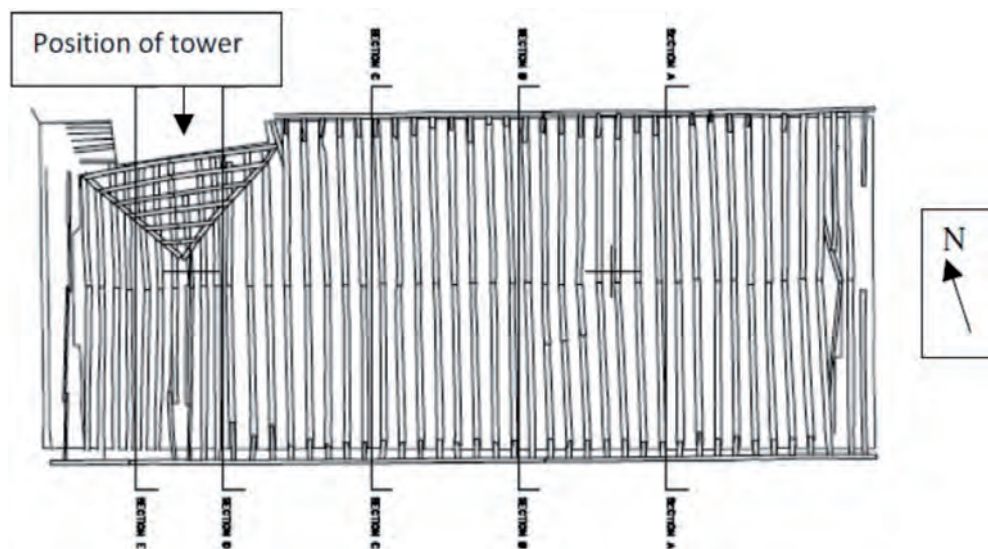
Fig. 10. Chapel roof plan (copyright Warner Land Surveys, 2014).

The plan of the roof timbers is shown in Figure 10. There are forty-five rafter pairs, the closely spaced eleven pairs at the west are scissor-braced, while the thirty-four pairs to the east are the surviving elements of a crown-post roof (Fig. 11).⁷²

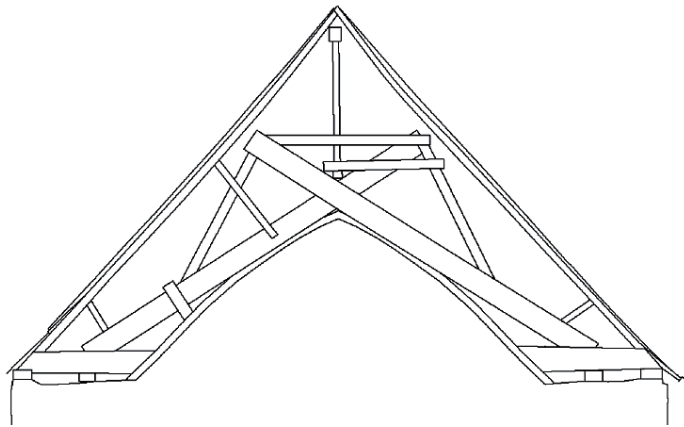
Fig. 12. Truss II (rafter pair 11) (copyright Warner Land Surveys, 2014).

Crown-Post Roof Figure 12 shows one of the principal-rafter trusses.⁷³ As with all the other trusses, the tie-beam has been truncated for the insertion of softwood structures to hold up

the present plaster vault. The residual stubs show that the beams were some $8\frac{3}{4}$ inches wide by 11 inches deep and had 3 inch chamfers with lamb's-tongue stops along their lower edges. All their collars had also been removed – apart from half of that at truss II (rafter pair 11, numbered from the east). In the soffit of this collar is a mortice for a crown-post brace.

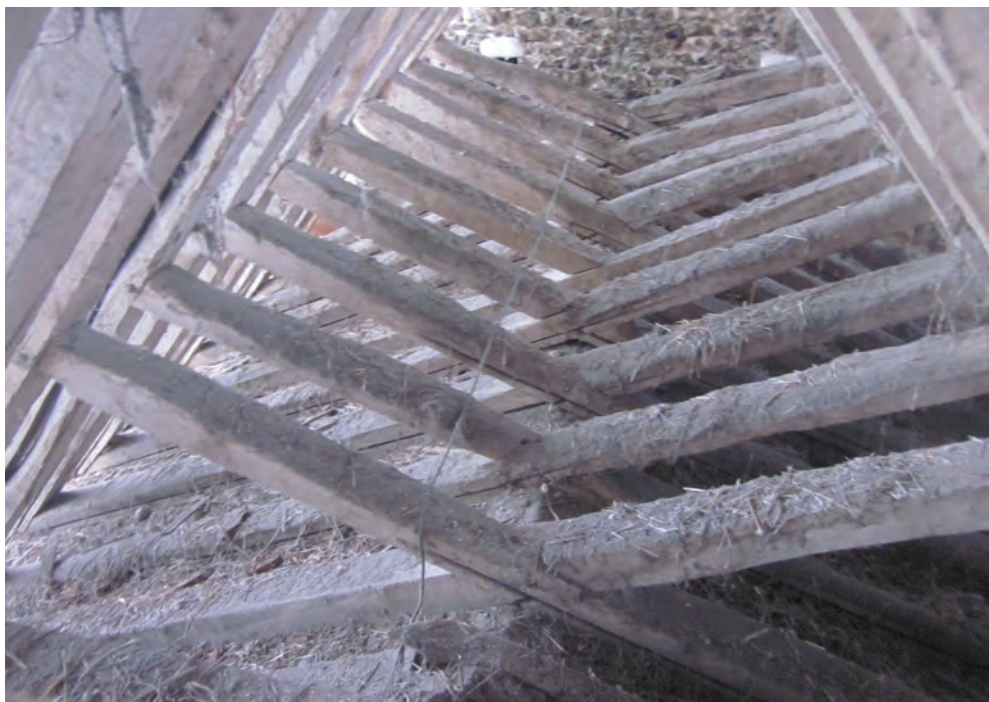
Fig. 15. Scissor-braces from east. Photo by David Clark.

Scissor-Braced Trusses We turn now to the scissor-braced trusses at the west end of the roof, of which nine complete trusses (37–45) and two incomplete ones (35 and 36) survive (Fig. 15). At 14½-inch centres, these trusses are more closely spaced than those in the crown-post roof. The scissor-braces are lapped and pegged – although not consistently in the same direction – and tenoned into the rafters.

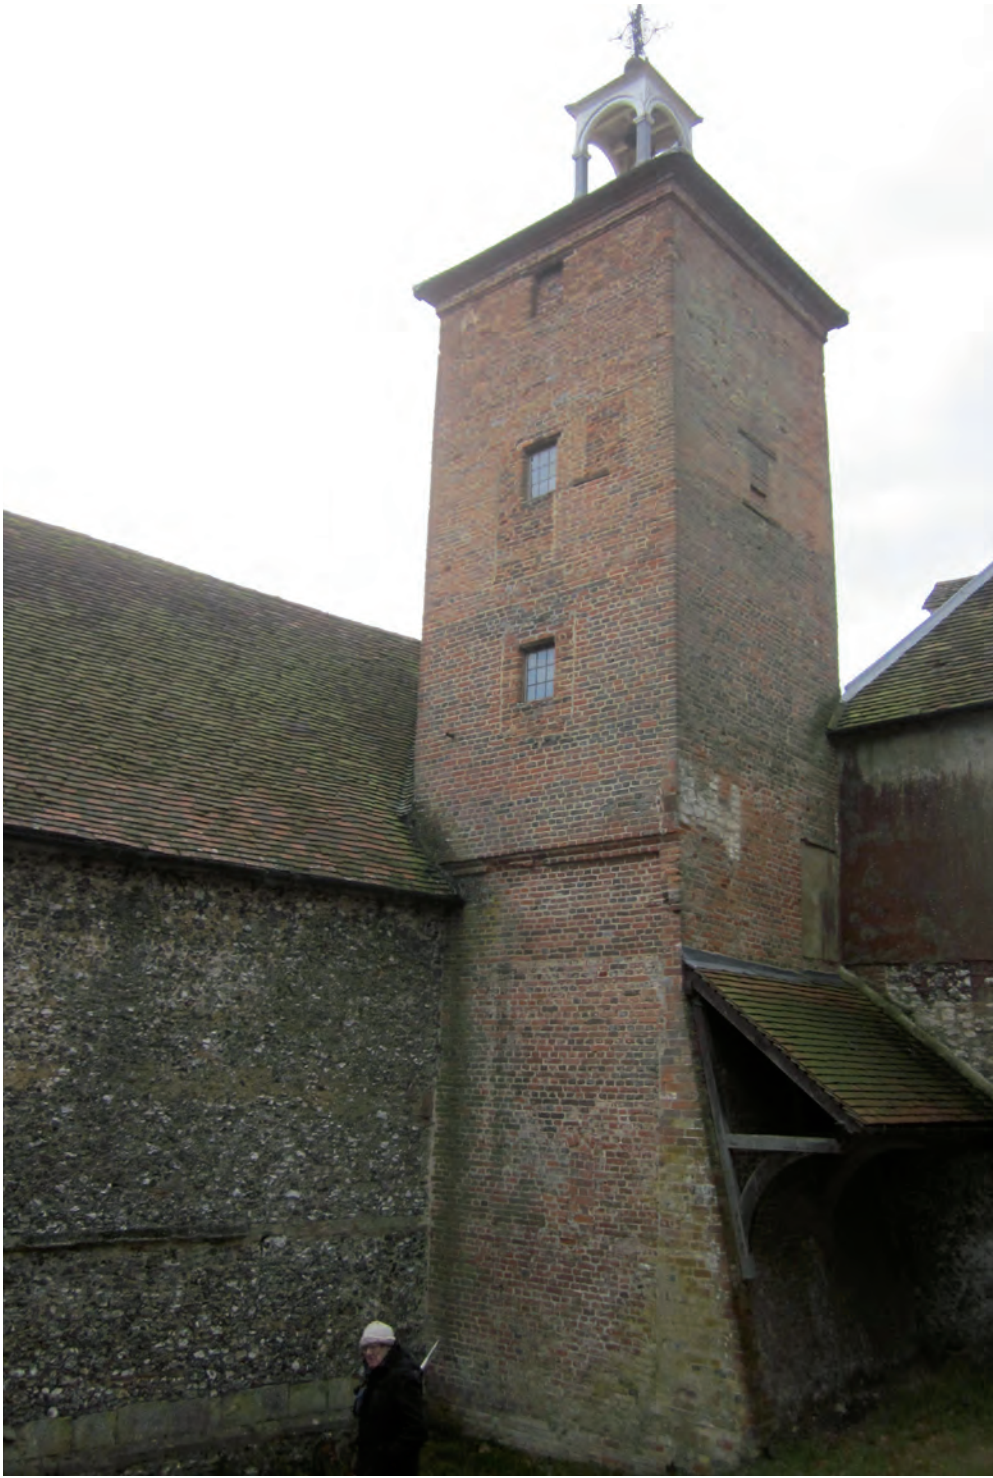
Fig. 21. Tower, east and north elevations. David Clark.

The tower is shown from the north-east in Figures 21 and 22, the latter a simplified sketch with the various levels labelled. The upper three floors (T2–T4 in Fig. 22) are corbelled out to the east over the lower ones. To the north is a sloping buttress with a straight-joint to the main tower structure. The main building material is brick, but each elevation has its individual characteristics, described in turn.

At course 46 above the corbelling (T3), the brickwork of the tower changes in character. Although similar sizes of bricks and mortar thicknesses are used, those above this course are laid without the regularity of the English Bond below. At this level there are straight-joints suggesting a blocked doorway (into which a later square window has been inserted) and a blocked square window to the right.

At level T4 is a further blocked window just under the eaves with a timber lintel in situ. The infill is recessed within the former opening, allowing the grooves for leaded glass to be seen at both sides. Above are further brick corbelling courses supporting the eaves.

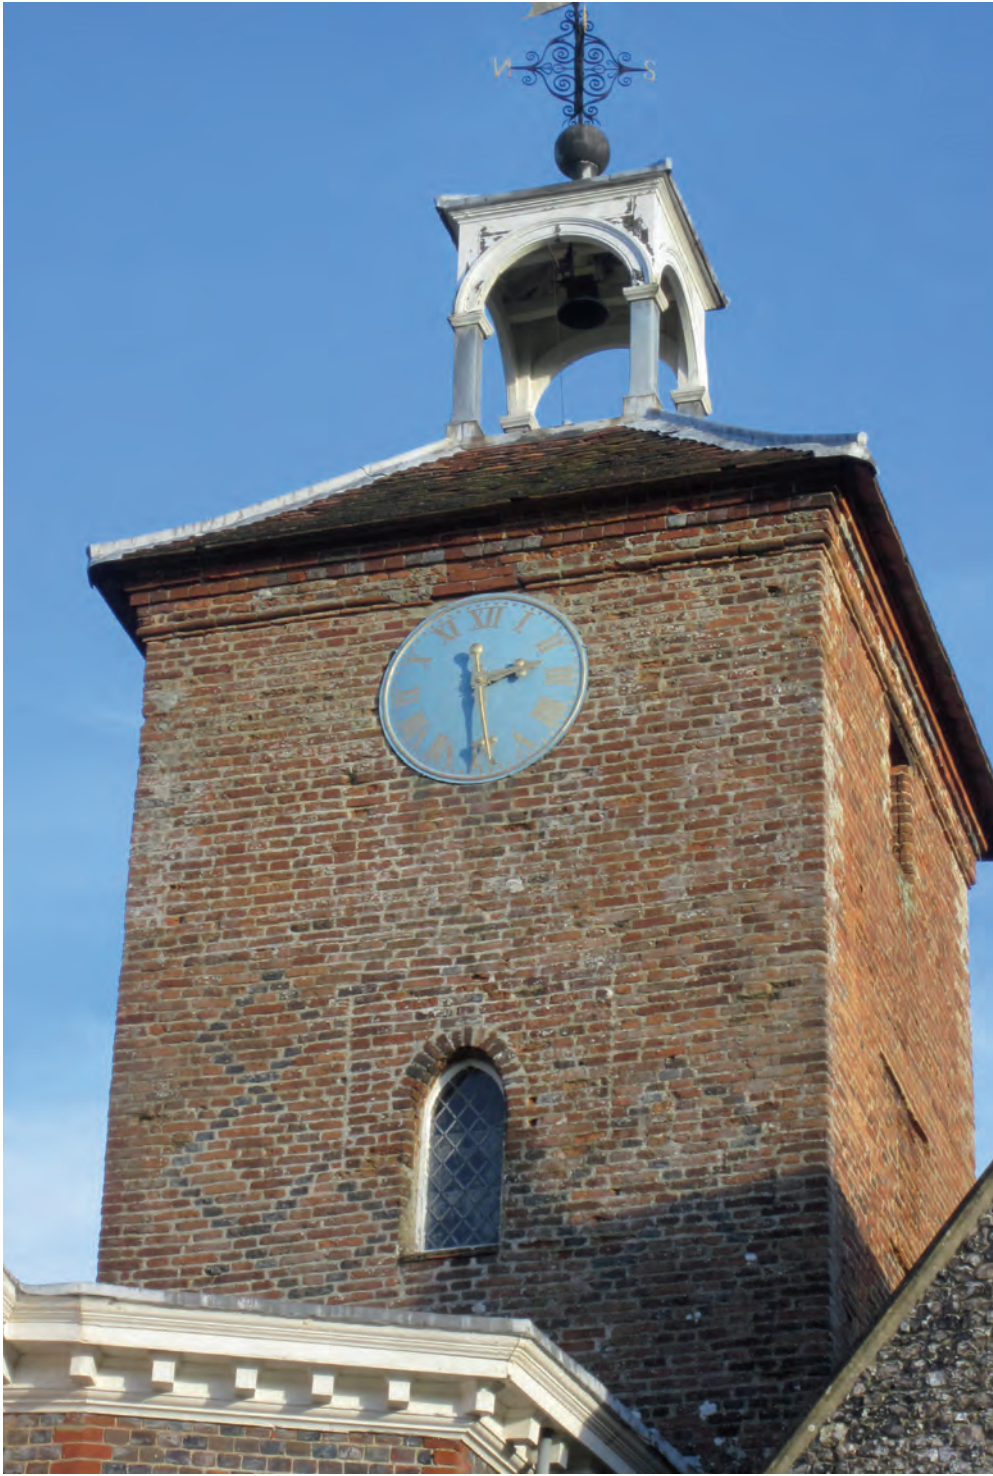
Fig. 23. Tower, west elevation. David Clark.

At level T2 is an opening in the brickwork giving access to the chapel roof. This has been rather crudely broken through, suggesting that the builders of the tower did not have a need to enter the chapel roof – and thus there was probably a valley between the two rather than the present pitched linking roof. In the brickwork are two (blocked) openings, with brick lintels – probably putlog holes. The brickwork obscured by the chapel was not of the same quality as that above. The arrangements around this area are discussed separately below.

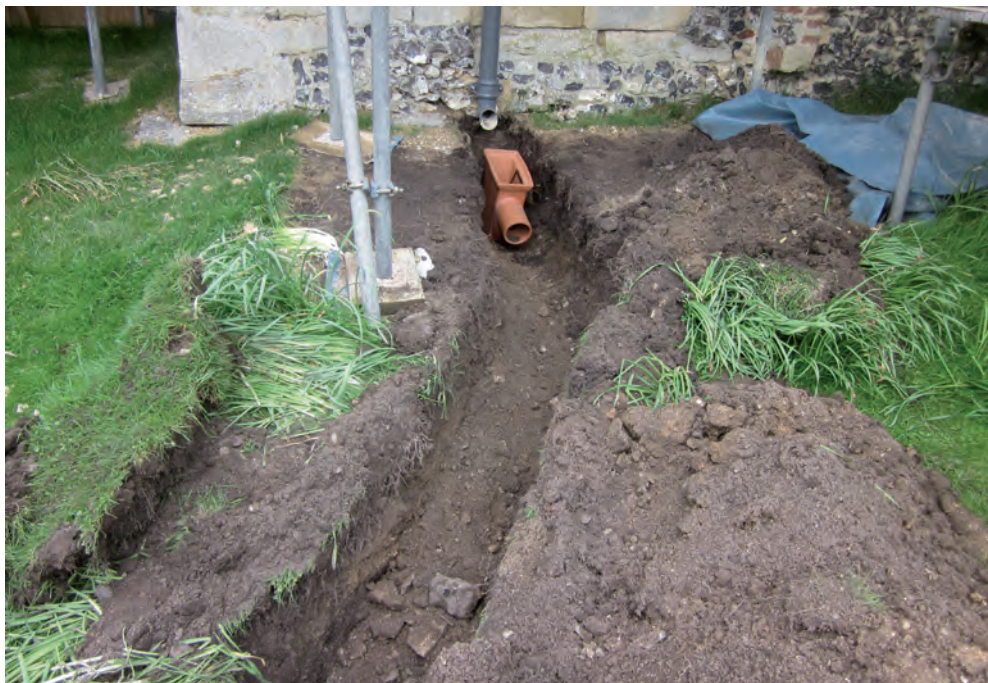
Fig. 24. Linking trench at south-west corner. Photo by David Clark.

In May 2015 a short length of trench was dug to link this pit with a down-pipe from the chapel roof (Fig. 24). This followed the slope of the land south of the chapel, cutting through topsoil at the north then chalk below it at the south. The trench exposed a section of the path to the south of the chapel, showing that it had layers of rubble aggregate with brick, tile and stone beneath more recent tarmac and gravel.

The main interest of the trench for the archaeology of the chapel was the negative finding that although it cut across the position of the wall shown in the 1687 painting (Fig. 5) there

was no evidence of foundations or that the soil had been disturbed. At the northern end of the trench some small flints were the only visible evidence of the chapel foundations.
