The Rectorial Barn at Church Enstone

By RAYMOND B. WOOD-JONES

THE Rectorial Barn at Church Enstone, Oxfordshire, represents a medieval structure of the greatest interest, which has survived to the present day in a very fair state of preservation. Its particular interest lies in its unusual and early structure in relation to the regional forms of timber construction, and in the fine fourteenth-century inscribed date-stone built into the structure, making the building an invaluable, if controversial, dating point in vernacular building.

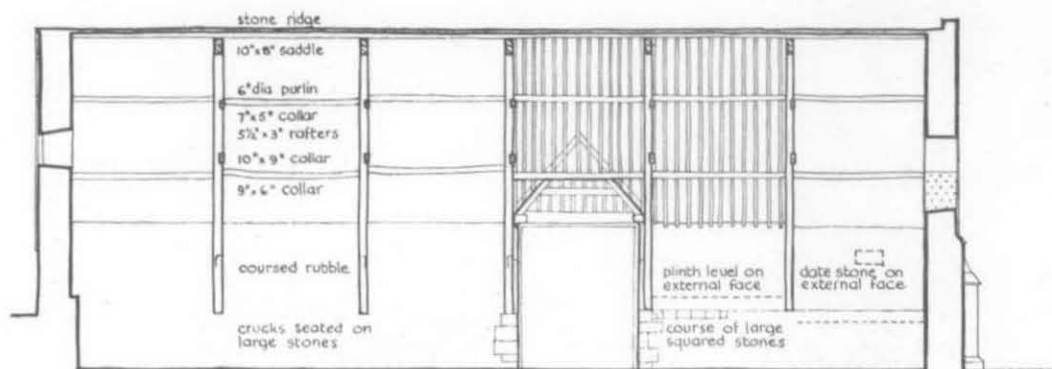
SECTION

THE RECTORIAL BARN CHURCH ENSTONE OXFORDSHIRE

The apex of the crucks is formed by a saddle 10 inches high and 8 inches thick—the same thickness as the top of the blades, to which it is morticed and pegged. On top of this saddle is a further triangular shaped block, pegged through the saddle, to raise the 4 inch squared ridge pole clear of the crucks. There are two purlins on each side of the ridge, laid flat and partly housed into the upper edge of the cruck. There are no wind-braces, nor any indication of such having been provided.

The absence of any tie until more than half-way up the cruck would leave some tendency for spread at the foot, and this outward thrust is counteracted to some extent by small buttresses in the lateral walls at the points of support. Apart from the crucks, the greater part of the roof structure is not original. The earliest surviving rafters are roughly squared timbers averaging $5\frac{1}{2}$ inches by 3 inches, laid flat and continuous from ridge to eaves. There is no evidence of an original wall plate, a 9 inch by 2 inch oak beam of recent date fulfilling this function on the outer face of the north wall, whilst the stonework is built up to infill between the rafters. The roof pitch is approximately 50 degrees, with a covering of Stonesfield slates, secured by pegs to the riven oak battens, and laid in diminishing courses from ridge to eaves, with a stone ridge capping. There appears to be a rough torching of lime plaster on the under side of the slating.

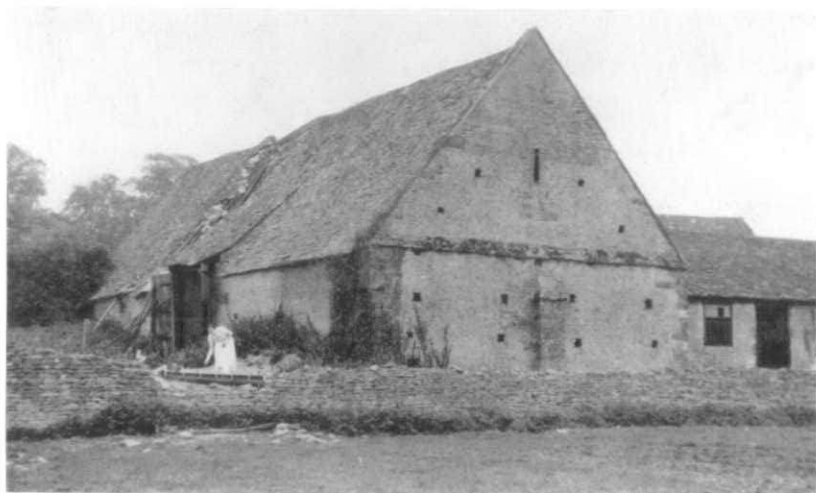
A

- A. The barn from the north-west.
- B. The south entrance front.
- C. The fourteenth-century inscribed date-stone.
