The Roof Carpentry of Oxford Cathedral

By JOHN ASHDOWN, IAN FISHER and JULIAN MUNBY

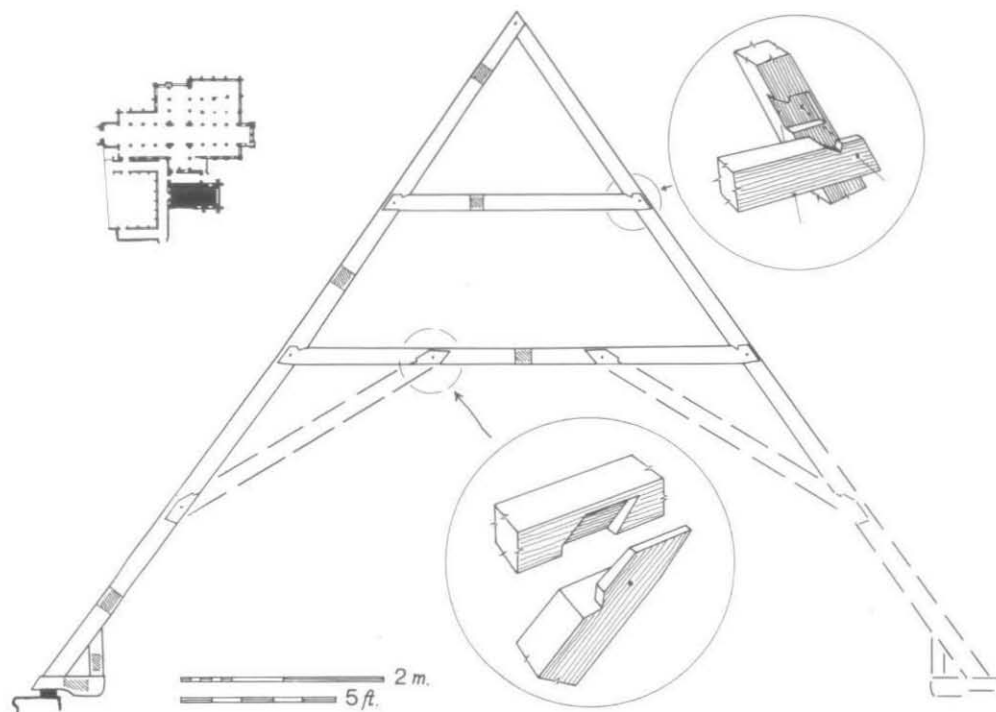
Fig. 83. Chapter-house: 13th-century roof-truss, looking W.

The roof consists of 29 individual rafter couples with no original lengthways stiffening, such support being provided only by the external covering. The trusses have two collar-beams, about 5 feet apart, and the lower collars had soulaces bracing them to the rafters. The rafters have a simple half-lapped joint at the apex, the collars and soulaces have open notch-laps (with what Hewett calls a refined entry profile). In addition to the usual face-pegs holding these joints, there are also pegs driven in at about 45 degrees from the lower fore-edge of the collar, through the lap-joint and into the rafter (Fig. 83, detail). These are an unusual feature, and were probably devised to draw the lapped end of the collar firmly back into the rafter; comparable double pegging has been noted in the 13th-century roof at Cogges Priory.⁸ The soulaces have all been removed, but their lower mortices (now filled) can still be seen in the rafters which bisect the dormer windows in the passage.

replaced by two softwood planks, and one near the W. end has been cut for the trap-door. Secondary features of the roof include longitudinal diagonal bracing in softwood, probably of 19th-century date, and side-purlins laid along the end of the lower collars, probably of the same period.

The junction of roof and side walls was partly opened for inspection in the recent works. The N. side was seen only where the roof is adjacent to the transept, and the truncated rafters rested on modern posts embedded in brickwork. On the S. side the standard triangular base arrangement existed, with ashlar-pieces morticed into the rafters and into large sole-pieces carrying the rafter feet. No original tie-beams were observed, and do not seem to have been present. The sole-pieces were shallower on the outside where there had been a wall-plate (now replaced with bricks) resting on the stone table at the top of the wall; some of the inner ends of the sole-pieces stand on small stone piers that may rest on the vaulting, though this is obscured by rubbish. It is possible that there was an inner wall-plate standing on the inner face of the wall. The present floor is carried on large transverse joists, whose soffits are obscured by rubbish, and are presumably supported by the side walls. The crown of the vault was observed a short distance below the joist soffits near the centre of the room. The span between the walls in the chapter-house itself is 23 ft. 11 ins. (7.29 m.).

It would be expected that the roof would be contemporary with the rebuilding of the Priory chapter-house in the second quarter of the 13th century. A loose notch-lap tenon, sampled for dendrochronology, was found to have a last ring dated to 1236 (without sapwood); although measured on the face of the timber rather than the cross-section, this sample matched very well with the Oxford dendrochronology mean curve.¹⁰ Allowance must be made for missing heartwood and about 15–35 years of sapwood, giving a felling date probably no earlier than 1250. It is unlikely, given the nature of the roof and its jointing, that it can have been built long after 1250, so it must date from soon after the masonry of the chapter-house. Only further sampling can determine a closer date, but similar results have been obtained from samples taken from reused timbers in Priory House, which share the same detail of diagonal pegging on the notch-lap joints (see following).

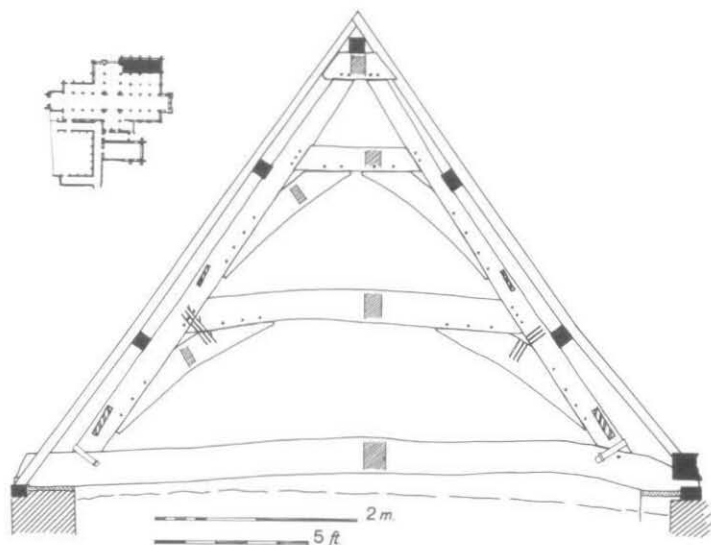
Fig. 84. Latin Chapel: 14th-century roof-truss, looking E.

THE LATIN CHAPEL (Fig. 84)

The Latin Chapel was built c.1320–40,¹² and the present roof is probably the original one. It is of four bays, like the vaulting of the chapel below, the trusses corresponding to the external buttresses. The W. bay has been partly removed, probably to give light to the clerestory window (which is late-medieval); half this bay for half its width has a flat lead roof, the resulting walls being of studwork, probably 19th-century, with a king-post and struts to the N. side. Against the W. wall is half an original truss, and there are four further trusses with the last inside the E. wall of the chapel. The tops of the side walls are mostly obscured by builders' rubbish from re-roofing, but there is at least one wall-plate on each side, in part ancient, with tie-beams resting on them and on short stone piers. The piers on the N. are flush with the inner edge of the wall and those on the S. side stand forward some 13 ins. (33 cm.). The distance between the walls is 19 ft. 6 ins. (5.95 m.). The trusses stand over the pockets of the vault, which are filled level with rubbish.

The roof is double-framed, with the principal trusses supporting four purlins and a ridge-piece, on which the common rafter couples rest. The principal rafters are joined together at the apex with a large yoke on which the ridge-piece is placed. There are two collars, each supported from below with curved braces. The side-purlins are supported by braces rising from the rafters, and are pegged to the principals, though not trenched into them. All the timbers are accurately cut and well pegged, though they are very waney and exceedingly irregular in outline, evidently being made from single branches and trunks.¹³ The joints are all pegged mortice-and-tenons, and the purlins are scarfed

with simple splays and three pegs (the ridge has trait-de-Juppiter scarfs). Modern additions include a series of braces from the ties to the lower purlins, and collars beaked to the upper purlins, whilst many of the common rafters have been replaced. Iron rods have been inserted in the centre of the trusses. The roof has recently been recovered with Bradstone slates, and felted.

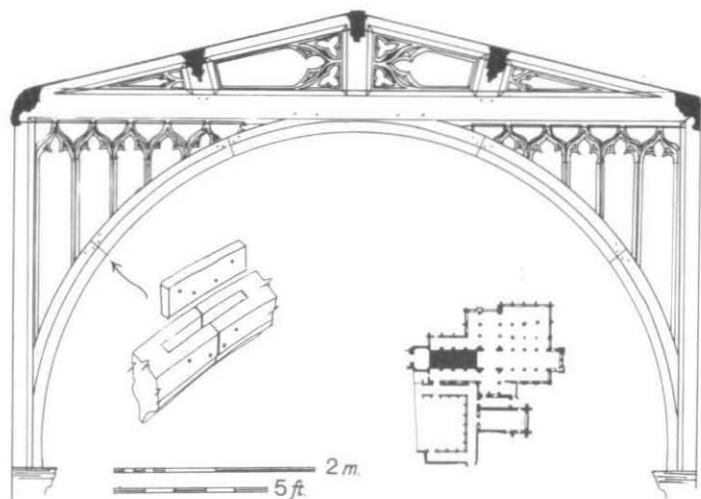
Fig. 85. Cathedral nave: 15th/19th-century roof-truss looking E., with detail of scarf-joint.

THE NAVE (Fig. 85)

The roofs of the transepts and nave were cleaned from scaffolding in 1979, and the nave roof was examined and drawn in August 1979. It was found to be partly of softwood, probably the replacement of 1816 noted by Britton (though a view by Thomas Malton in 1802 shows that the original roof was of the same appearance).¹⁷ It is of five bays, the westernmost largely of Scott's restoration (i.e. the western truss and probably the next). The next four bays and four trusses are contemporary, probably of 1816; the easternmost truss is hard against the tower.

The width of the nave between the walls is 22 ft. 5 ins. (6.83 m.), the full length from tower to W. wall 75 ft. 7 ins. (23.05 m.). Wall-posts with hollow chamfers are mounted on the corbels, with a plain butted scarf near their base. They support the tie-beams, which are braced by a semi-circular arch-brace (with an ogee moulding) rising from the corbels to the centre of the tie. It is in at least five sections, with free tenons joining the individual curved pieces (Fig. 85, detail), and presumably chase-tenons joining them to the tie. The spandrels between the brace and tie are filled with an open arcade of traceried lights, trefoiled in ogival heads. The wall-plates have a casement moulding and double ogee. The low-pitched principal rafters are supported by a king-post and two raking side-struts, all hollow-chamfered. The king-posts may have internal iron supports, having a peg on their W. side and a small wedge on the E. Above the tie the spandrels are also filled with open traceried panels. The ridge-piece is hollow-chamfered, and the purlins on the side-struts have in addition a roll and hollow. Where the ridge joins the later part of the roof there is a splayed and tabled scarf with under-squinted abutments, and two diagonal iron rods.

above the purlin, and 24 below (in three rows of eight panels). At every intersection are applied plaques, decorated with faces, figures or foliage. These have a different patination from the rest of the roof, and may be original.
