The Infirmary and Hall of the Medieval Hospital of St. John the Baptist at Oxford

By BRIAN DURHAM

SUMMARY

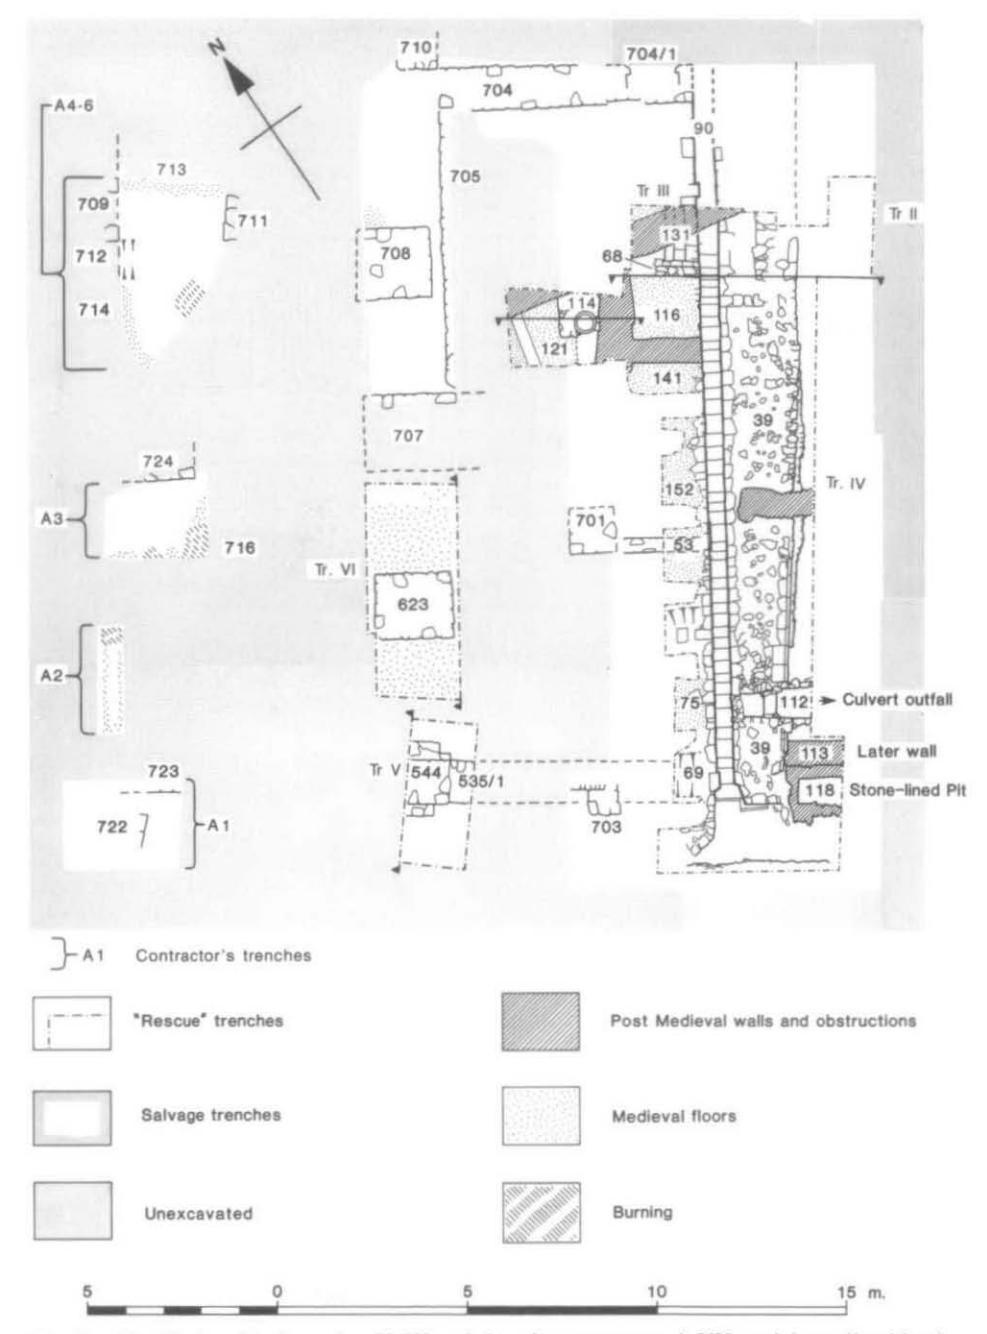
Fig. 5. The Kitchen Yard trenches II-VI and the salvage area trench VII: mainly medieval levels.

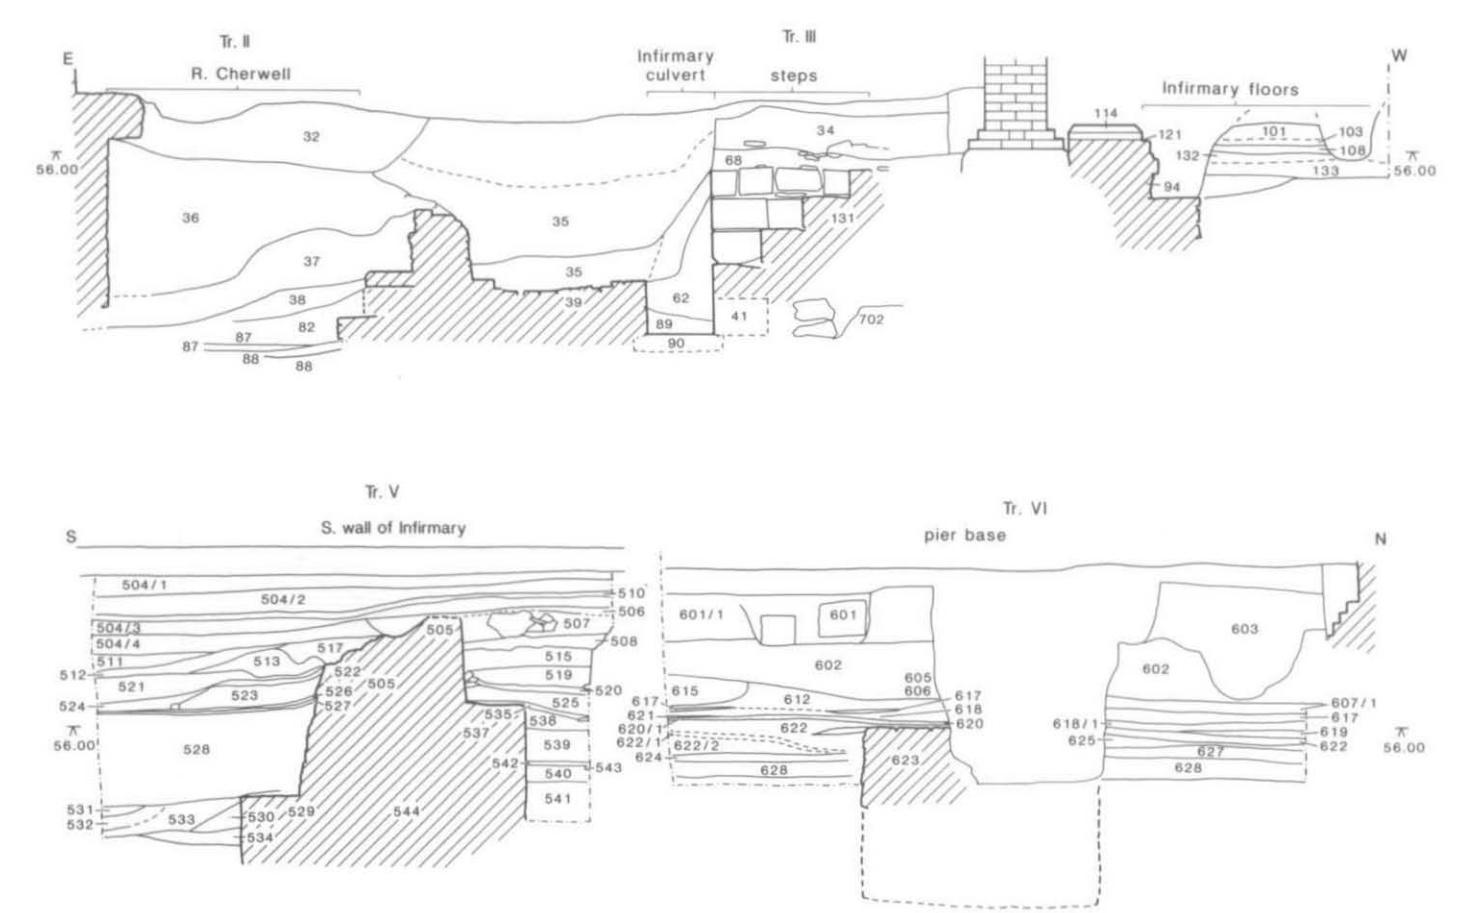
Fig. 6. Kitchen Yard excavations. Above: Trenches II-III, E.-W. section across east end-wall of infirmary; below: Trenches V-VI, N.-S. section across S. wall of infirmary F544, with a pier base F623 of the heavier arcade.

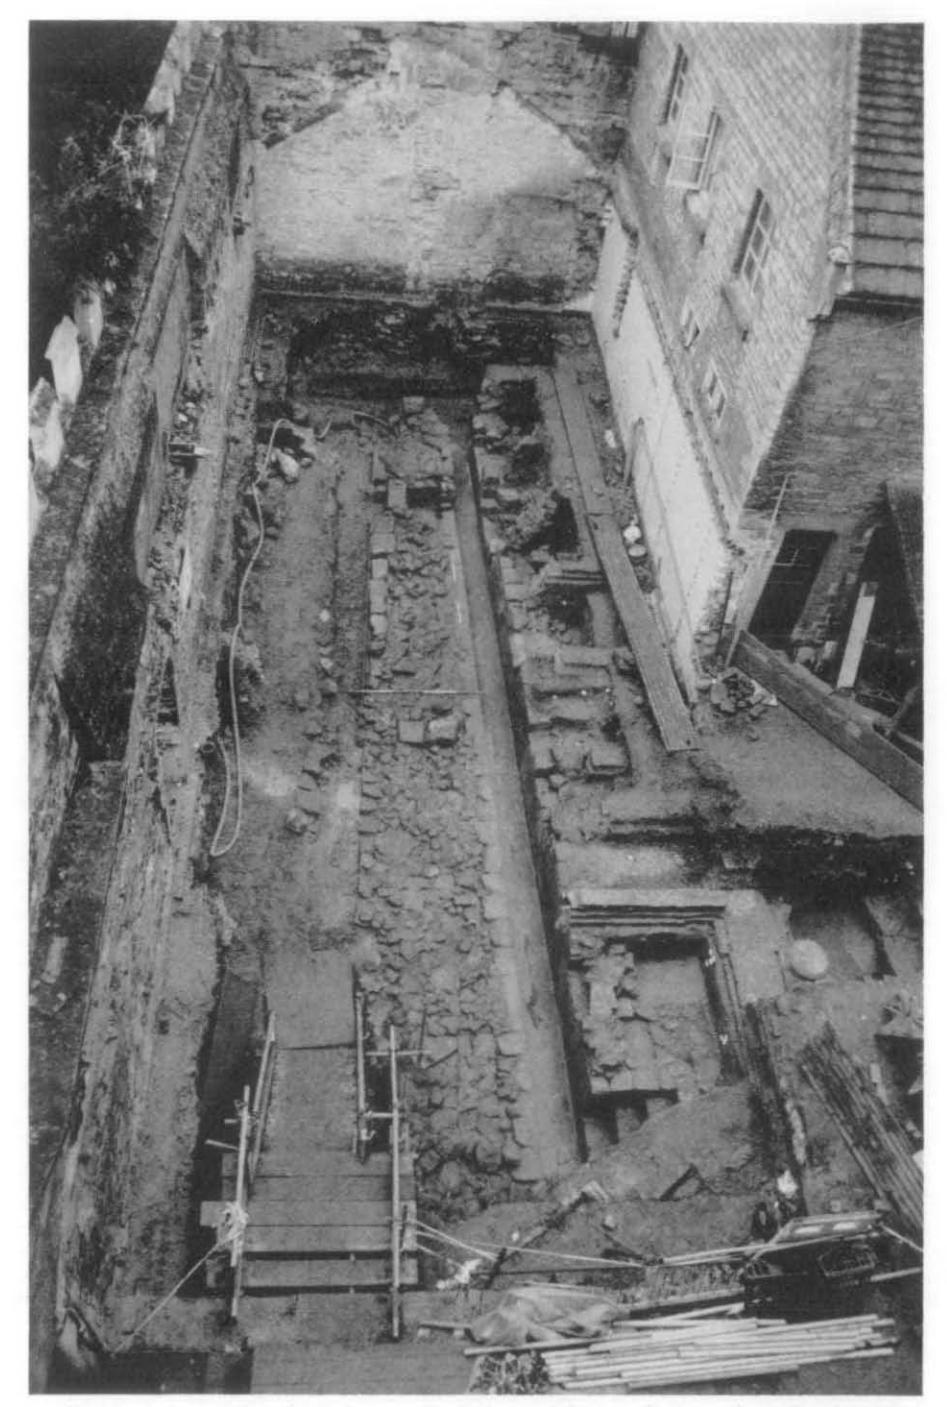
Plate 1. High level view of Trench IV from north. At lower right note the base of arcade column F114, and stair F131 into culvert.

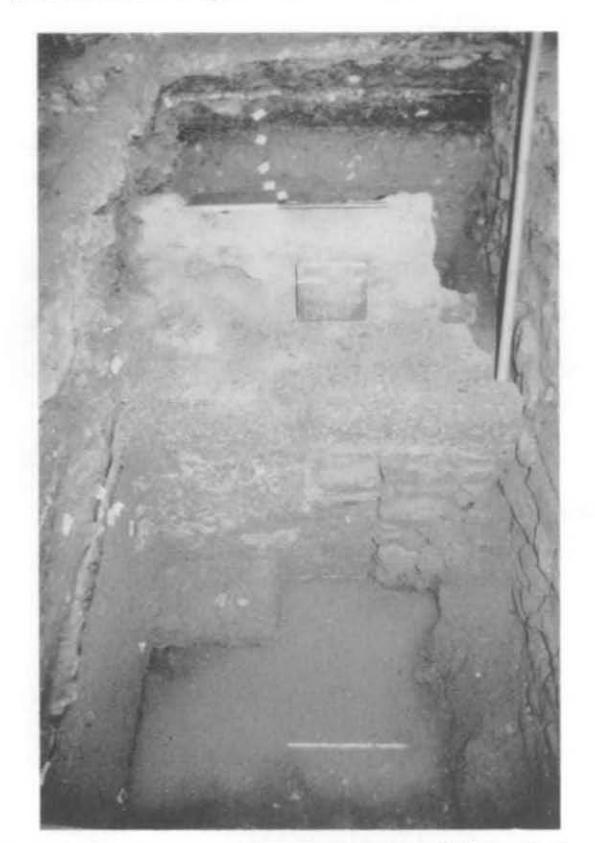
Plate 2. Trench V from south, showing external buttress of south wall F544 of infirmary (left), and blocking F535/1 of the second relieving arch.

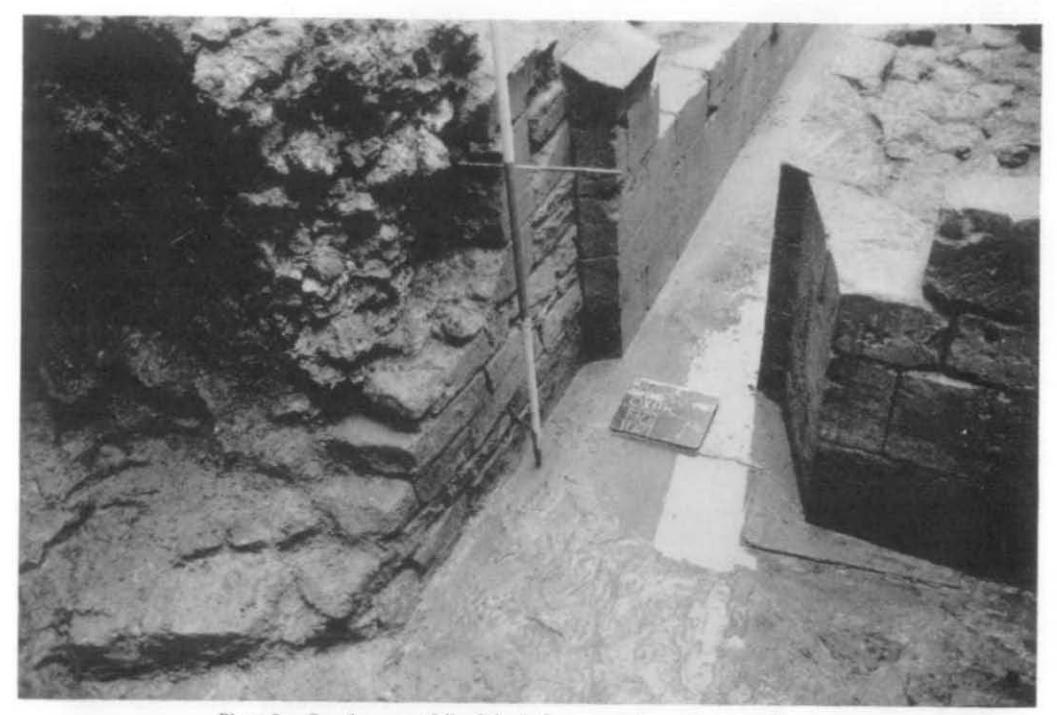
Plate 3. Southern outfall of the infirmary culvert, from south-east.

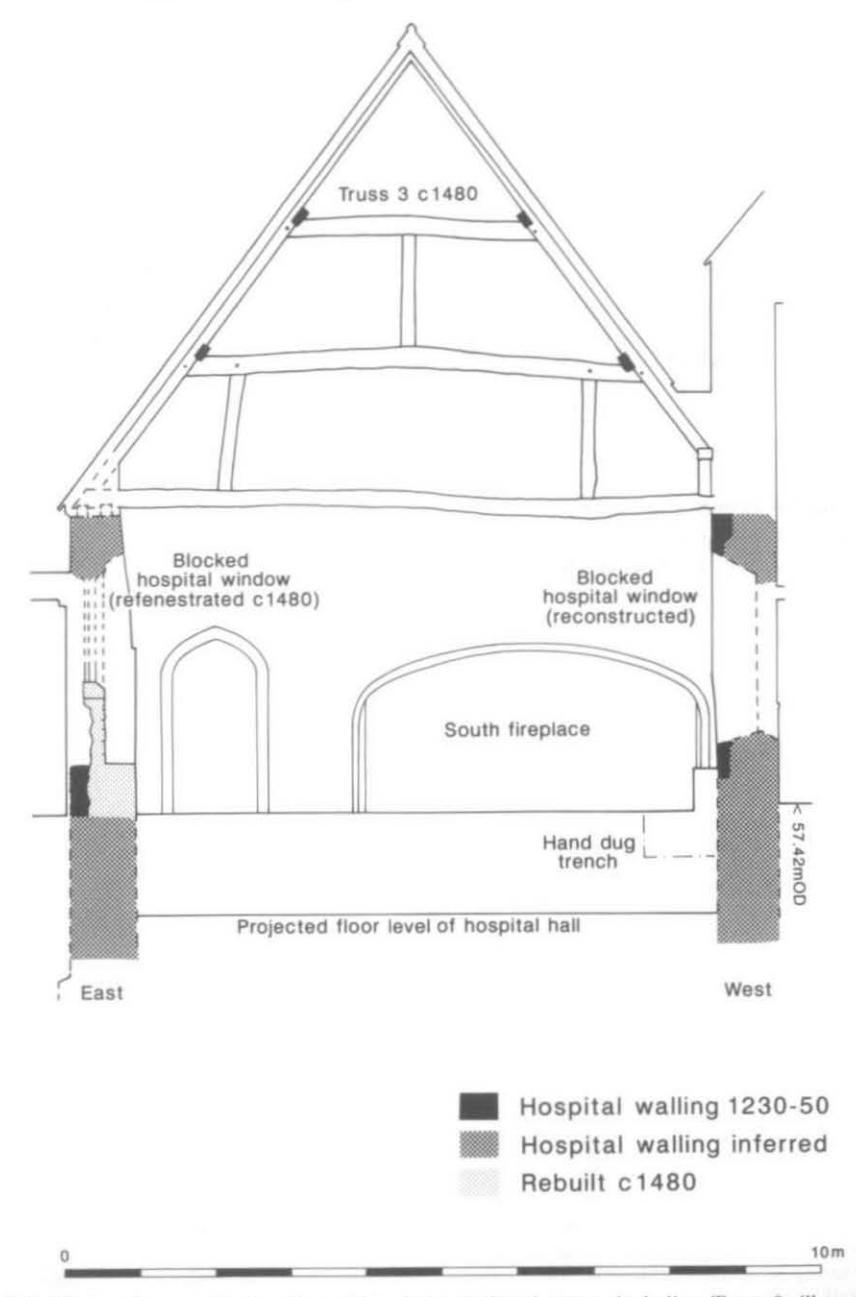
Fig. 7. Old Kitchen Survey: Composite section of the medieval range, including Truss 3, illustrating the hospital window openings and the refenestration of the E. Window. Based on R. Selwood survey.

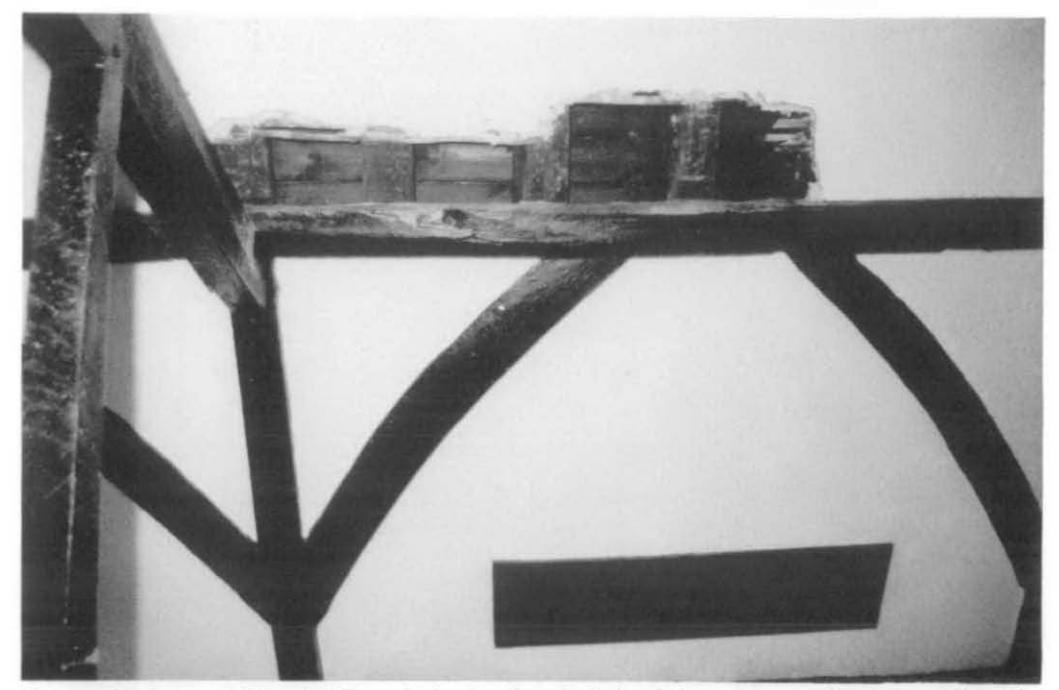
Plate 4. Kitchen roof, W. end of Truss 3, showing the principal and three common rafters exposed above the upper purlin.

A small area of plaster ceiling was removed above the west upper purlin north of Truss 3. This confirmed that the principal rafter continued up to the ridge in a diminished form, now hidden beneath the plaster. The purlin was clasped by the upper collar which was itself secured to the rafter by an (angled) tenon and single peg. The purlin showed a simple splayed scarf joint with two pegs, as elsewhere in the roof. The wind-brace was let into the purlin with an unsplayed notch and fixed with a single iron nail. The common rafters were at 0.44 m, to 0.53 m, centres.

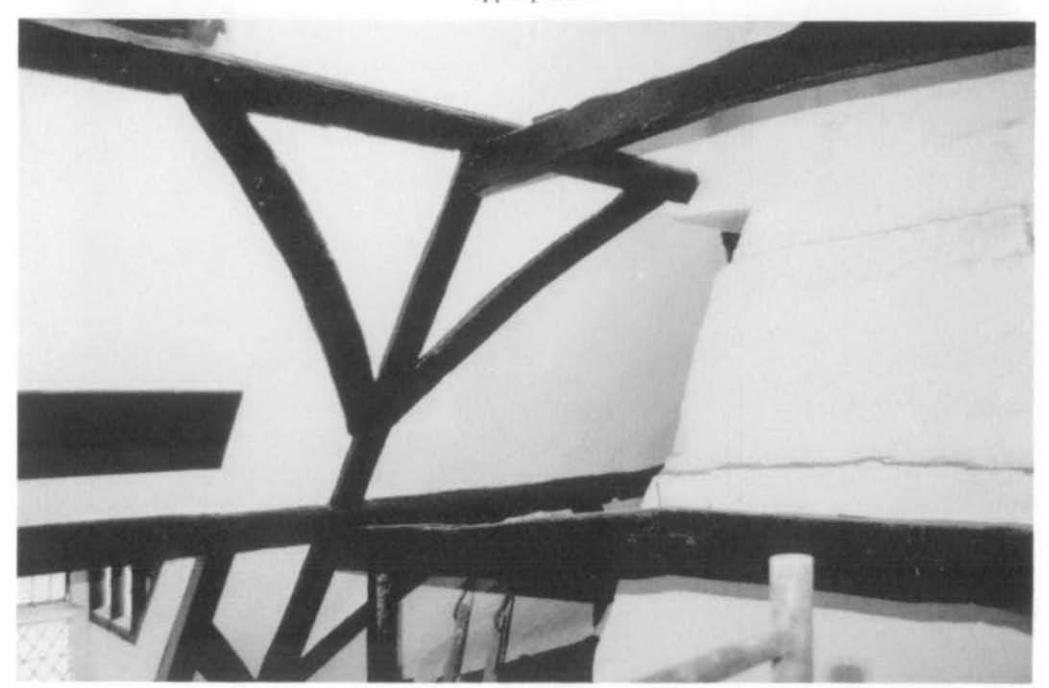
Plate 5. W. end of Truss 2, showing iron strap repairing the lower collar and opening cut through the lower collar, with king-post missing.

There was nothing to support the RCHM's suggestion that the queen struts were later insertions, although in Truss 2 the collars had been altered as if there had been an attic room here at some stage. The north ends of both trusses 3 and 4 had been cut away, apparently to accommodate the buttery, and the principal rafters are now supported on short ashlar posts rising from a substantial replacement wall-plate.

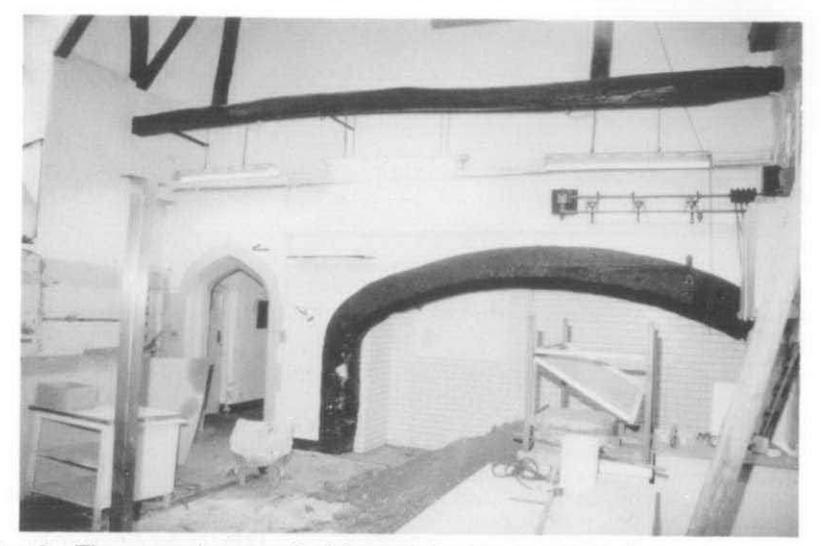
Plate 6. Three-centred stone arch of the south fireplace from N. during building operations.

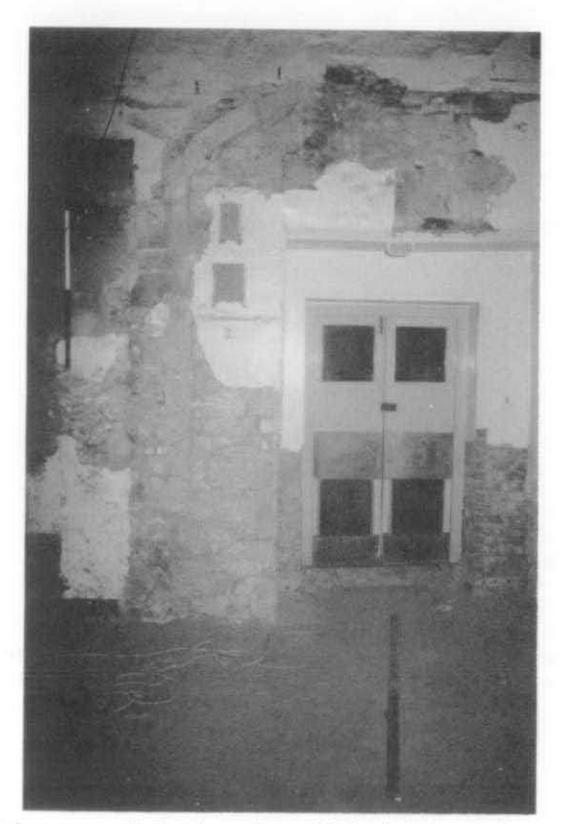
Plate 7. Elevation of kitchen west wall showing ashlars of S. jamb and part of arch of hospital hall window.

Elevation drawings were made of the stripped areas of both east and west inside elevations, including in the west wall a third window arch F1020 surviving to its full height and with much of the head reconstructable. It was becoming clear that we were seeing the remains of a substantial hall or ground-floor chamber of the hospital period. A chamfered quoin low down in the south-west corner of the kitchen prompted an investigation of the external face in the kitchen passage, where the head of an elaborate doorway F1012 was found just above modern floor level (see below). The wall south of this was inspected wherever there was any new exposure, but there was no sign of a further medieval window opening.

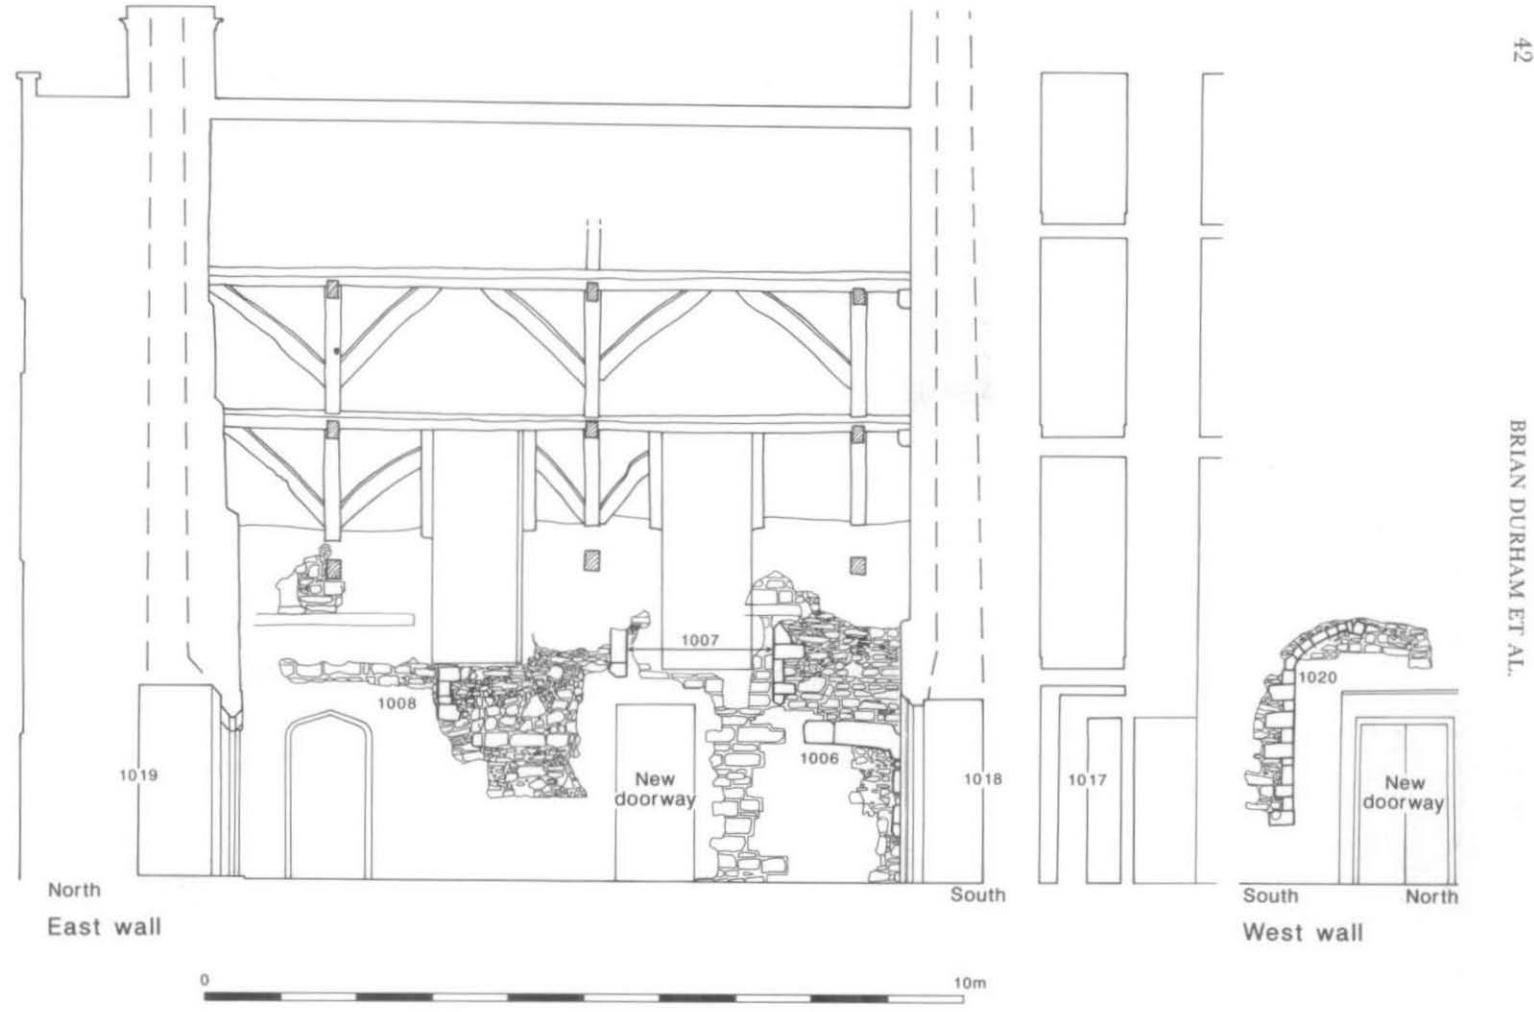
Fig. 8. Old Kitchen Survey: Elevations of east wall, illustrating the surviving ashlars of hospital windows F1007 and 1008, with a reconstructed section through the cupboard F1017 and corridors behind Stack F1018. Inset at right: Elevation of rere-arch window F1020 in opposing wall. Based on R. Selwood survey.

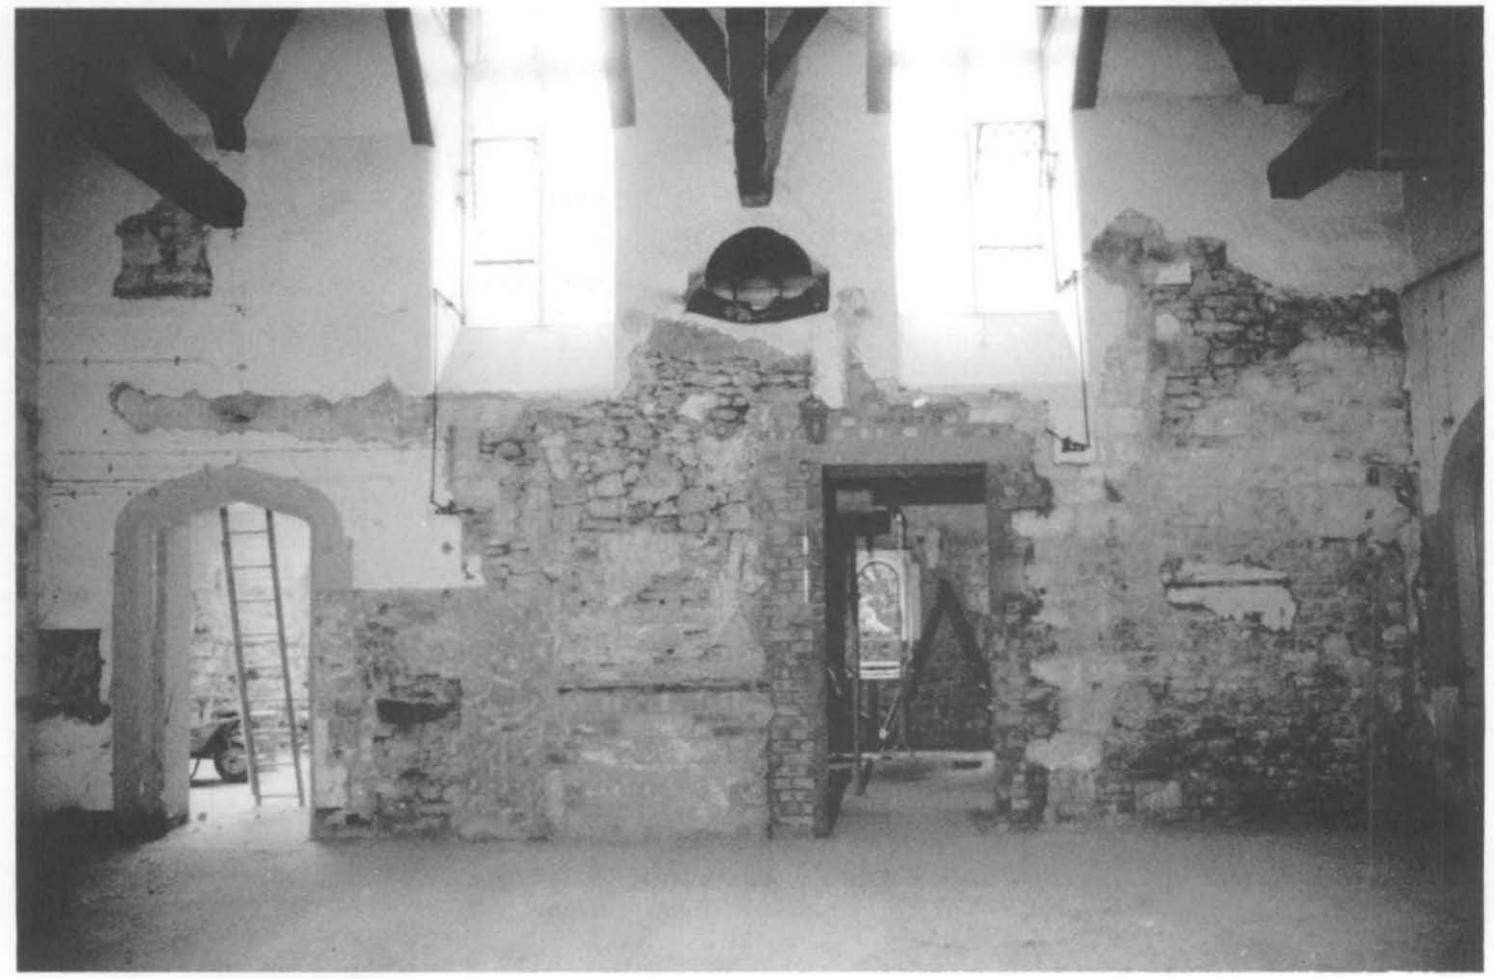
Plate 8. Internal elevation of E. wall kitchen showing ashlars of hospital hall windows in stripped surface, one being cut by new square-headed doorway (centre). A blocked fireplace of post-1635 kitchen shows at right.

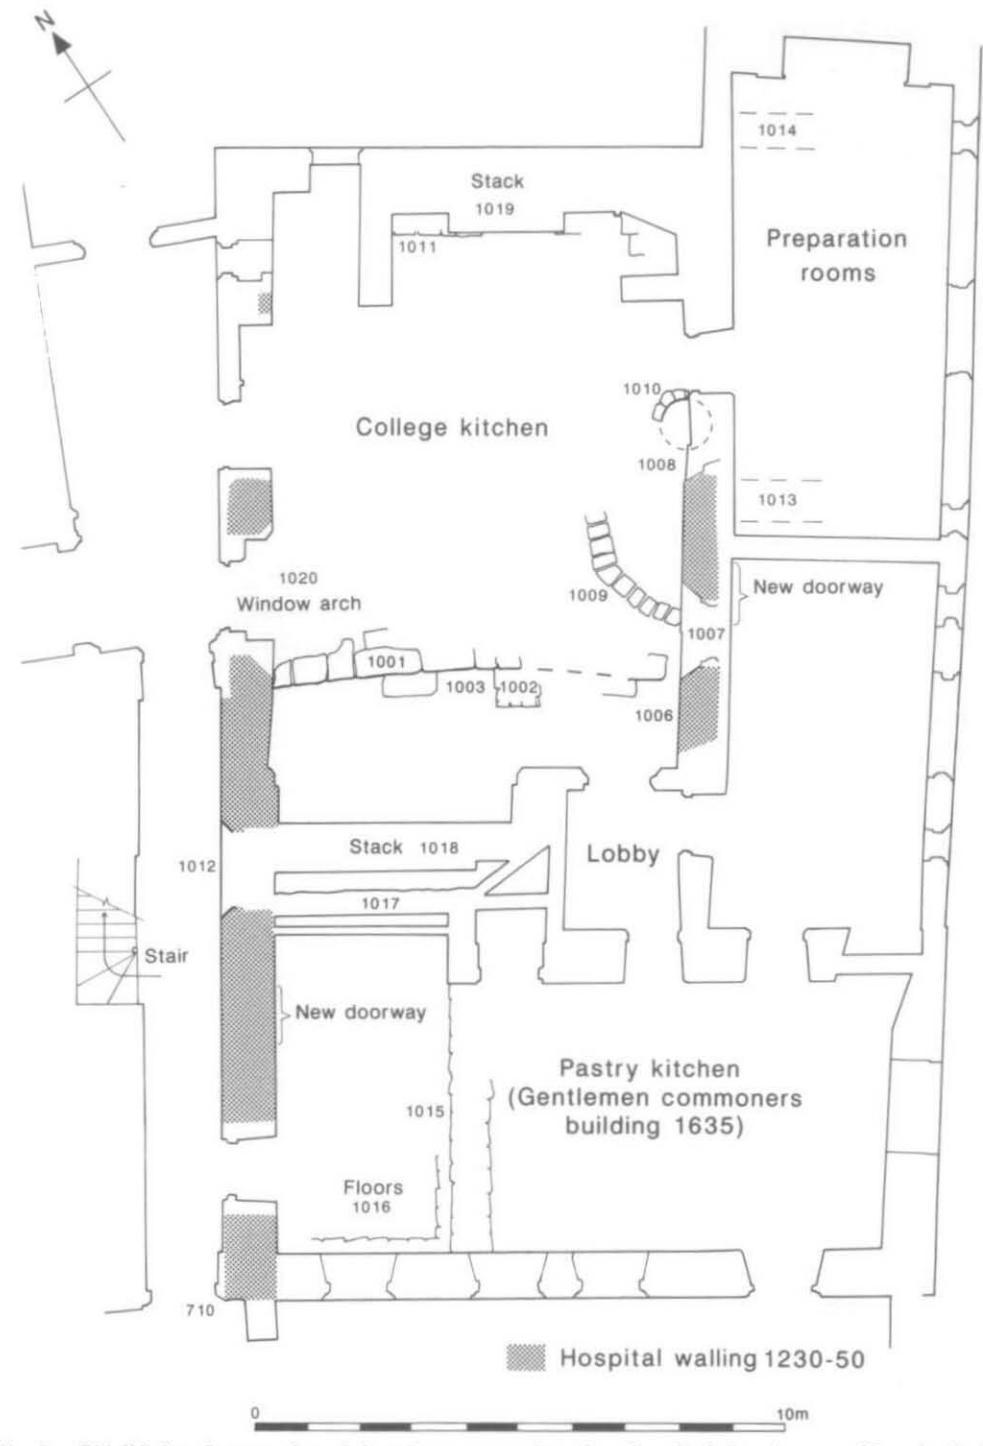
Fig. 9. Old Kitchen Survey: plan of the salvage excavations, based on R. Selwood survey. Note the limited survival of 13th-century fabric.

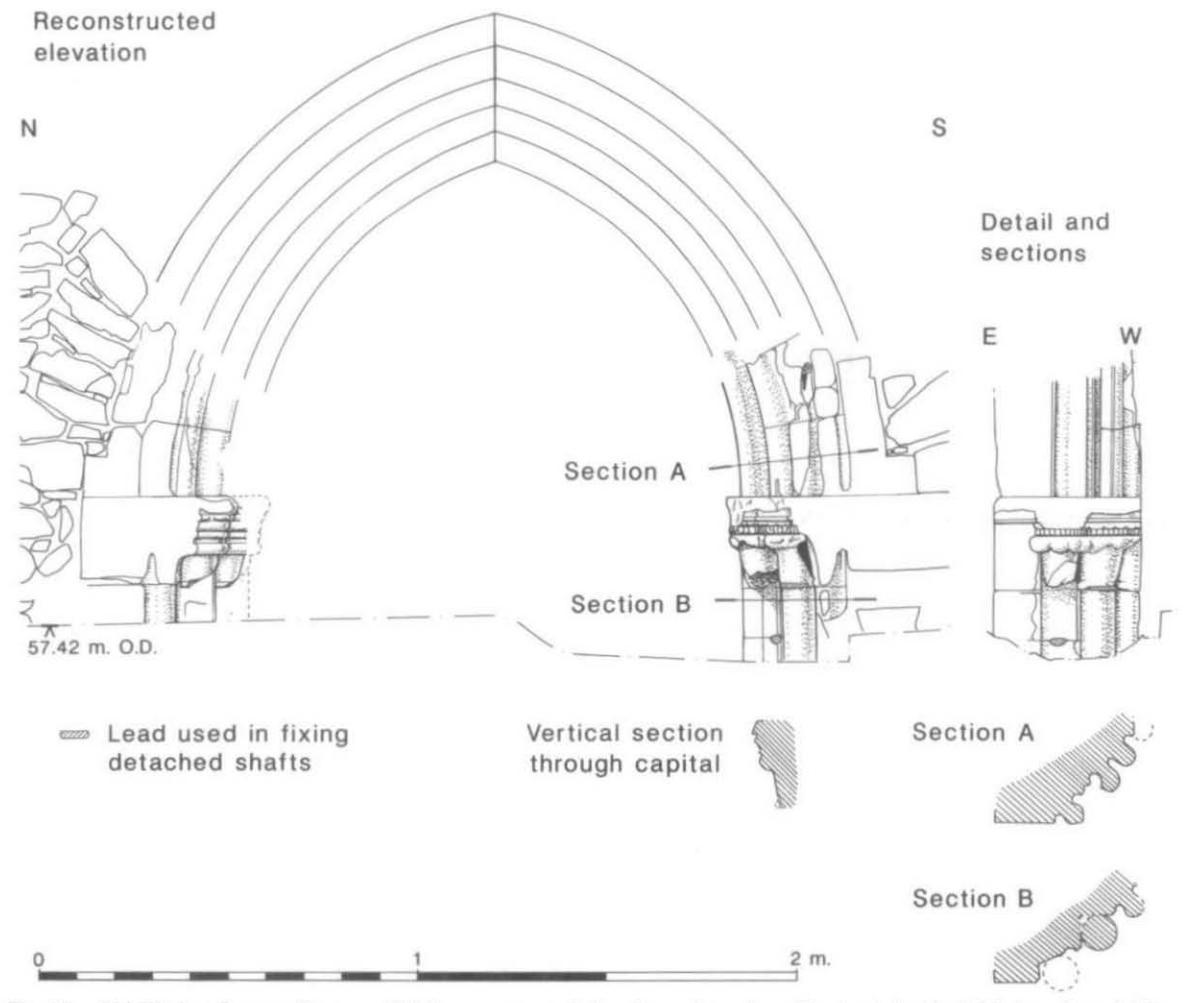
Fig. 10. Old Kitchen Survey: Doorway F1012, reconstructed elevation and sections. The lead plug is visible just above infill level on S. jamb.

The Medieval Doorway (F1012, Figs. 9, 10; Pl. 9)

The college's engineers were prepared to allow part of the stone blocking to be removed from the outer elevation of the medieval doorway to investigate and record the mouldings. Since the south jamb had survived better from the cutting back of the outer mouldings, it was this side which was chosen to be more completely exposed. Danyon Rey recorded elevations and sections, and noted the contrast between the two capitals. The college decided that the more complete south side should remain exposed in a reveal which would be covered with clear plastic when the remainder was panelled, and it was therefore available to be inspected by R.K. Morris who has recorded it as No. 901 in the University of Warwick Mouldings Archive. Dr Morris writes that he has:

little doubt that the doorway lies in the date-range 1220–60 and most probably c. 1230–50. Most distinctive is the type of roll-and-fillet of the arch, beaked only on one side. This feature is typical of the above period, mainly in provincial works in the south of England: examples are rare after 1260, and then usually combined with more elaborate filleted mouldings as found for instance in the north transept of Hereford Cathedral, c. 1260–80. Other good examples of the period include St. Frideswide's at Oxford (Lady Chapel, c. 1230); the choir arcades of Pershore Abbey (by the same workshop as St. Frideswide's); Ely cathedral, Bishop Northwold's work on the east arm 1234–52; Glastonbury Abbey, the Galilee doors, c. 1230 (?); St. Albans Abbey, the west front N.W. porch; Worcester Cathedral choir 1224–1235/40. Of these, the examples at Ely, Glastonbury and Worcester are close to the Magdalen college example in style, combining the beaked roll-and-fillet with keel mouldings as in the Magdalen arch; and significantly, Ely and Worcester are firmly dated.

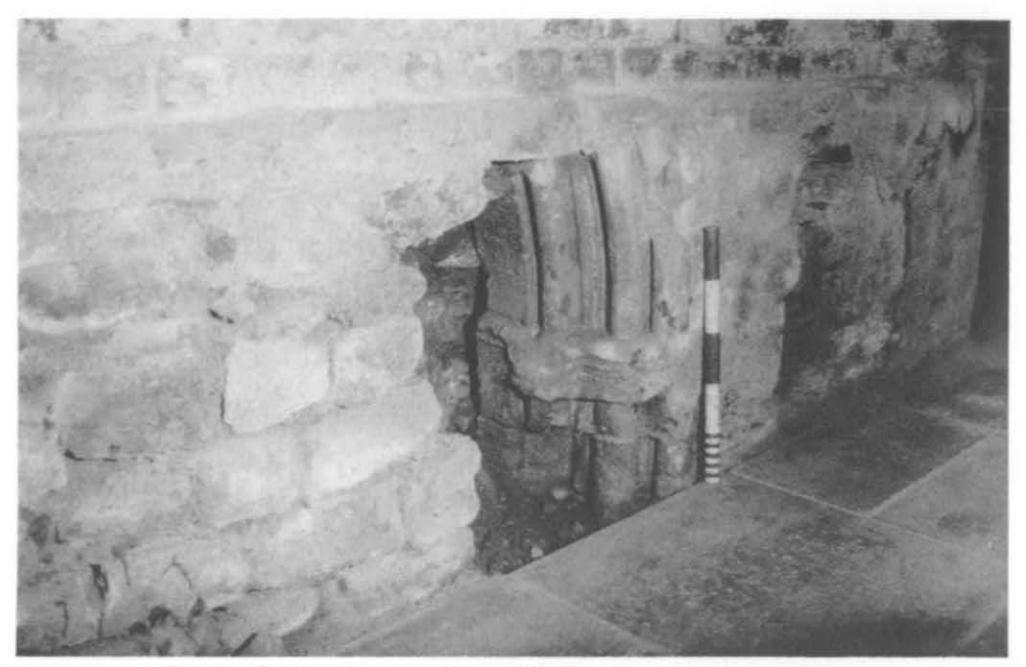
Plate 9. Detail of doorway of hospital 'hall' as exposed in kitchen passage.

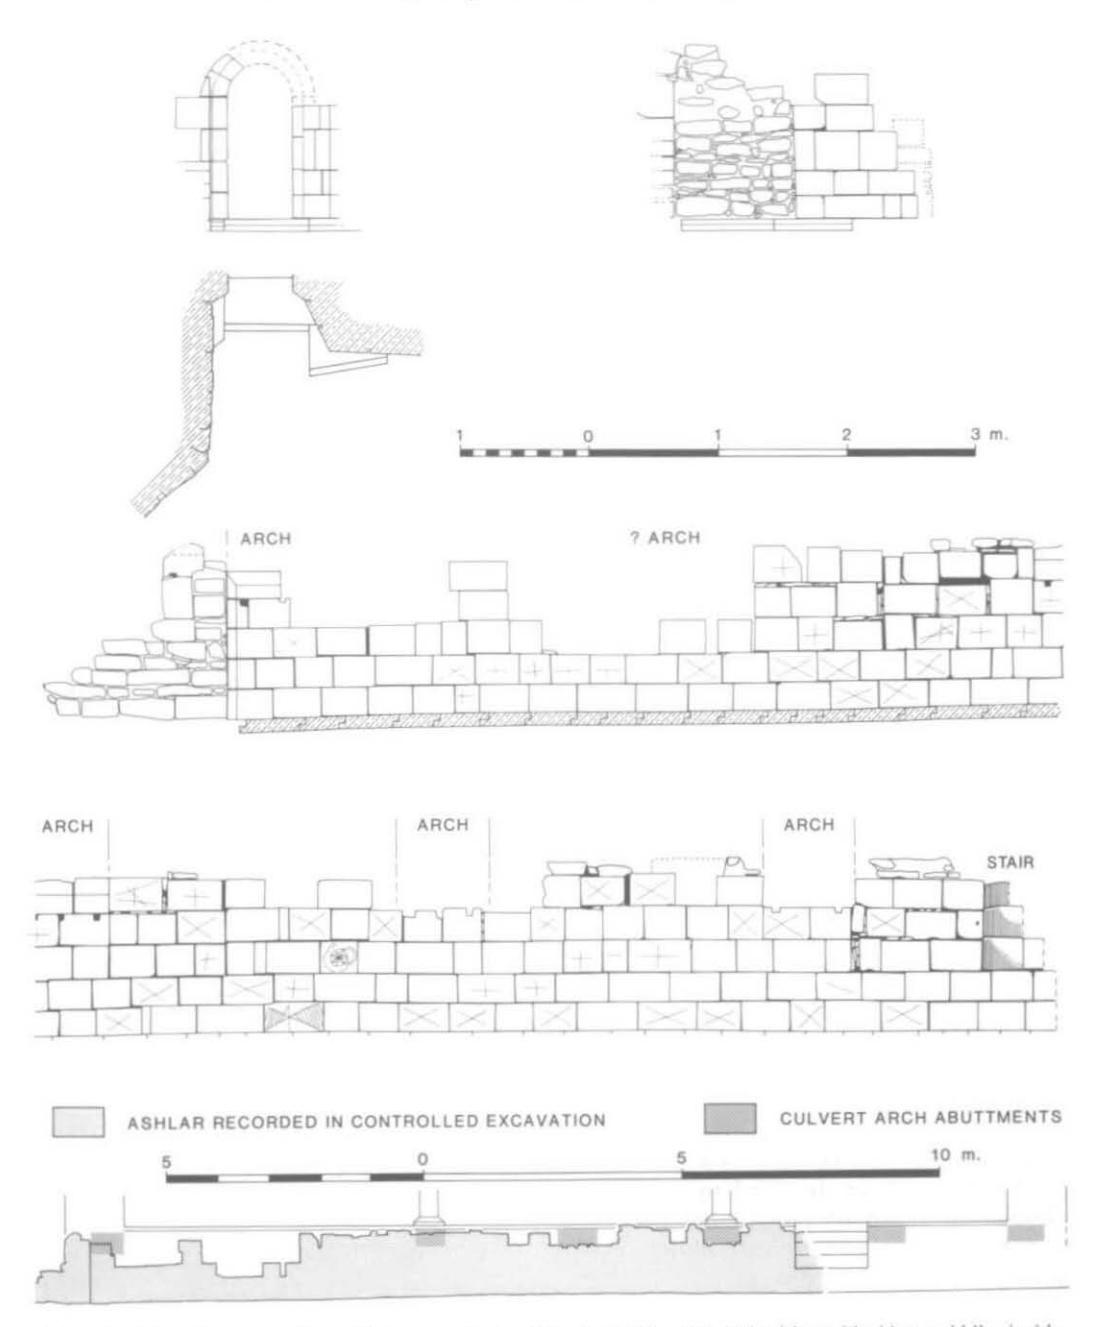
Fig. 17. The infirmary culvert. Above, south elevation of outfall, with and without blocking; middle, inside elevation of west wall of culvert showing graffiti and straight-joints; below, as above, reconstructed to show the relationships of culvert arches and stair to the three-bay arcade bases.

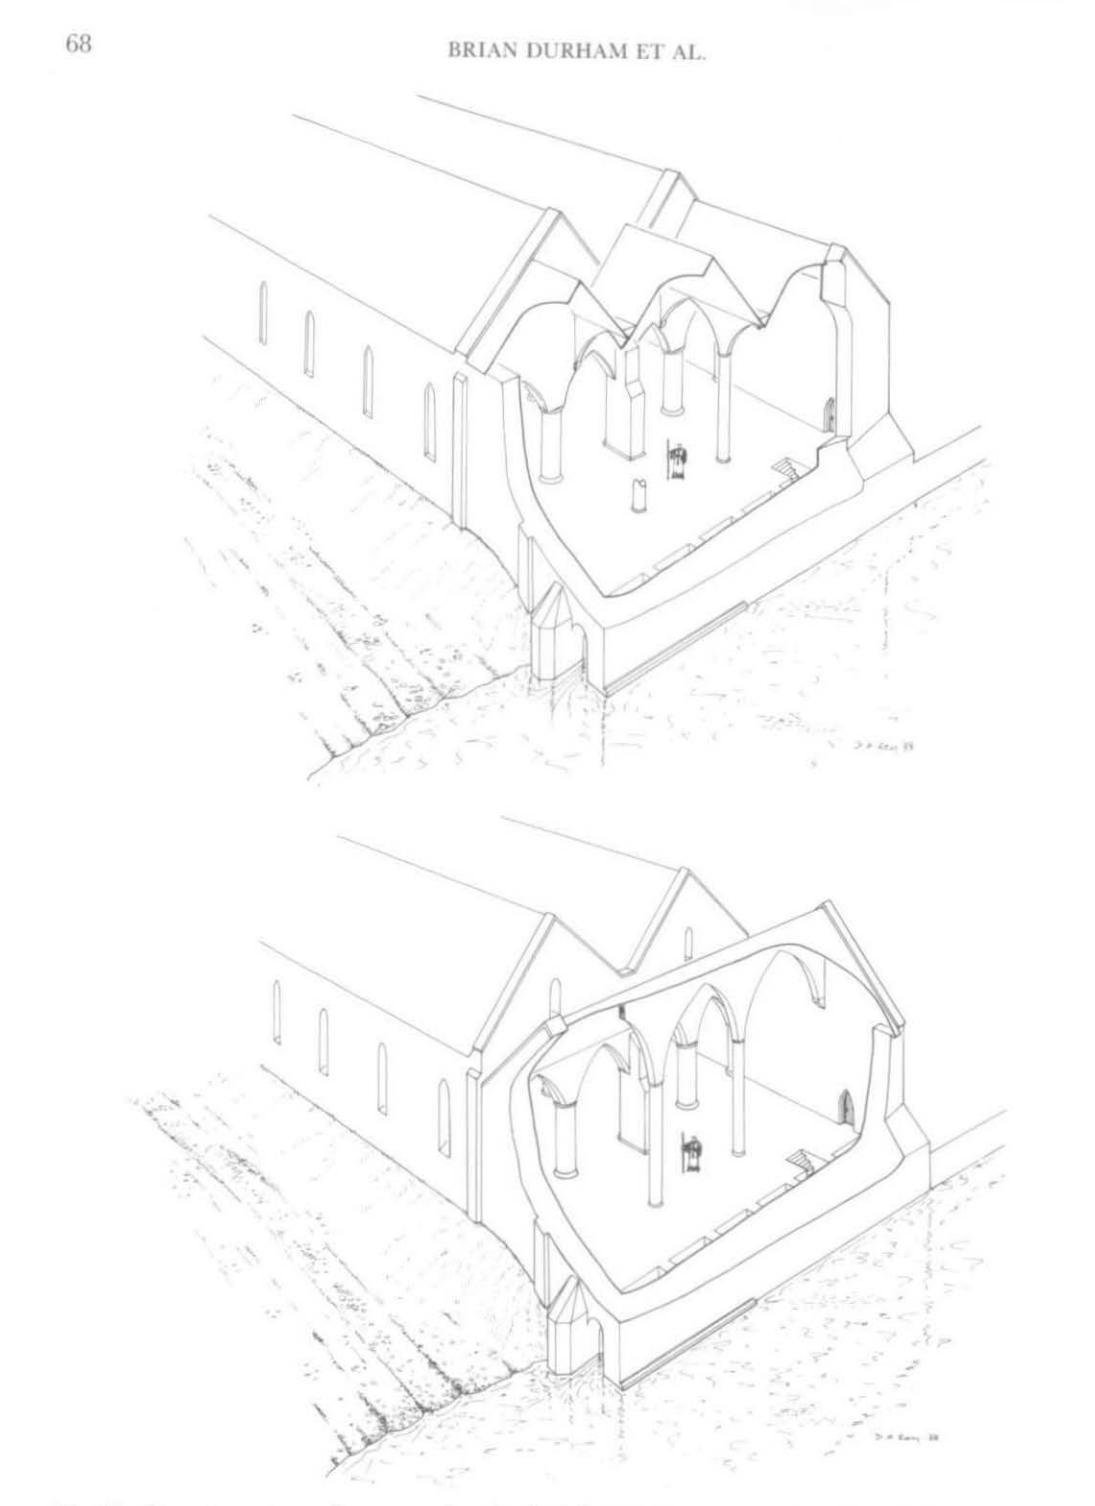
Fig. 18. Two alternative roof reconstructions for the infirmary east annexe: above, the 'aisled' option; below, the cross-roof option.

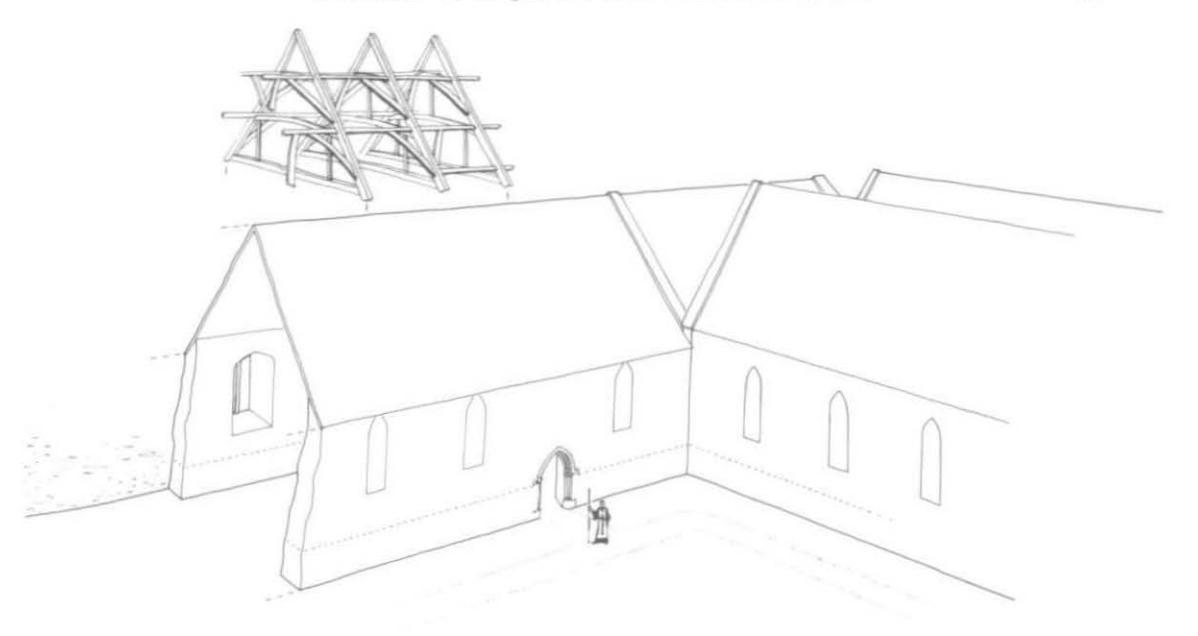
Fig. 19. Reconstruction of south-east corner of hospital courtyard, with the college roof trusses inset.
